MARINE SAFETY INVESTIGATION REPORT

**Safety investigation into a crew member fatality
inside the cargo hold on board the
Maltese registered general cargo**

KATI

**in the port of Wismar
on 16 July 2018**

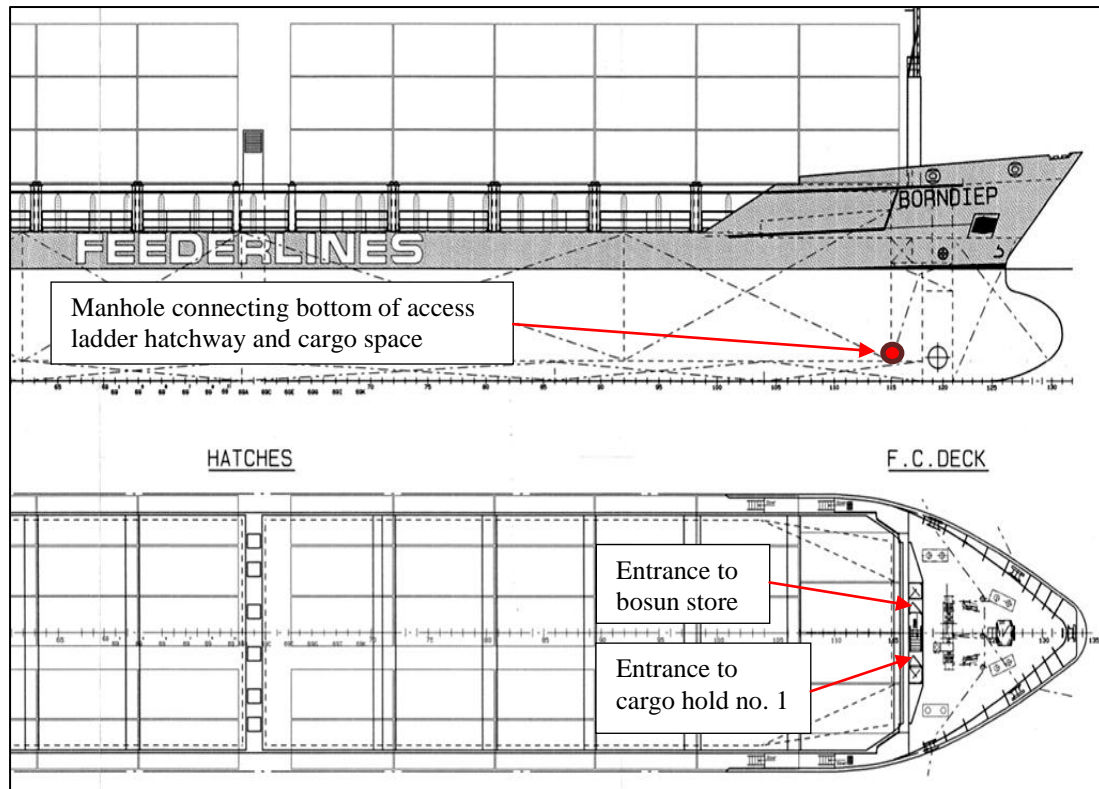
The access door to the hatchway, leading down to cargo hold no. 1, was located further to starboard and within the wave breaker's structure. Vertical ladders led to the tank top (Figure 2), approximately nine metres below.

Figure 2: Access points iwo the wave breaker

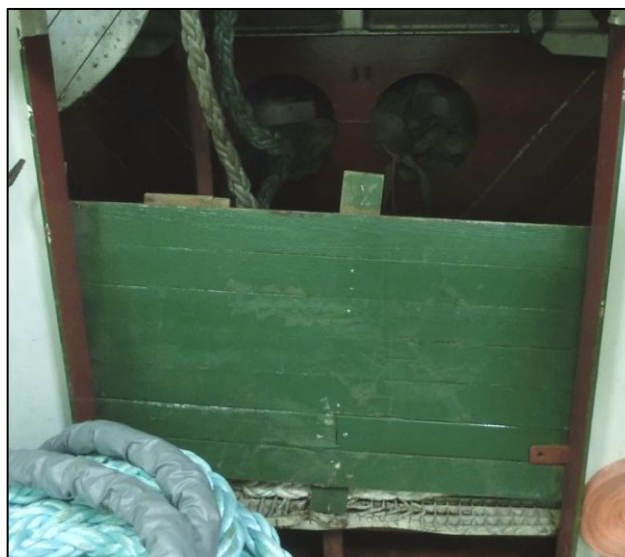
Figure 3: Wooden boards in use to block access

However, with the current cargo of wooden logs, it was not found necessary to block the manhole since there was obviously no danger of cargo spilling inside the space¹.

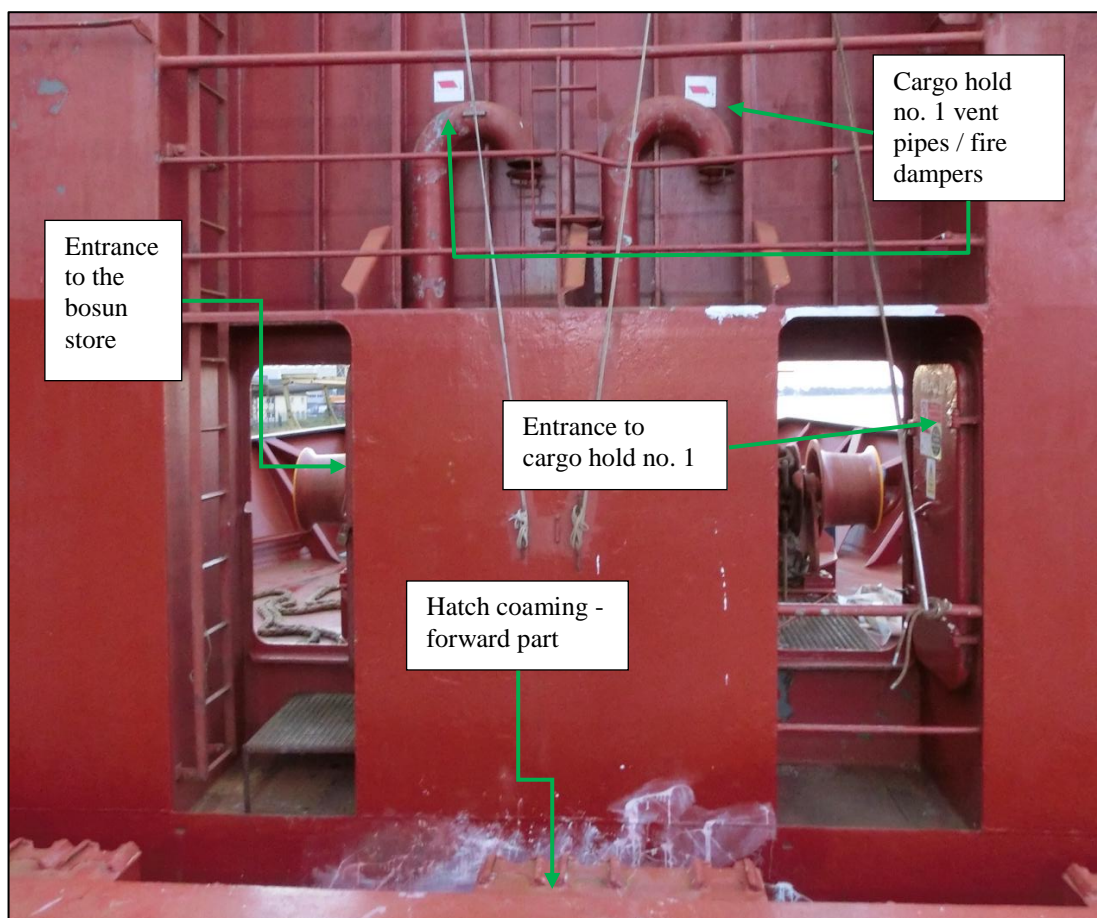
Figure 4: Wave breaker with entrance to bosun store and cargo hold no 1

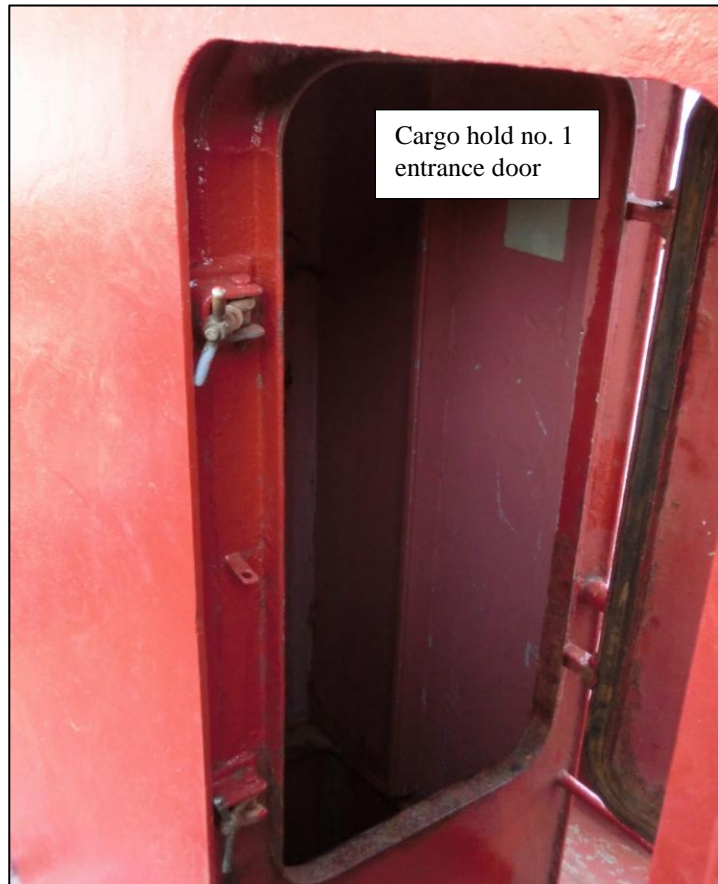
At approximately 1335, the bosun went to have a look inside the cargo hold entrance (Figure 5) and noticed a person lying on the deck, approximately eight metres down at the bottom of the access duct. The bosun notified the master by VHF about his findings. Together with the chief officer, the master immediately proceeded to the forecabin.

Figure 5: Entrance to cargo hold no. 1

- .3 The entry to the cargo hold was accessible to the crew member, with no signs posted to remind of / mark the dangers which were inside as a result of the nature of the stowed cargo;

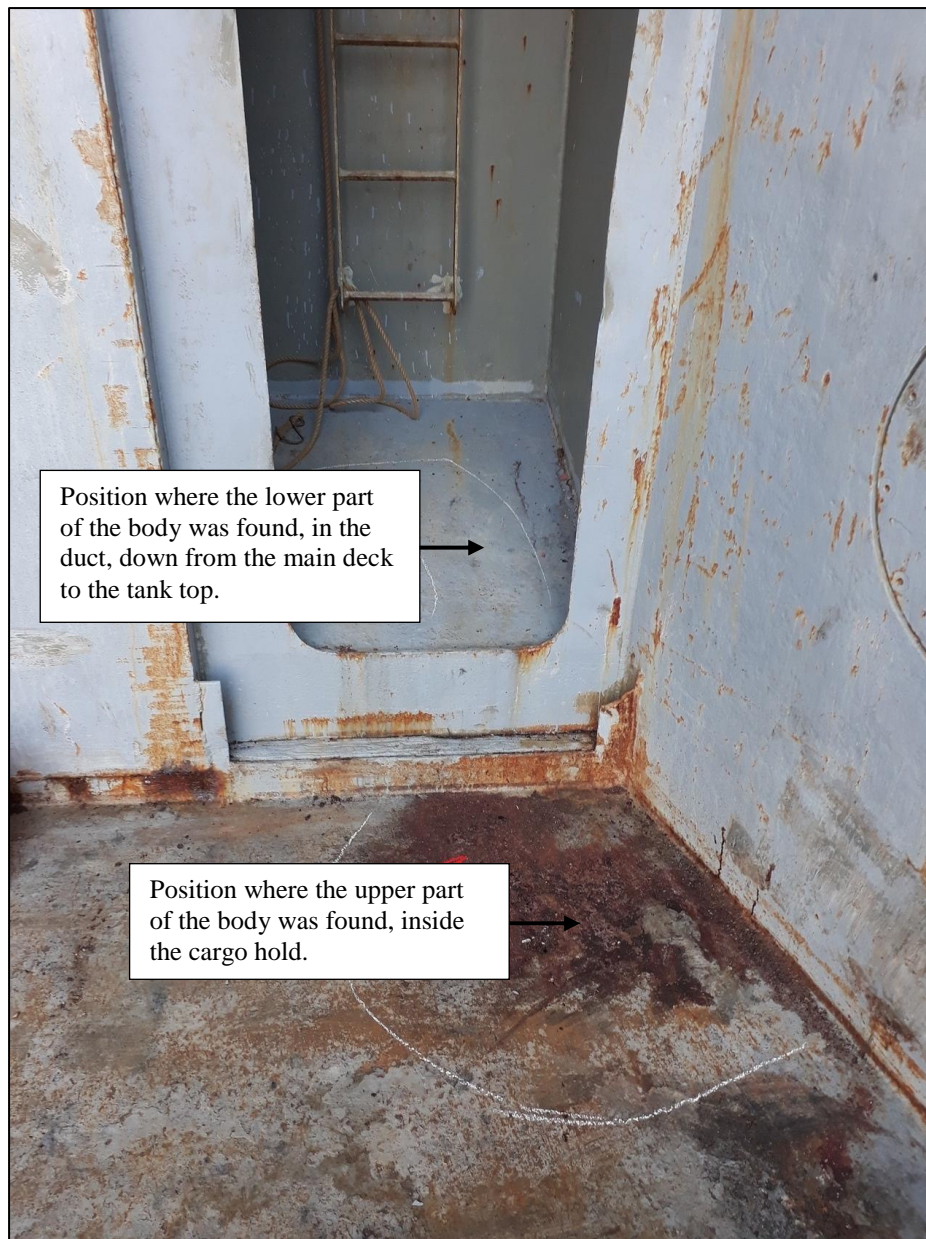
In the meantime, the crew members tried to call the distressed person lying on the tank top (Figure 6) but no reaction was observed. The second officer donned his BA set and climbed down the ladders to check the condition of the person inside the cargo hold. Down inside the cargo hold, it was noticed that the person was the AB missing

Figure 6: Location where the crew member was found, in close proximity to the access duct

The AB was found with injuries to his head. Although the MSIU could not verify the cause of these injuries, it was considered that probably, he had fallen off the ladder in the access duct for cargo hold no. 1 during his descent and before reaching the tank top, as a result of the above mentioned symptoms.

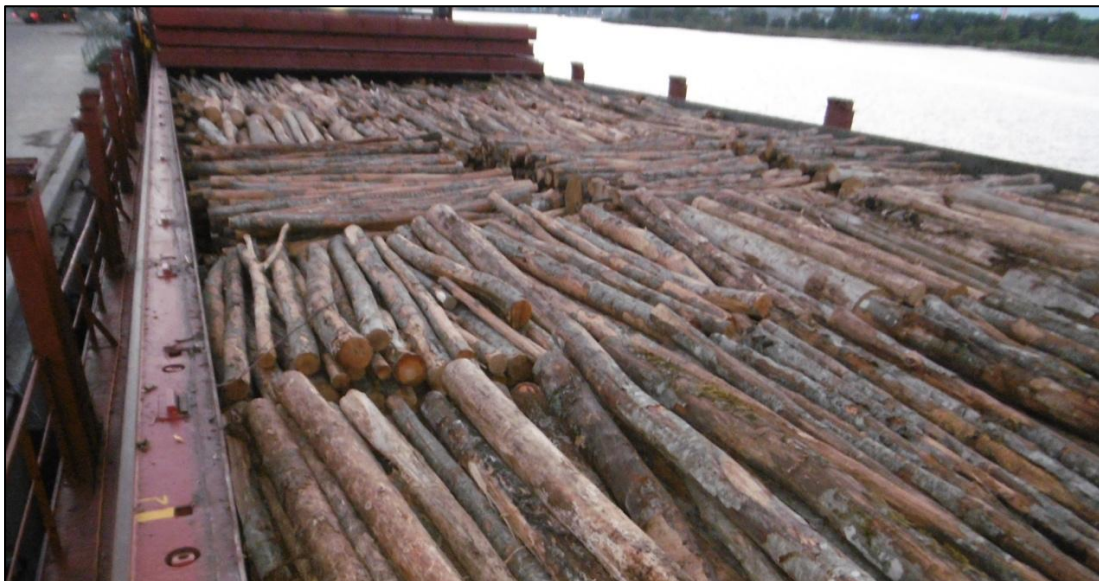
Figure 7: Fuel logs loaded on board in Pärnu

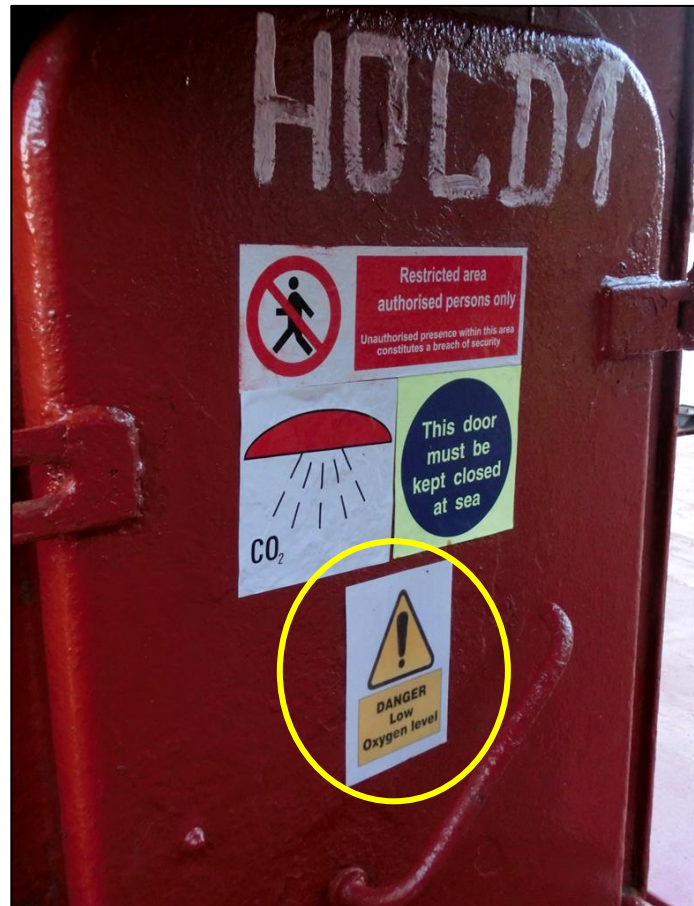
Figure 12: Warning sign affixed to the cargo hold access door

Immediately following the accident, notices cautioning of the potentially hazardous situation on board were affixed on the access door to cargo hold no. 1 (Figure 12).
