Lifeboat accident on board M.V. "Lowlands Grace" on 7.10.2004 causing two fatalities

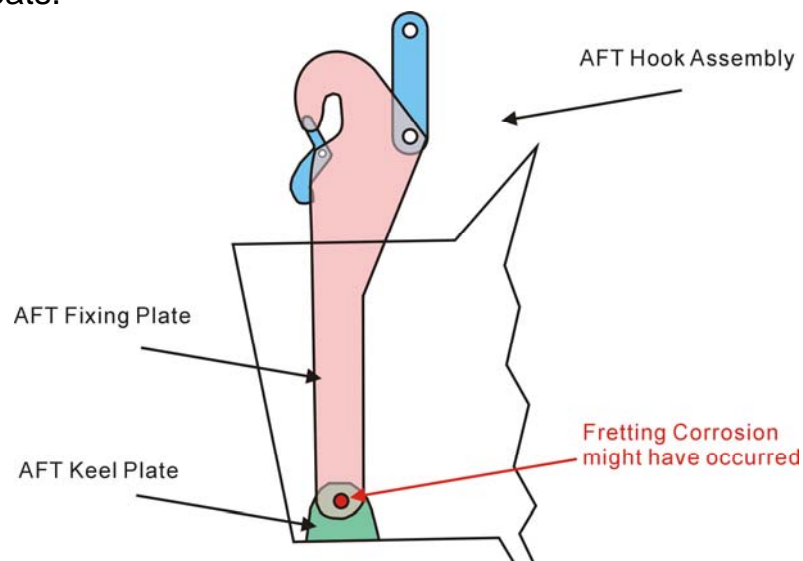
- c. Fretting corrosion might have also occurred around the securing bolt area of the fixing plates. The securing bolt was a full threaded bolt instead of a fit bolt. Fretting corrosion could have therefore occurred between the contact surface of the securing bolt and the lower part of the fixing plates.
- d. Metal defects, which may be hidden, has long been associated with failure of fabricated structures. The crack being suspected in this fatal incident, may have initiated when excessive stress encountered during the rough handling of lifeboat during launchings. The crack can, over some period of time, move slowly its way across the material as the part flexed or the stress is oscillated at different levels. The crack weakened the structure and subsequently tend to cause fractures or failure of structure.

Fretting Corrosion at Contact Surface of the Securing Bolt and the Lower Part of the Fixing plates

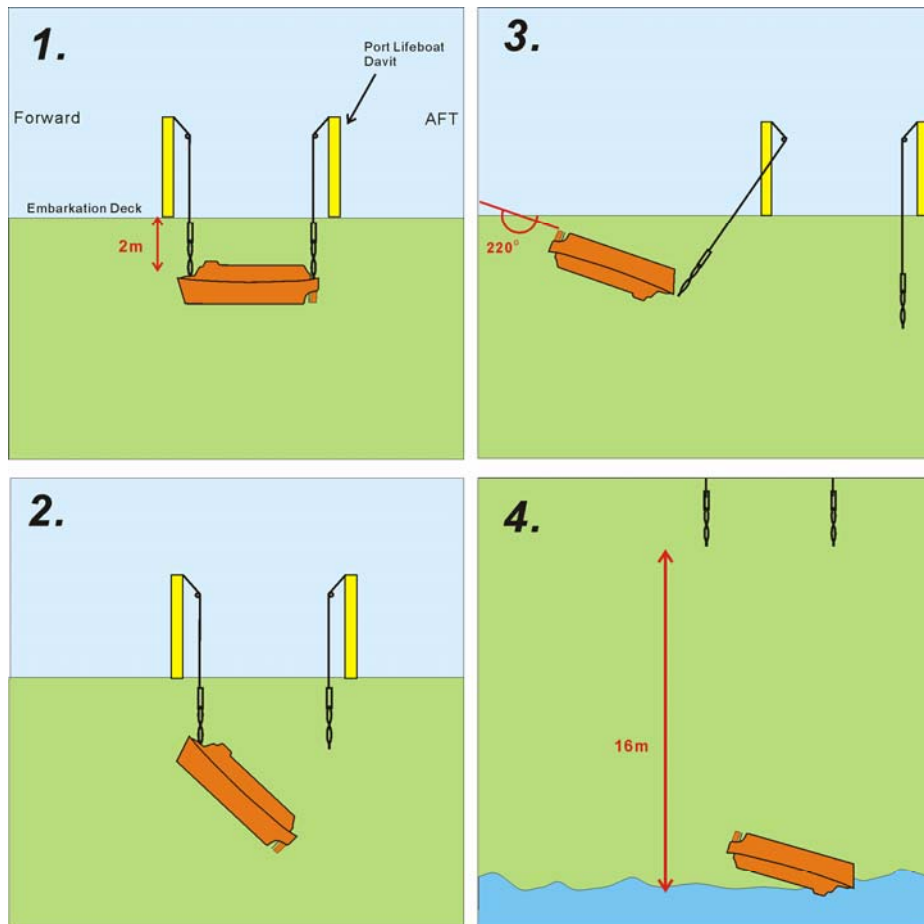
1. The port lifeboat was launched by the 3/O using the remote control wire inside the lifeboat.
2. After the port lifeboat had travelled for about 2 m, the after part of the port lifeboat detached and the port lifeboat swung forward on the forward hook.
3. The forward hook opened at the top of the swing for about 220° and the port lifeboat started to plunge into the sea in an up side down position.
4. The port lifeboat plunged into the sea from a height of about 16 m.

Sequences of Events Leading to the Dropping of Port Lifeboat into the Sea
