**The Bahamas  
Maritime Authority**

**NOVA BRETAGNE**

**Report of the investigation into the  
Accidental release of lifeboat during a drill**

**Antonina, Brazil**

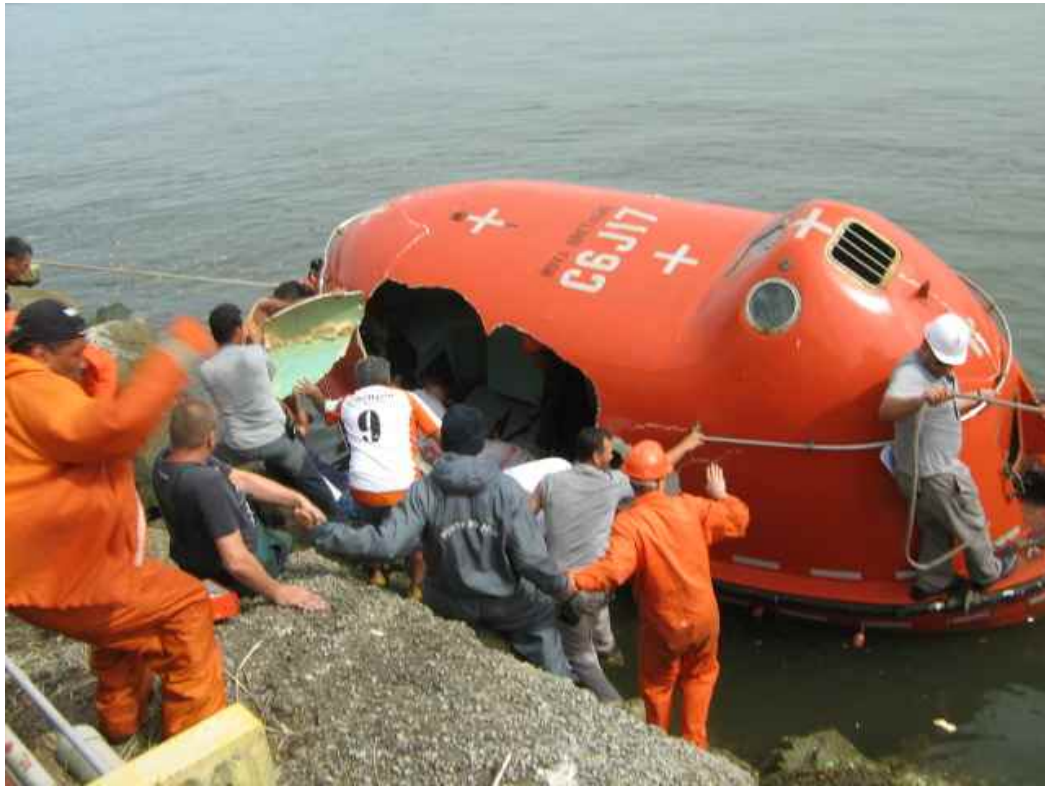
- 1.7** The boat righted itself in the water but substantial damage had been inflicted on the upper works of the hull. Minor holing identified as contact with the davit had also occurred to the hull.

**Photo 1: Ship's crew move quickly to recover the damaged boat to the shore after the accident and to rescue the injured boat's crew.**

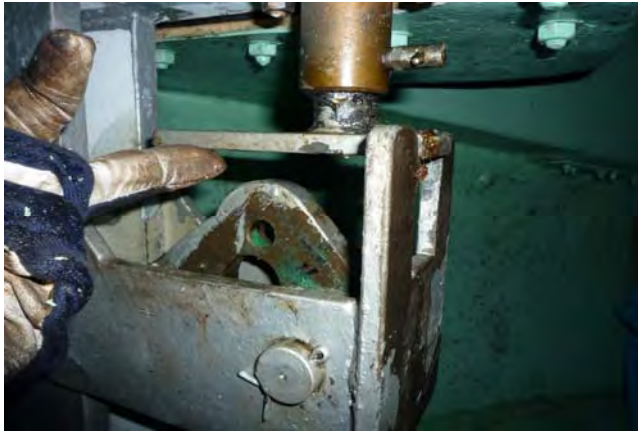
Photo 2 and 3: Under-deck cam plate.

The under-deck Cam Plate indicating a position in which the release of the hook was possible (not necessarily the position in which the failure occurred but held in this position for clarity of subject area )

- 4.27** The Cam Plate(s) – Fig.2 ④, must have been out of position for the above to occur. They must have been below the horizontal indicated in the instruction close to the helmsman's feet (Photo 2). If they had not been the hooks would have been effectively locked. This indicates therefore that the crew did not correctly interpret this signal of danger, assuming they observed it at all.

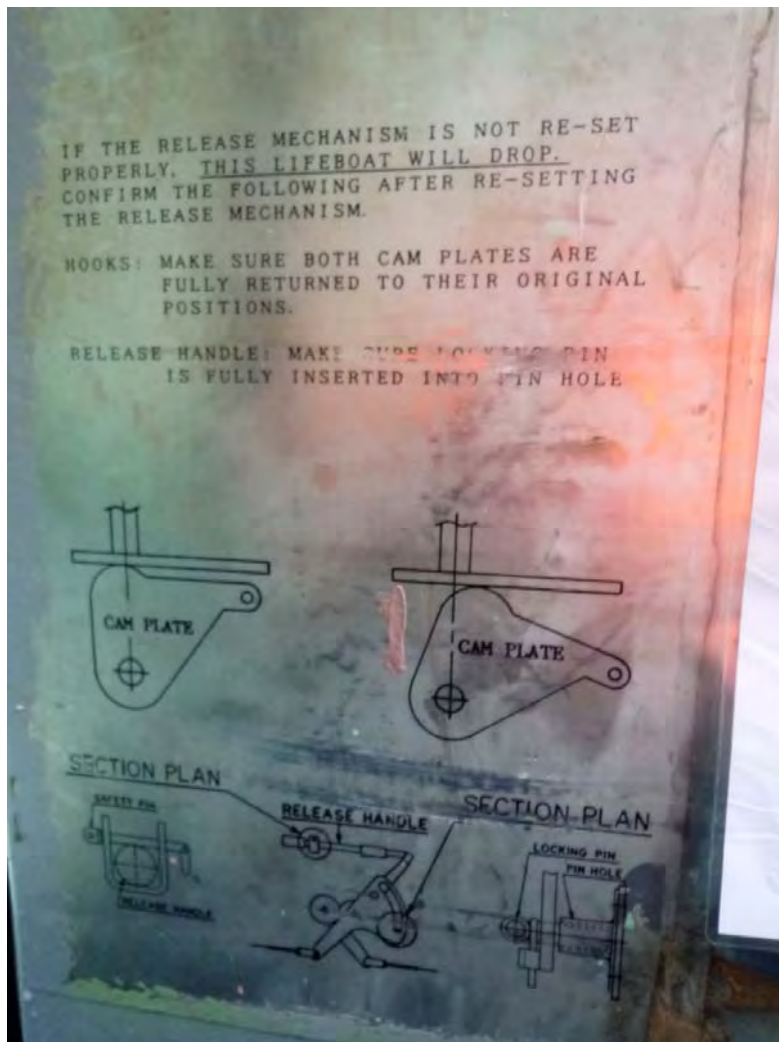
Above:  
The instruction plate close to the helmsman's feet, indicating correct and incorrect settings for the under-deck cam plate

- 4.45** The instruction plate (Photo 3) relating to the Cam Plate ④ setting is an engraved plaque. It does not have any highlighting features, it should have. Similarly the Cam Plate (Photo 10) is a neutral colour. It could be painted in a highly contrasting colour so as to emphasise its importance.
- 4.46** The decision to disconnect the boats from the falls is entirely within the requirements of SOLAS but, ignoring the competence of the crew and their natural instinct for self-preservation, there is very little to prevent the users doing so inadvertently.

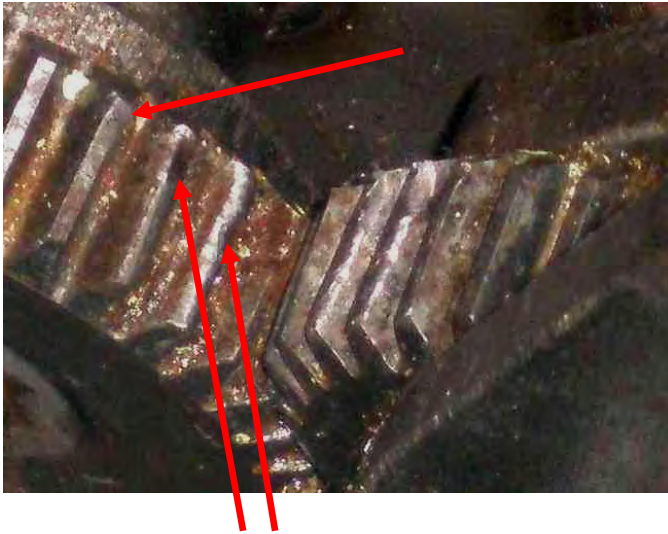
**Photo 4 and 5: Release mechanism activation point.**

- 4.5 Investigation revealed that the release lever mechanism at the activation point used by the helmsman was damaged although it was still operable. Interlocking teeth of the two meshing gear wheels were damaged. These in turn operate the cranks that are connected through the turnbuckles to the flexible cables operating the under-deck cams.

**Gear teeth showing damaged interlocking surfaces; Some but not all signs of damage arrowed.**

- 4.7 The cause of the damage to the gear teeth has not been determined, there were no records relating to it. The cause of a lock-up as suggested above was not evident during investigation, all movement on the hooks and associated parts, including cables having been found free. This does not however prove that it was always thus. No records were available reporting such malfunction.

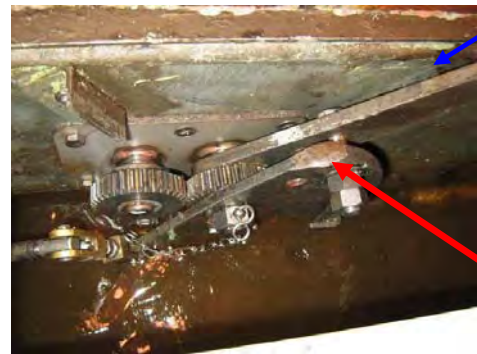
**The assembly as a whole seen from above and slightly outboard to starboard; Evidence of abuse hammering: arrowed red and backplate joint of flattened lever stop: arrowed blue.**

- 4.9** The stop referred to above is not fully visible in Photo 5 but it's joint with the back plate is. It is positioned behind the lever, between it and the back plate in a folded flat state. This means that the lever pictured is not in the correct position – it is too far forward – suggesting that the whole linkage is out of adjustment. This in turn allows for a final position of the Cam Plate intended to lock the hook could be out of the horizontal. (see also 4.5 above and 4.11 below).

- 4.34** The abuse damage found on the gears and crank of the after release gear, added to the damaged stop plate strongly suggests that the mechanism has not been fully understood by crews in the past. The significance of the release lever being out of position and other linkages similarly has apparently been missed.

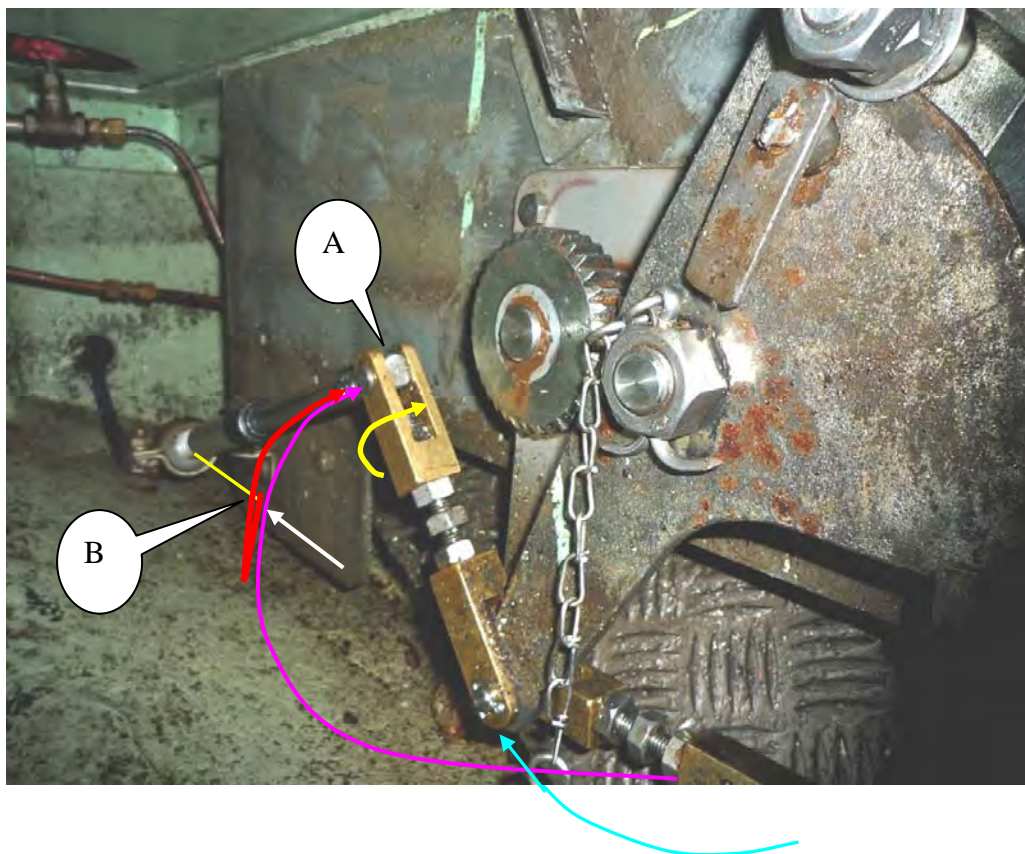
**Photo 6: Release handle mechanism displaced from correct re-set position as found possible at repair yard. Note orientation of outer clevis (upper centre of picture).**

- 4.14** Displacement of the after outer clevis is possible as in Photo 6 through the conical path shown in magenta. Because the locking nut on the turnbuckle is inadequate to resist the resulting torsional forces the rotation indicated by the yellow arrow in Photo 6 is possible. The Release Lever, in being pushed forward to the re-set position causes the crank to which it is attached to describe the arc shown in turquoise (light blue) in the vertical longitudinal plane. The crank arc is constrained to the longitudinal plane by its rotation about the pinion of the Gear Pin (see Figure 1), which is fixed in the athwartships or lateral plane. The cable end to which the outer clevis is attached however is free to rotate over a limited field of movement by the ball joint bracket by which it is constrained (left of picture in distance of Photo 6). The correct path for the cable/clevis joint is shown by the yellow line and white arrow.

- 4.17** In the event of resistance of movement of the under-deck cam plate, the conical displacement shown by the magenta line in Photo 6 is possible as soon as the clevis rotates under the asymmetric rotational forces acting upon it in the event of a resetting movement. The additional articulation of the linkage caused thus will result in little or no movement of the under-deck cam plate at the far end, i.e. the after or forward hook, all of the displacement having been taken by the articulation of the outer clevis. This in turn leaves the hook susceptible to opening as the tail of the hook is not fully secured in the correct closed position.

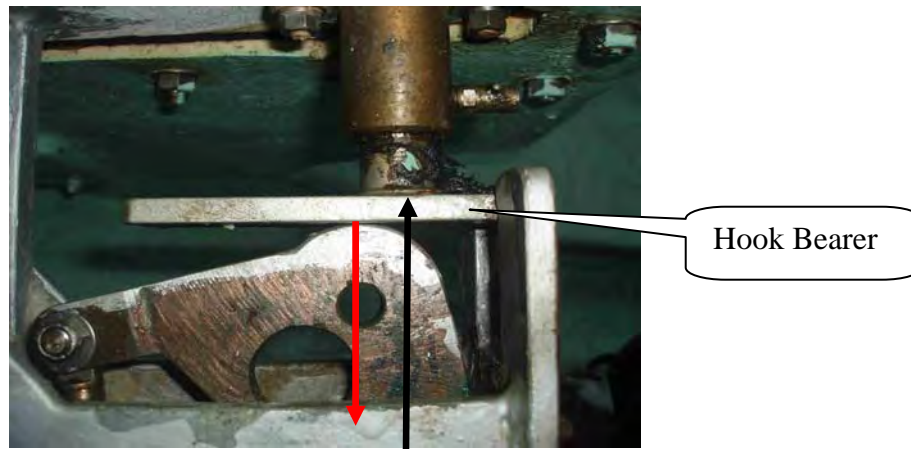
- 4.18** The under-deck Cam Plate, position in the above abnormal circumstance would be similar to Photo 7 below.

**Photo 7: Under-deck Cam Plate in incorrectly re-set position.**

In this position the tangential contact of the Cam Plate with the Hook Bearer will not be aligned vertically above the fulcrum point and the combination of the down thrust due to the pressure from the hook (red arrow) and the upward reaction through the Cam Plate fulcrum (black arrow) will result in an opening couple. See also Figure 2.

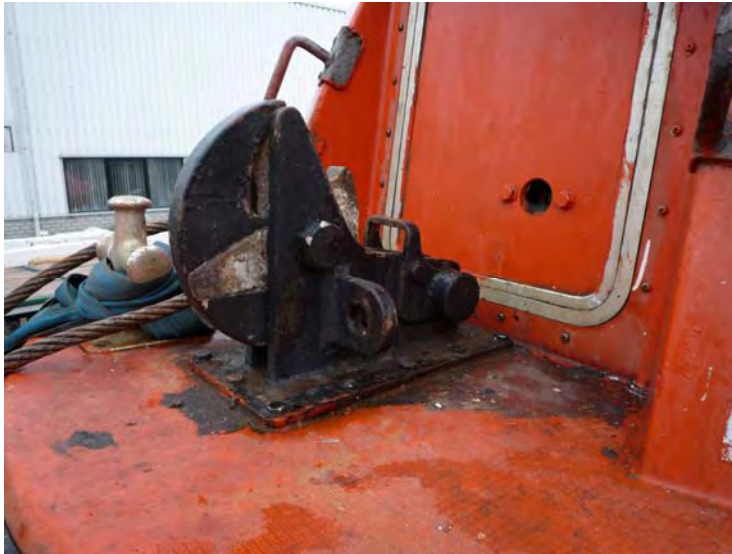
- 4.21** It is noted that there are some minor differences between the hook fitted to the boat (Photo 8) and the one depicted in the manufacturer's drawing (Figure 2). The side plates do not have the extended horn with hanging-off points formed by the shackling hole - Figure 2 - (30). They are however provided with lugs on either side (starboard lug visible in photo). These lugs have significance in the use of FPDs discussed below.

**Photo 8: Hook as fitted. Note lug on side of side plate. There is another on the opposite side.**

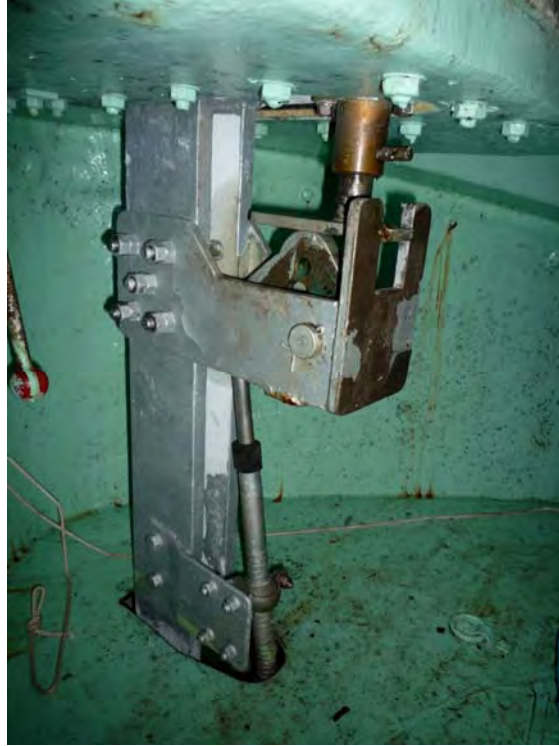
Cam Plate in the horizontal position are locked shut. Unfortunately, if the Cam Plate is not correctly positioned it provides a lever that is able to transmit forces into the system of linkages (cables, turnbuckles and levers) between that position and the control. If any part of that system allows sufficient play the hook may reach a position whereby it releases. There is no locking arrangement to ensure the Cam Plate is held in the correct position. There could be. (see recommendations)

**Photo 10: Underdeck Cam Plate visible for status check. Note this is incorrectly set.**

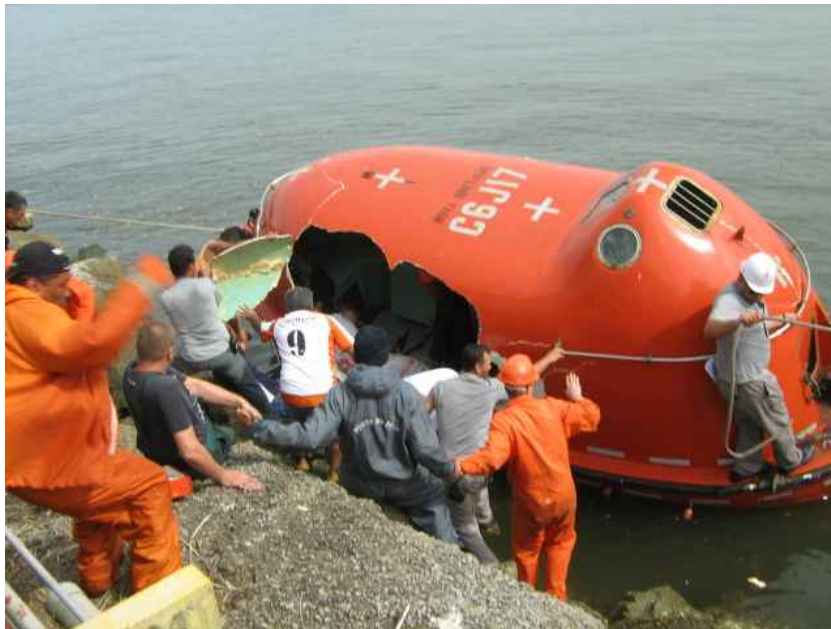
**Photo 11: Lifeboat immediately after the accident. Note in relation to 4.45 above, the positions of the viewing apertures available to the helmsman and directions in which they face.**

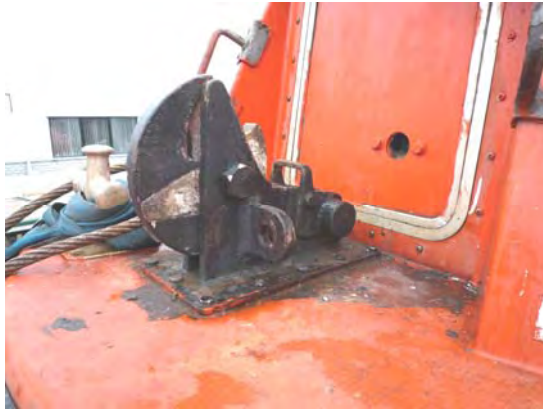
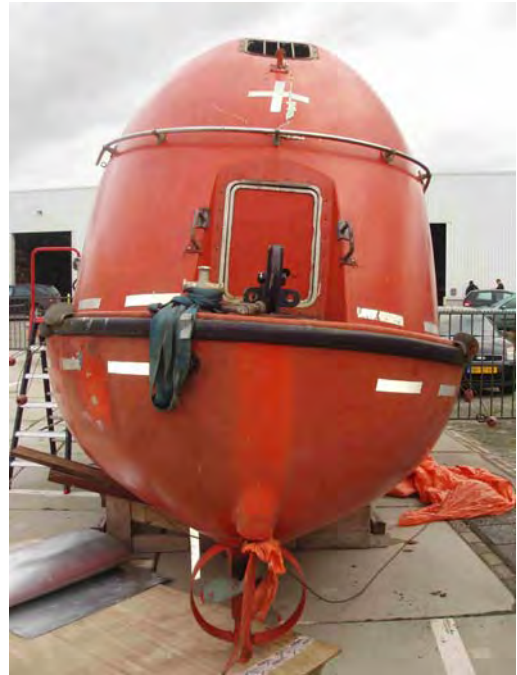
**Above and Right:** After hook arrangement on the SHIGI boat showing side lugs that are suitable points of attachment for FPD Slings.as in the arrangement below.

Note the close proximity to the access hatch, making this arrangement even more suitable as an immediate modification.

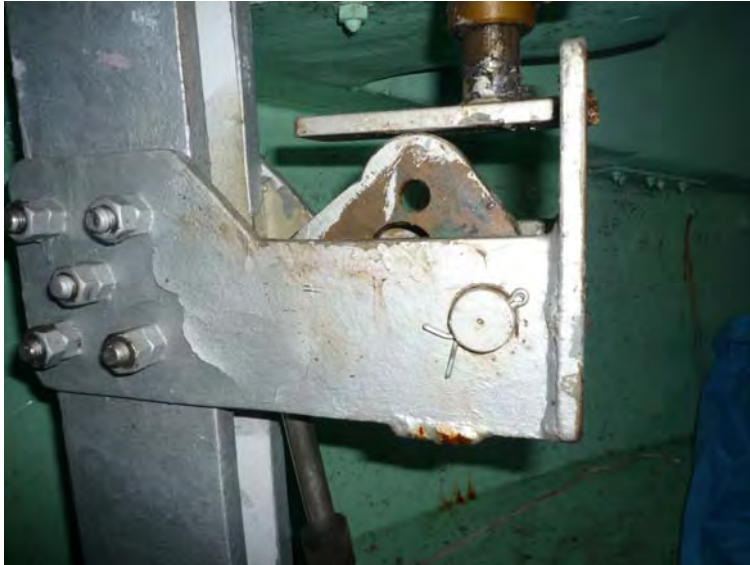
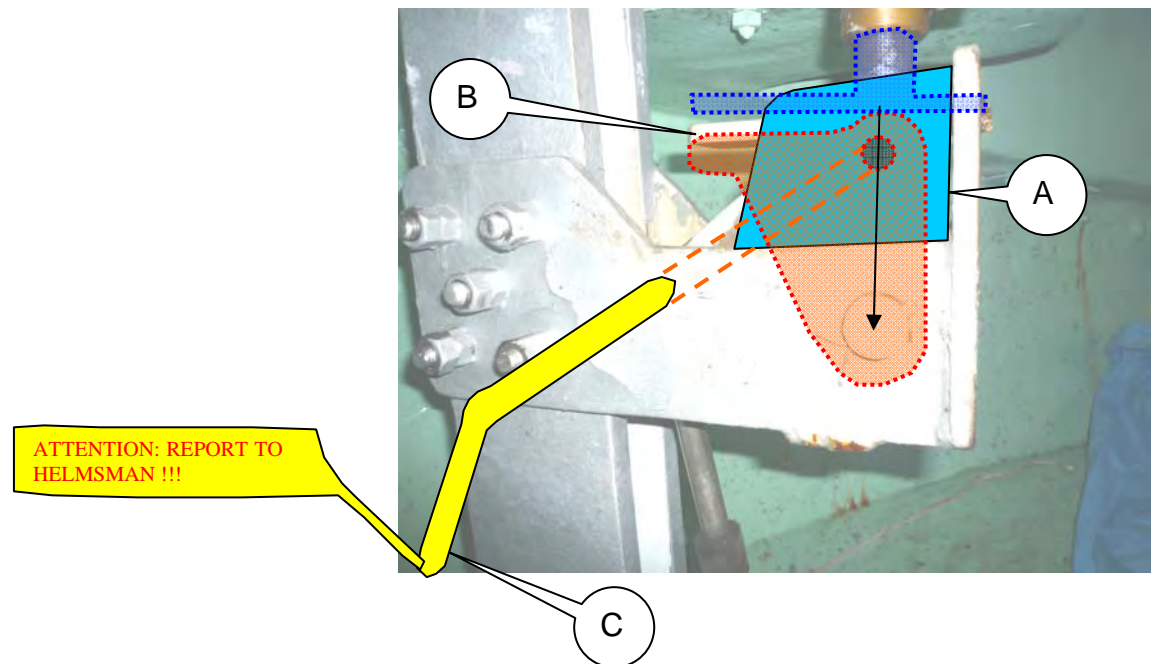
### 2: Pins.

Left: The existing arrangement in the Shigi boat and

Below: One possible modification .

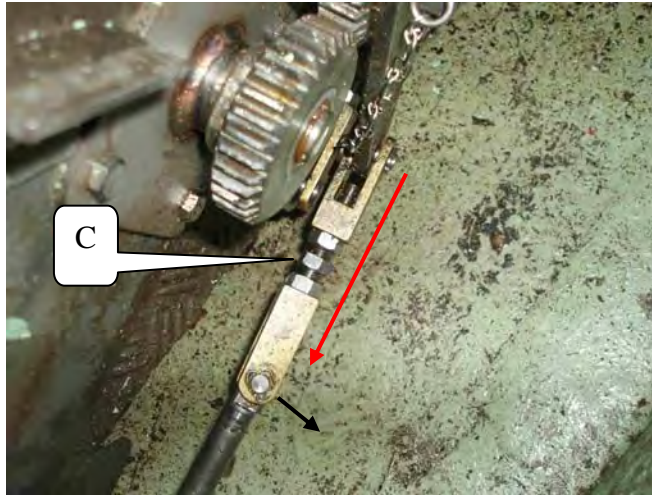
- 4.37** The single point of failure evident at each of the hooks is further compounded by another at the turnbuckle which has a single inadequate locking arrangement. The arrangement is evidently unable to prevent inappropriate rotation and additional articulation in the linkages.(see 4.15, 4.16 and Appendix III)

In the photo above the turnbuckle adjuster has been correctly adjusted with the two clevis pins at right angles to each other. In the photo the reset lever has begun its travel towards the re-set position and it can be seen that the clevis serving the after cable connection (bottom of picture) has already begun rotating out of the right angle aspect to its partner. The locking nut on the adjuster (C) is unable to resist the torsional stress caused when the cable end is displaced outboard (arrowed black) during the compression movement (arrowed red). The locking nut amounts to a single point of failure.
