MAIB SAFETY BULLETIN 2/2011

Malfunction of a proximity switch, which resulted
in failure of a fall wire with the loss of one life
on the car carrier *Tombarra*

MAIB

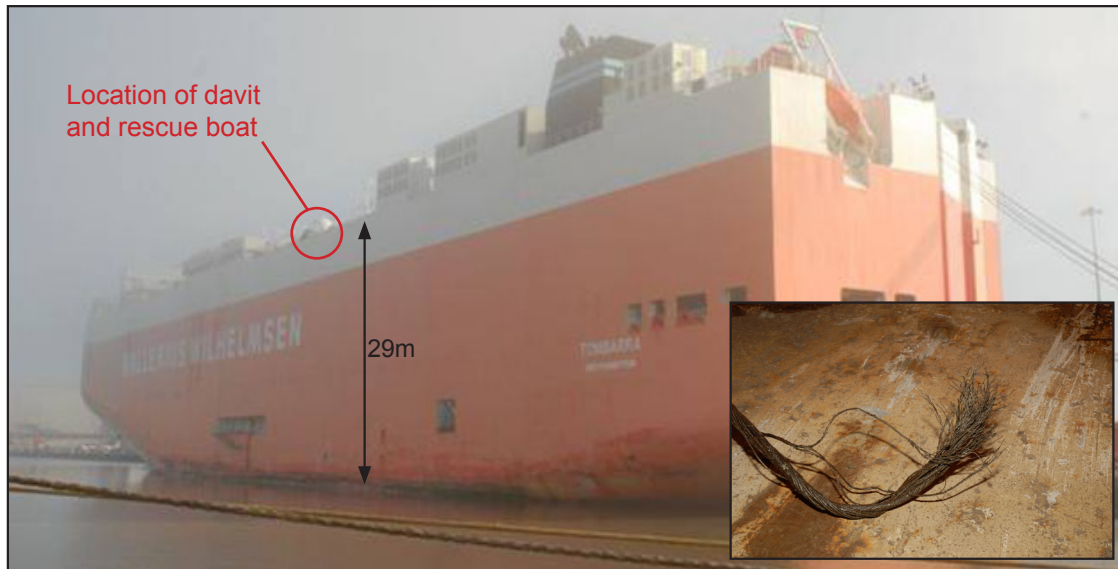
Figure 1

At approximately 1550 (UTC) on 7 February 2011, the fall wire of the rescue boat on board the UK registered car carrier *Tombarra* parted when the vessel was alongside in Royal Portbury Docks, Bristol, UK. The accident occurred as the rescue boat reached its stowed position on the davit following a monthly drill. Hoisting was not stopped before the davit reached its stowed position. The proximity switch, that should have cut electrical power to the winch motor before the davit reached its stops, failed to function. The rescue boat and its four crew fell nearly 29m (**Figure 1**) into the water below. One of the boat's crew died and two were hospitalised.

Vessel and parted fall wire

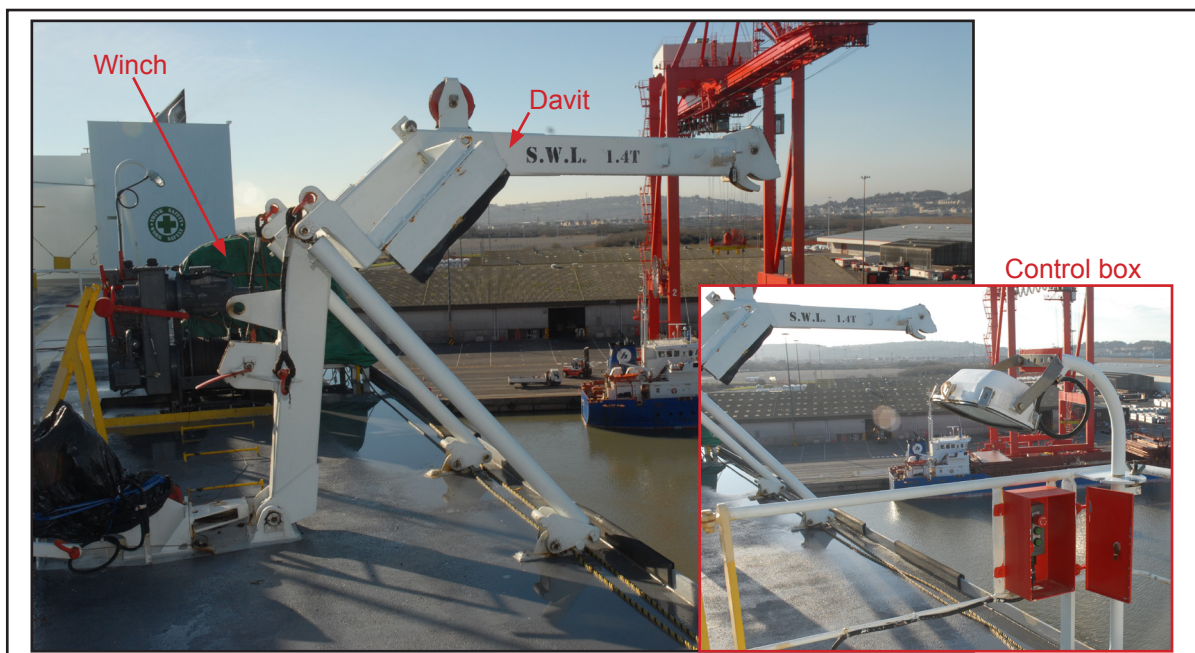
Figure 2

The 12mm diameter fall wire had a certified minimum breaking load of 141kN. Its safe working load (SWL) was 23.5kN based on a factor of safety of six. The wire was fitted to a single-arm davit (SA 1.5) (**Figure 2**), manufactured by Umoe Schat-Harding Equipment AS (Schat-Harding). The davit system was powered by a Schat-Harding W50 two-speed electric winch with a nominal pull of 50kN.

Davit system

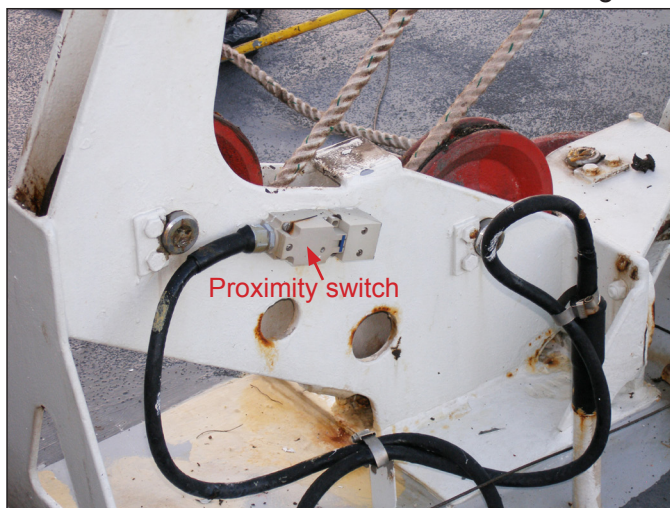
Figure 3

The winch was operated by a control panel sited forward of the davit. The boat was hoisted using the buttons on the control panel until the davit was near the stowed position. It was then intended that hoisting be completed manually by the use of a winch handle adjacent to the winch motor. To prevent the inadvertent operation of the winch when the rescue boat was in its stowed position, an inductive proximity sensor/switch (Telemechanique XS7-C40FP260) was fitted on the davit (**Figure 3**). The switch was intended to cut off power to the winch when the davit closed to within approximately 12mm of the sensor.

Proximity switch on davit

- The proximity switch fitted to the Schat-Harding SA 1.5 davit, and also known to be fitted to the SA 1.75 davit, is considered by its manufacturer to be inappropriate for use as a 'final stop' or safety device.

- The fitting of the proximity switch was not compliant with its manufacturer's instructions. As a result, the gland and cable entry were higher than the switch body and its susceptibility to water ingress was increased.

Schat-Harding has issued a Product Awareness Notice (PAN) to its customers highlighting the need to test the proximity switches fitted on its SA 1.5 and SA 1.75 davits on each occasion before hoisting operations commence, and recommends that the proximity switch is replaced every 2 years; it also highlights the need for caution when using pressure washers on deck.

- In the case of vessels fitted with the Schat-Harding SA 1.5 and SA 1.75 davits, follow the advice contained in the PAN recently issued by the manufacturer or urgently contact Schat-Harding¹ if a PAN has not been received.
- Ensure that all devices (inductive or mechanical) fitted to boat davit systems to prevent overload are tested on each occasion before a boat is hoisted and that such devices are not relied upon during operation.
- Follow manufacturers' recommendations regarding the maintenance and periodic testing, examination and replacement of safety devices, seeking clarification from manufacturers where ambiguity exists.
- Verify the effectiveness of watertight seals on electrical equipment fitted to boat davit systems on weatherdecks.

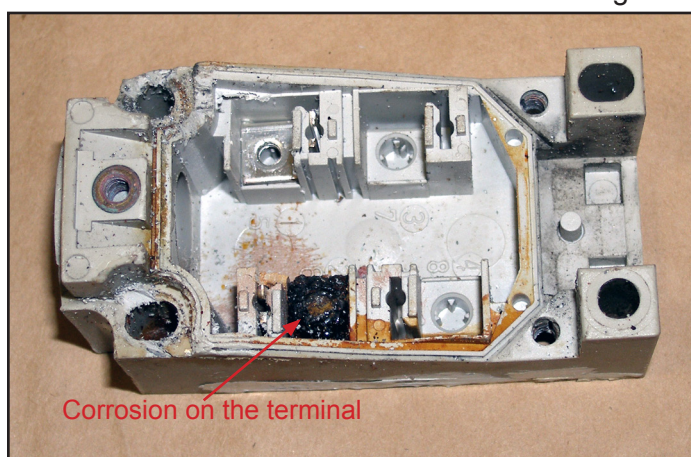
Figure 4

The fall wire was observed to be in good condition and when tested after the accident it achieved a breaking load of 137kN. The wire parted near the lower most davit sheave as the rescue boat reached its stowed position and the winch was still hoisting under power. Although the winch motor was rated with a nominal pull of 50kN, the maximum pull that it was capable of exerting when trying to overcome the increased resistance in the system during the final stages of hoisting would have rapidly exceeded the breaking load of the wire. The proximity switch, which should have prevented this situation from occurring, was tested in situ and was found to be defective.

Water ingress into proximity switch

The switch was installed in 2006, and prior to the accident it was not tested before hoisting was commenced. Inspection identified that the switch body had been penetrated by water (**Figure 4**). However, detailed analysis highlighted that the switch malfunctioned due to an unrelated electronic fault. The MAIB is aware of both inductive proximity and mechanical limit switches fitted on other vessels that have also failed to operate correctly. However, none are known to have resulted in a similar accident.
