ATSB TRANSPORT SAFETY INVESTIGATION REPORT
Marine Occurrence Investigation No. 208
Final

Independent investigation into the lifeboat accident and
fatalities aboard the Hong Kong registered bulk carrier

Lowlands Grace

at anchor off Port Hedland, Western Australia on
7 October 2004

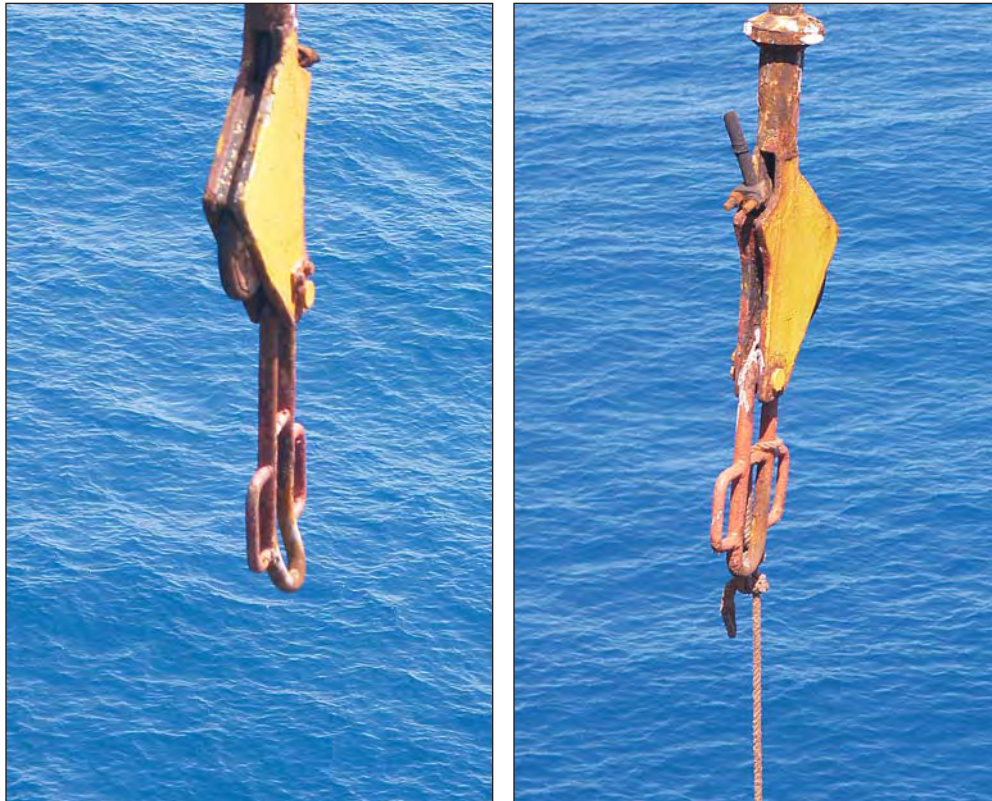
Figures 12: Lifeboat forward and after hook suspension rings after the accident

While on board *Lowlands Grace*, investigators inspected the port lifeboat's falls. The suspension ring (long link) attached to the end of the lifeboat's forward fall was slightly bent on the end normally attached to the hook. The after suspension ring was also still attached to its fall and did not exhibit any apparent damage or marks (Figure 12). The davit and falls did not reveal anything else of significance.

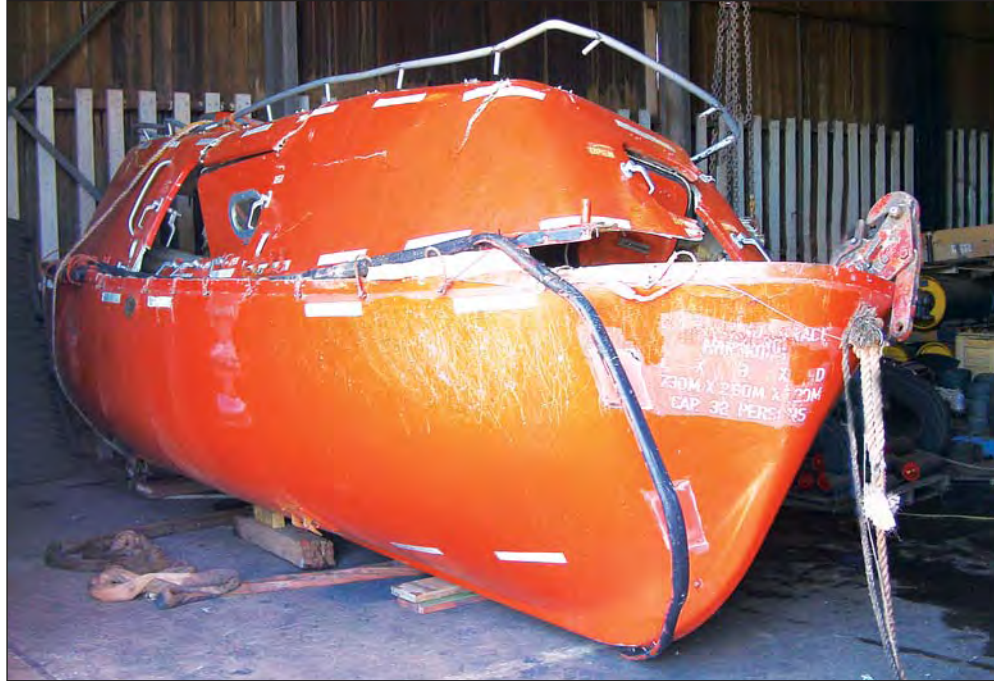
Figure 13: Port lifeboat after recovery

The port lifeboat was inspected in Port Hedland after it had been recovered and transported to a facility ashore. The boat had sustained extensive damage, in particular to its canopy, which exhibited numerous cracks, pieces missing etc. and had been almost completely detached from the hull (Figure 13). The foredeck in way of the forward hook mechanism was completely missing. Inside, the lifeboat was filled with debris, buoyancy foam and equipment which had broken free when the lifeboat impacted the water (Figure 14).

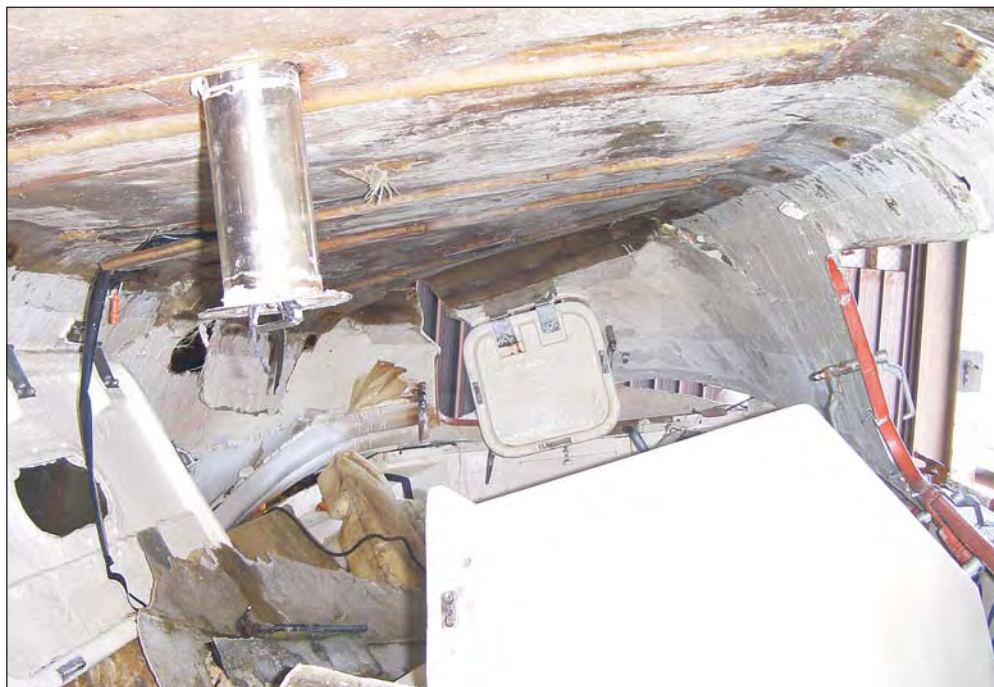
Figure 14: Port lifeboat interior after recovery

The on-load release system was inspected in its 'as found' condition. The operating mechanism for the on-load release system was found to be in the fully reset position. The safety pin was in place and hydrostatic locking lever was in the locked position with the operating quadrants for both hooks locked in the reset position below it. The forward hook was found to be in a tripped condition with the clevis fitting between the operating cable and the operating lever and the housing covering the operating lever missing (Figure 14).

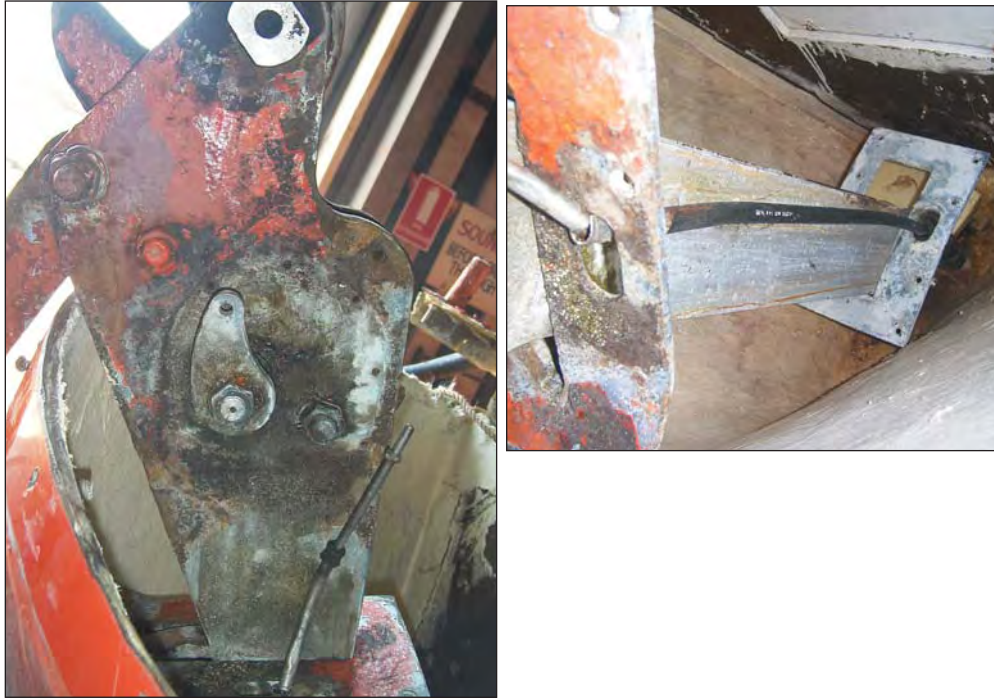
Figures 14: Forward hook, forward hook attached at keel block

lifeboat was indicative that there was an ongoing problem with corrosion and wastage of the keel stays at the point of attachment (Figures 21 and 22). One of the keel stays on the forward hook of the port lifeboat, while in significantly better condition than the stays in the starboard lifeboat, also exhibited a significant amount of wastage due to corrosion. This was measured at approximately 4 mm in the area adjacent to the keel block bolt hole, which is 25 per cent of the total thickness of the 15 mm stay.

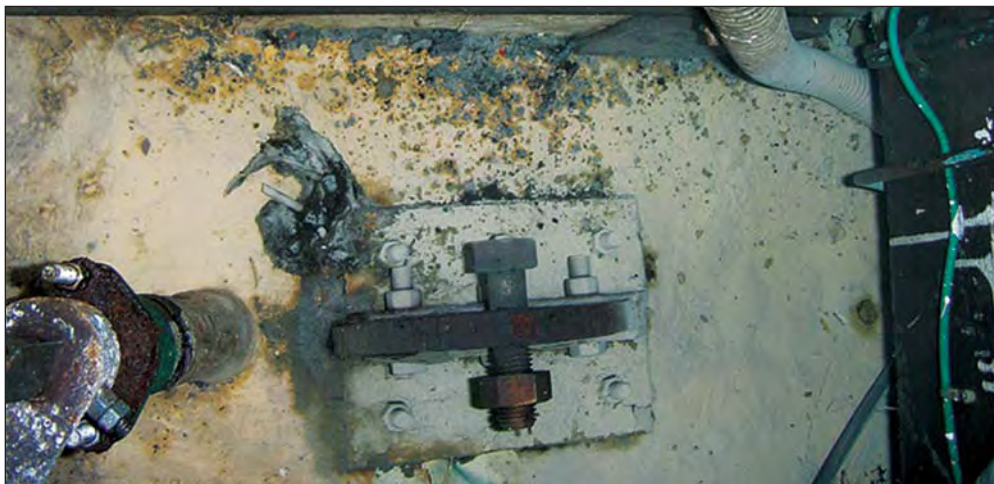
Figure 15: Port lifeboat after hook keel attachment

The after hook assembly was found to be completely missing with the keel block and keel stay securing bolt still in place (Figure 15). The after deck was structurally intact with the damaged operating cable end still evident in its normal position leading through its opening in the deck (Figure 16). (The top locating plate for the hook mechanism is not in place in the photograph as it had been dislodged during the lifeboat recovery operation.)

Although the after hook assembly was not recovered after the accident, the intact condition of the keel block and keel stay securing bolt (including the nut and split pin), is clear evidence that the after hook's keel stays failed where they were connected to the keel block. The failure of the after hook's keel stays was the event which initiated the accident and the evidence strongly suggests that they failed as a result of wastage due to corrosion. The condition of the keel stays in the starboard

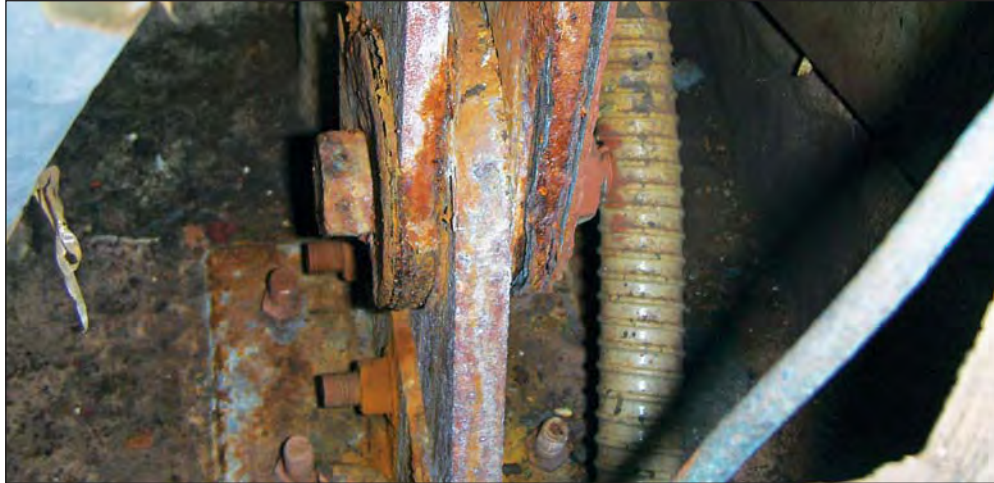
Figure 17: Starboard lifeboat after hook keel attachment

On 12 October, while *Lowlands Grace* was alongside, the starboard lifeboat was examined, in particular the connections between the on-load release hooks keel stays and their keel blocks in the forward and after compartments. Both forward and after hook assemblies exhibited a significant amount of exfoliating corrosion and wastage of their keel stays where they were attached to the keel blocks (Figures 17 and 18). The class surveyor inspecting the stays at the time estimated approximately 25 per cent wastage. It was also evident that the keel stays had been painted at some time in the past in an apparent attempt to inhibit the corrosion. Although both the forward and after compartments were dry when inspected, both sets of keel stays showed signs that moisture had been regularly running down the keel stays from the decks above.

The corrosion found on the starboard lifeboat's keel stays was extensive and would have occurred over a relatively long period of time. Initially, the galvanising on the keel stays would have protected any adjacent areas of the underlying mild steel where the coating had been damaged or broken down (for example where the securing bolt passed through the stays). Eventually the zinc coating on the stays in the area of the keel block connection would have been completely consumed and from that point of time the corrosion would have progressed unchecked in the area. The corrosion would also have gradually worked its way up the keel stays as the galvanised coating was progressively consumed and this phenomenon was particularly evident on one keel stay of each of the starboard boat's hooks.

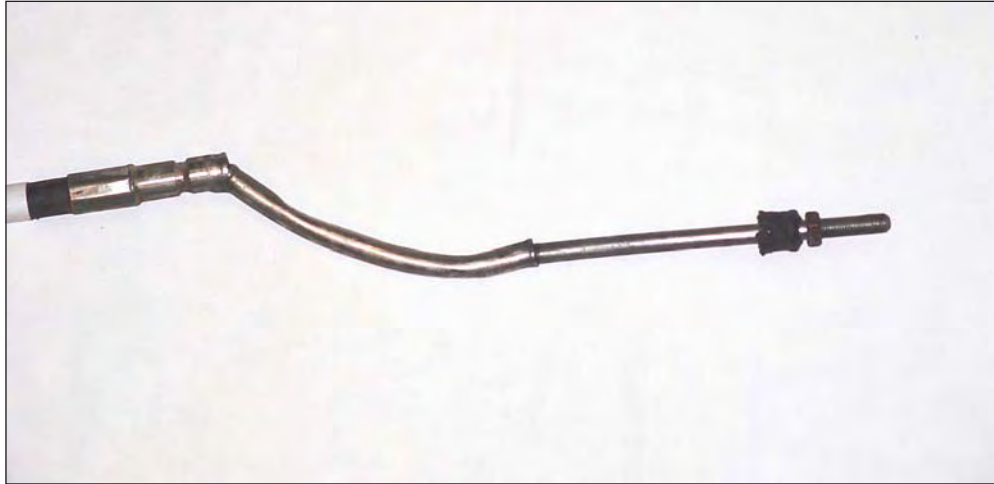
Figure 19: Forward hook operating cable end

The inspection of the hook end of the operating cable revealed a significant bend (buckle) with a series of indentations on the inside radius of the bend (Figure 19). A bend in the top plate and witness marks in the keel stay slots in the mounting plate where the forward hook's keel stays passed through the foredeck was also noted (Figure 20).

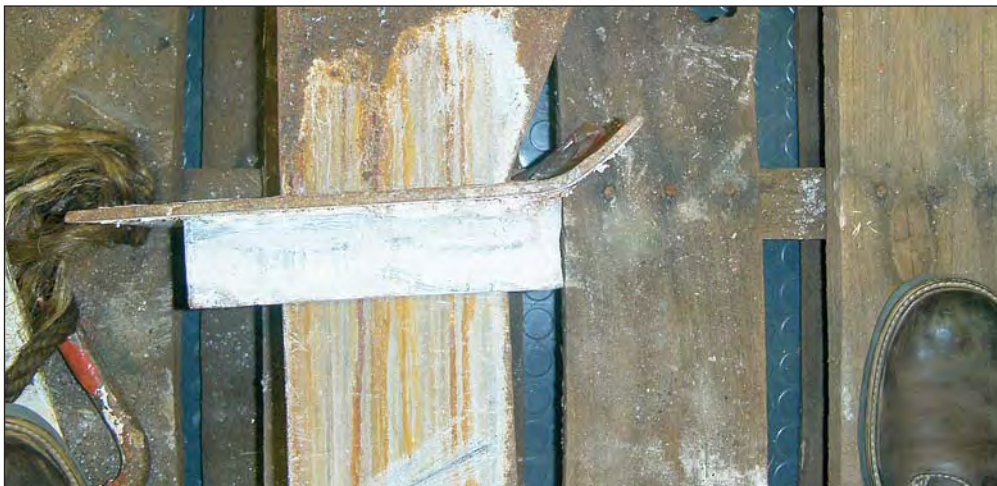
Figure 20: Top mounting plate

- When the foredeck failed the screws attaching the mounting plates to the deck sheared and the lower plate either fell entirely or more likely became cocked (lower at the after end). The forward end of the top locating plate was then bent upwards as the hook assembly was pulled towards the bow of the boat. More critically, the section of the operating cable running through the 'mouse holes' in the mounting plates (now loose) was damaged. This section of cable was probably bent by the cocked lower mounting plate and/or the section of deck between the plates as the hook mechanism rotated forward. (This theory is supported by the damage to the cable as the inside 'radius' of the bend showed a succession of marks/indentations made by hard contact.) It is also likely that the bolts securing the cam release pin cover were sheared when the deck failed (which allowed the cover to fall away).

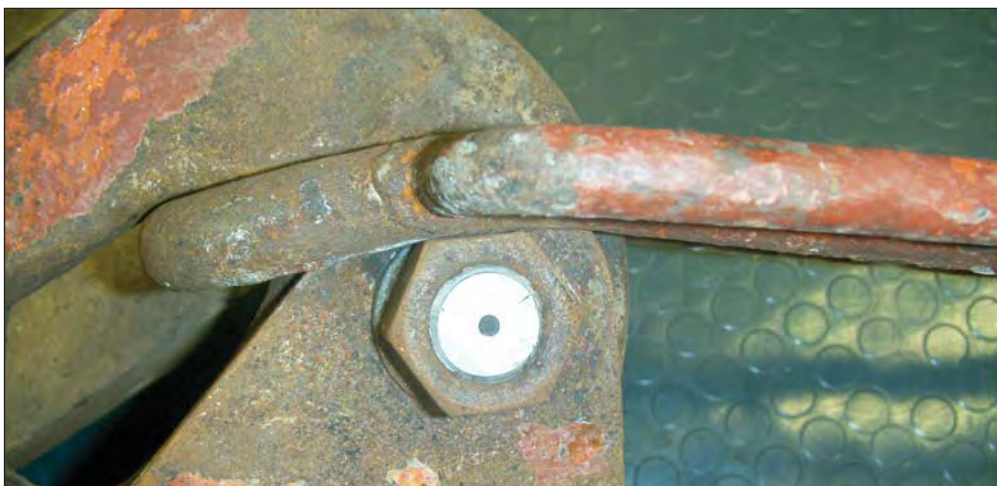
Figure 21: Forward suspension ring on hook

Examination of the forward suspension ring revealed a bend of approximately 10 degrees on its hook end and witness marks on the inside radius of the bend. When the suspension ring was re-attached to the hook and rotated through approximately 45 degrees (from its normal loaded position), the witness marks coincided with the position of the main pivot pin's head and nut (Figure 21). This indicated that the suspension ring had made hard contact with, (and been bent around), these parts of the main pivot pin.

Measurements indicated that first contact between the main pivot pin and the forward suspension ring would have occurred when the lifeboat's stern had fallen to be approximately 4.5 metres below the horizontal plane (a rotation of approximately 35 degrees about the fixed point of the forward hook).

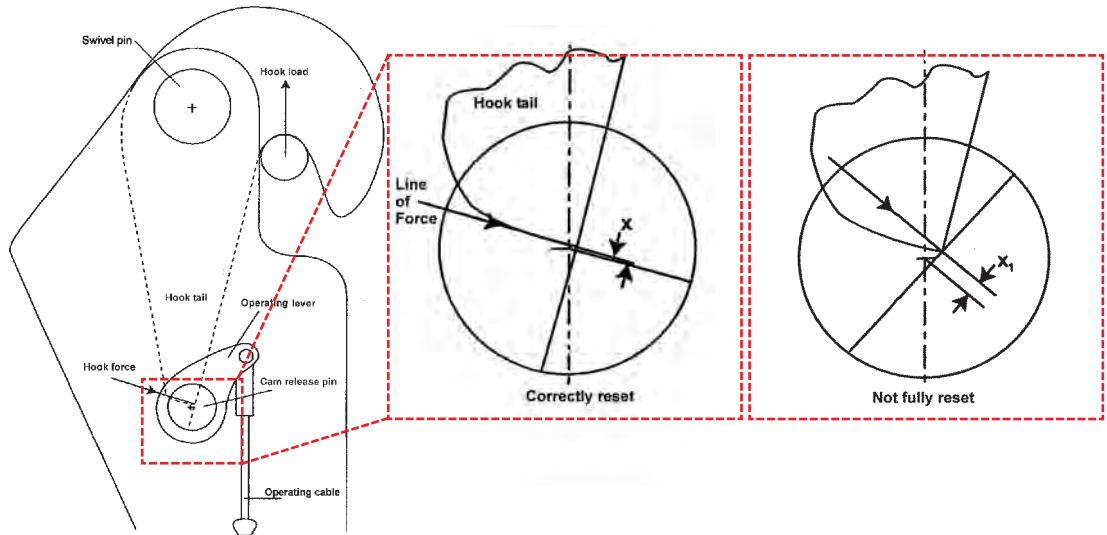
Figure 23: Hook locking mechanism with detail of cam release pin and hook tail contact

When the operating cable for the forward hook on *Lowlands Grace*'s port lifeboat was bent at the time the foredeck failed, the cam release pin holding the hook closed was slightly rotated to the effect that X increased to X_1 . This dramatically increased the turning moment on the cam release pin. The remaining stiffness in the operating cable (as the operating system at the other end of the cable remained locked) was insufficient to carry the additional force being transmitted from the heavily loaded hook. The cam release pin rotated further and allowed the hook to open.

The way in which the hook is locked by the cam release pin makes this type of system particularly prone to spontaneous release when not fully reset and/or when parts of the mechanism are worn. For these reasons this type of system has been implicated in a number of other lifeboat accidents and thus there is a compelling need to make the system as fail safe as possible throughout its service life. While good maintenance practices and correct operation by competent crew mitigate these risks, it is almost certain that during their service life many of these systems will not be operated or maintained in the fashion that the manufacturer stipulates.
