**Bundesstelle für Seeunfalluntersuchung**  
**Federal Bureau of Maritime Casualty Investigation**  
Federal Higher Authority subordinated to the Ministry of Transport,  
Building and Urban Development

**Summary**  
**Investigation Report 554/07**

**Person injured by the fall of a lifeboat on the**  
**MS MSC GRACE**  
**at Neue Weser North-Roads**  
**on 31 October 2007**

1 August 2008

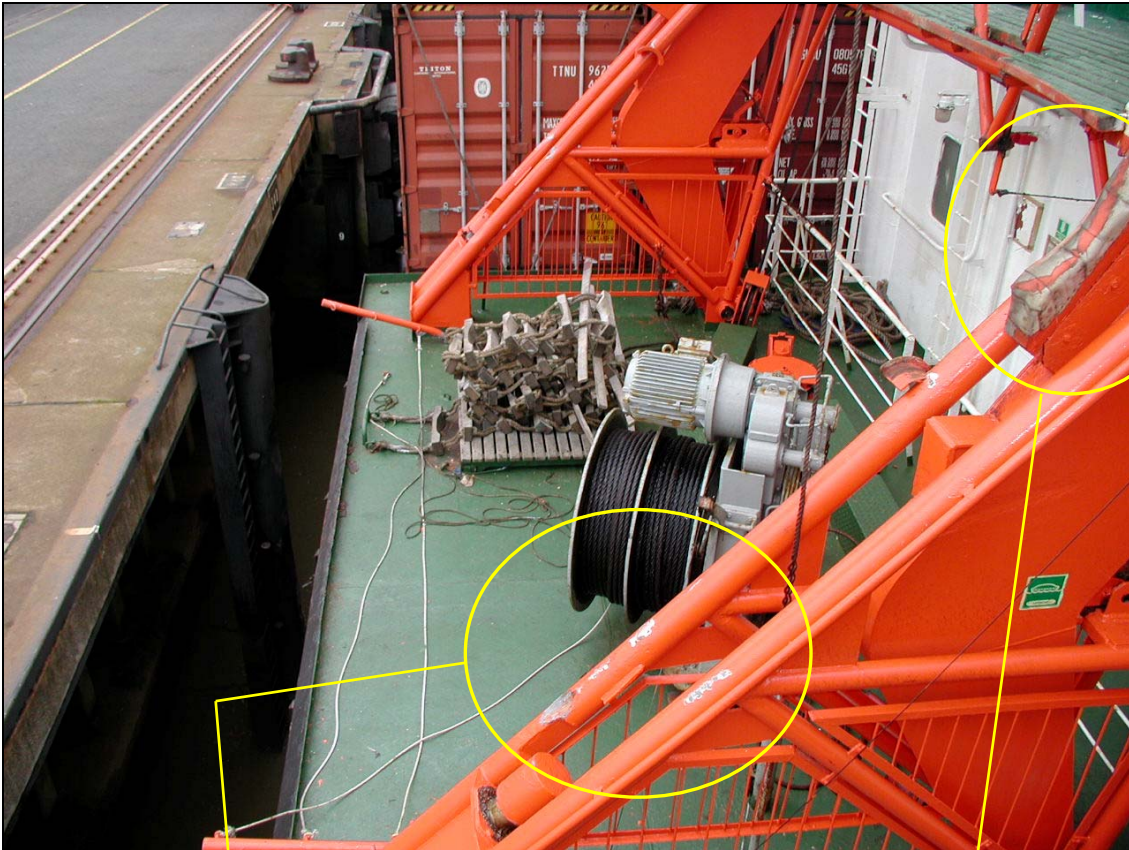
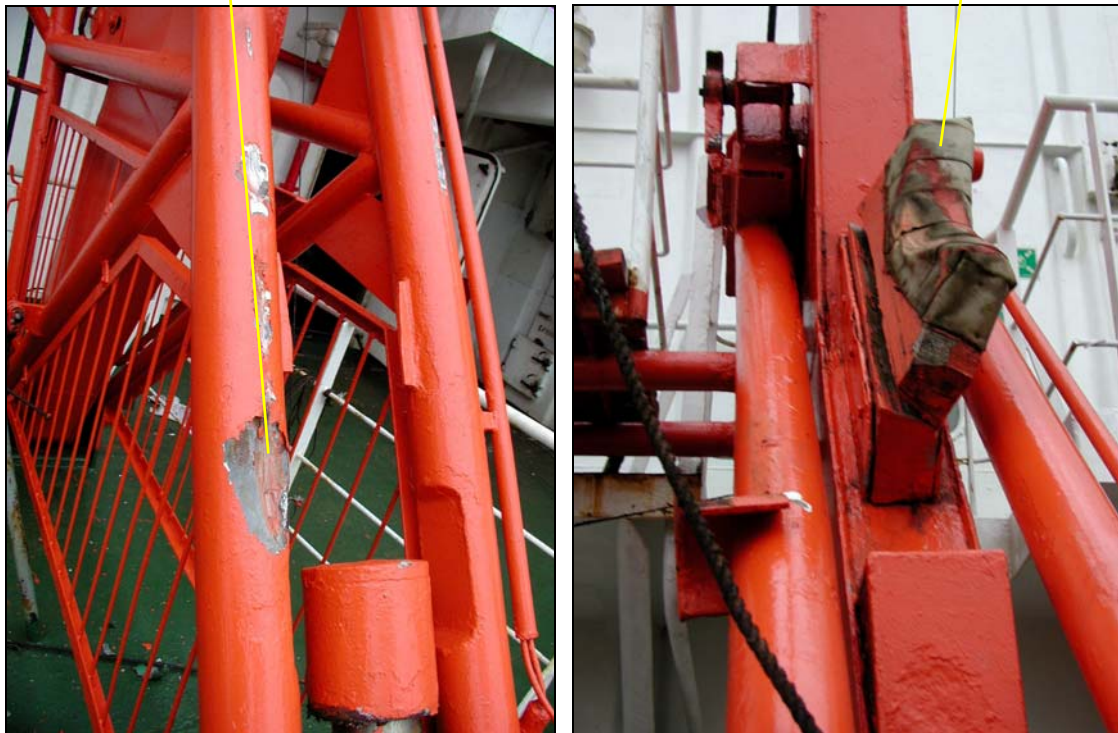
The falling boat damaged the davits (Figures 5 and 6). The girders were dented from being hit by the boat; the wooden boat blocks were pressed to the side; and two railing supports were bent.

Figure 5: Damage to the davit system

Figure 6: Details of the damage

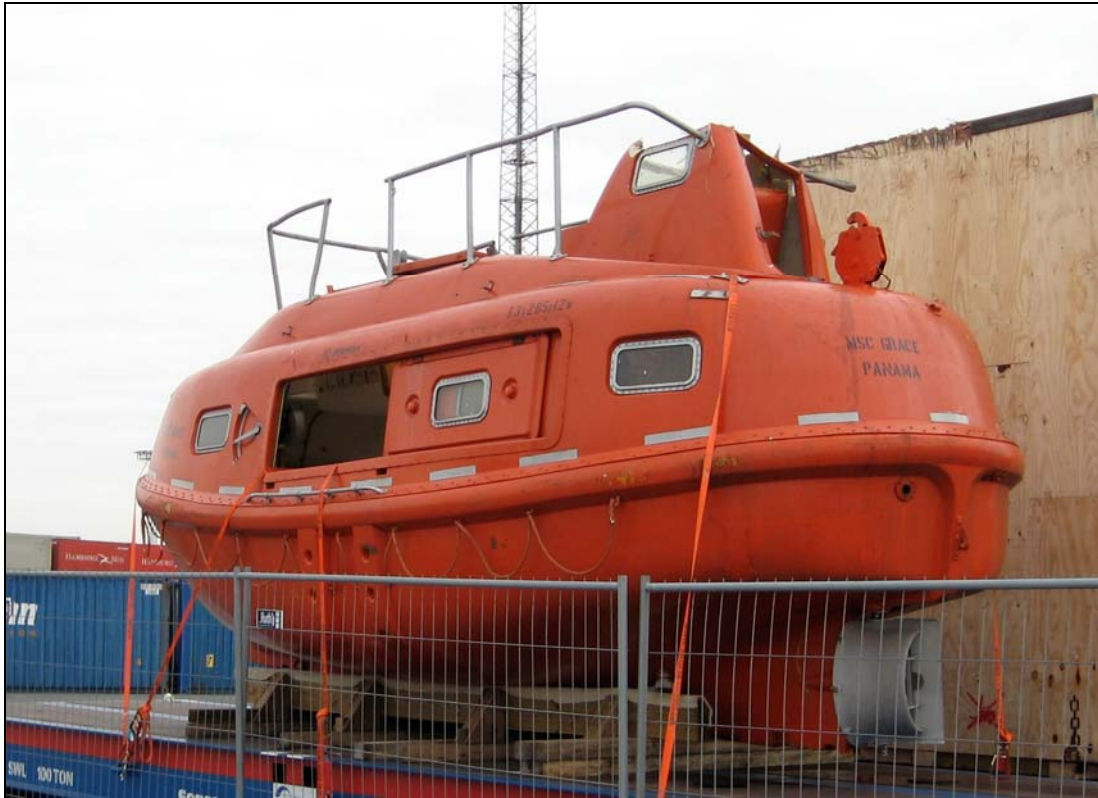
The lifeboat was severely damaged on the top (area above water level) of the starboard side by its fall and by subsequently hitting the ship's side as it was held against the ship by painter; consequently it was irreparable (Figure 7). It was replaced by a new lifeboat from the manufacturer Jianguyinshi Beihai LSA CO.LTD.

Figure 7: Port lifeboat of the MSC GRACE

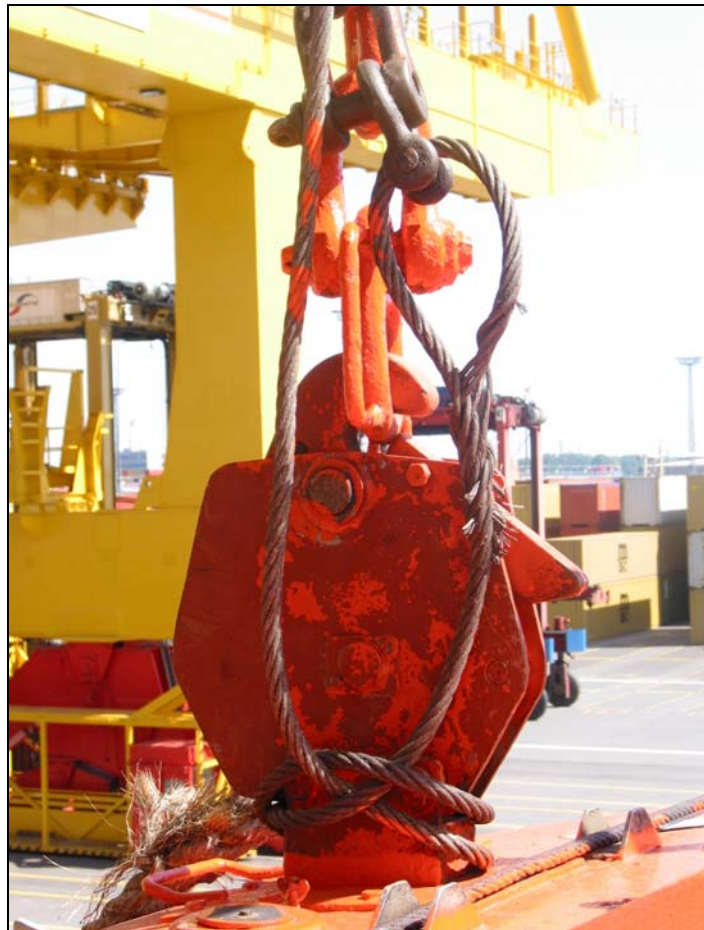
Figure 8: Front releasing hook on the starboard lifeboat with securing cable

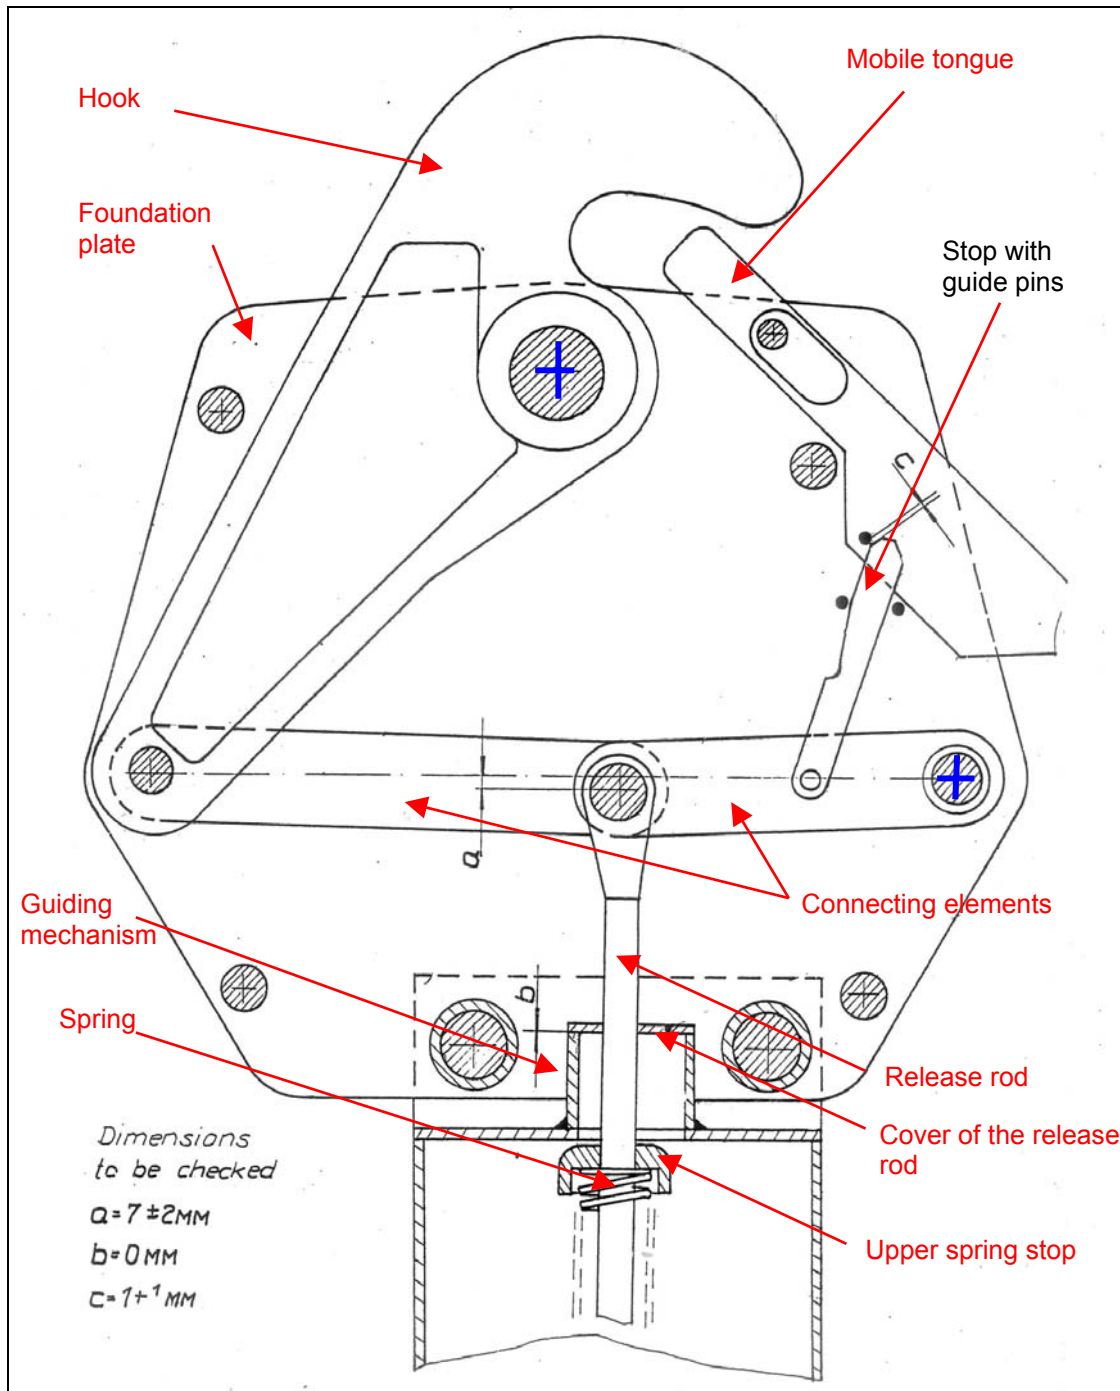
Figure 9: Releasing hook in closed position, + = fixed rotary axes

In Figure 9, the releasing hook is pictured in a self-locking position. This position is characterised by two features. Firstly the cover (which is securely fixed to the release rod) is lying without a gap ( $b$ ) on the guiding mechanism of the release rod. Secondly, the arms of the connecting elements do not form a horizontal line but are at an obtuse angle to each other. The load applied to the releasing hook by the suspended boat consequently generates a downward motion of the release rod.

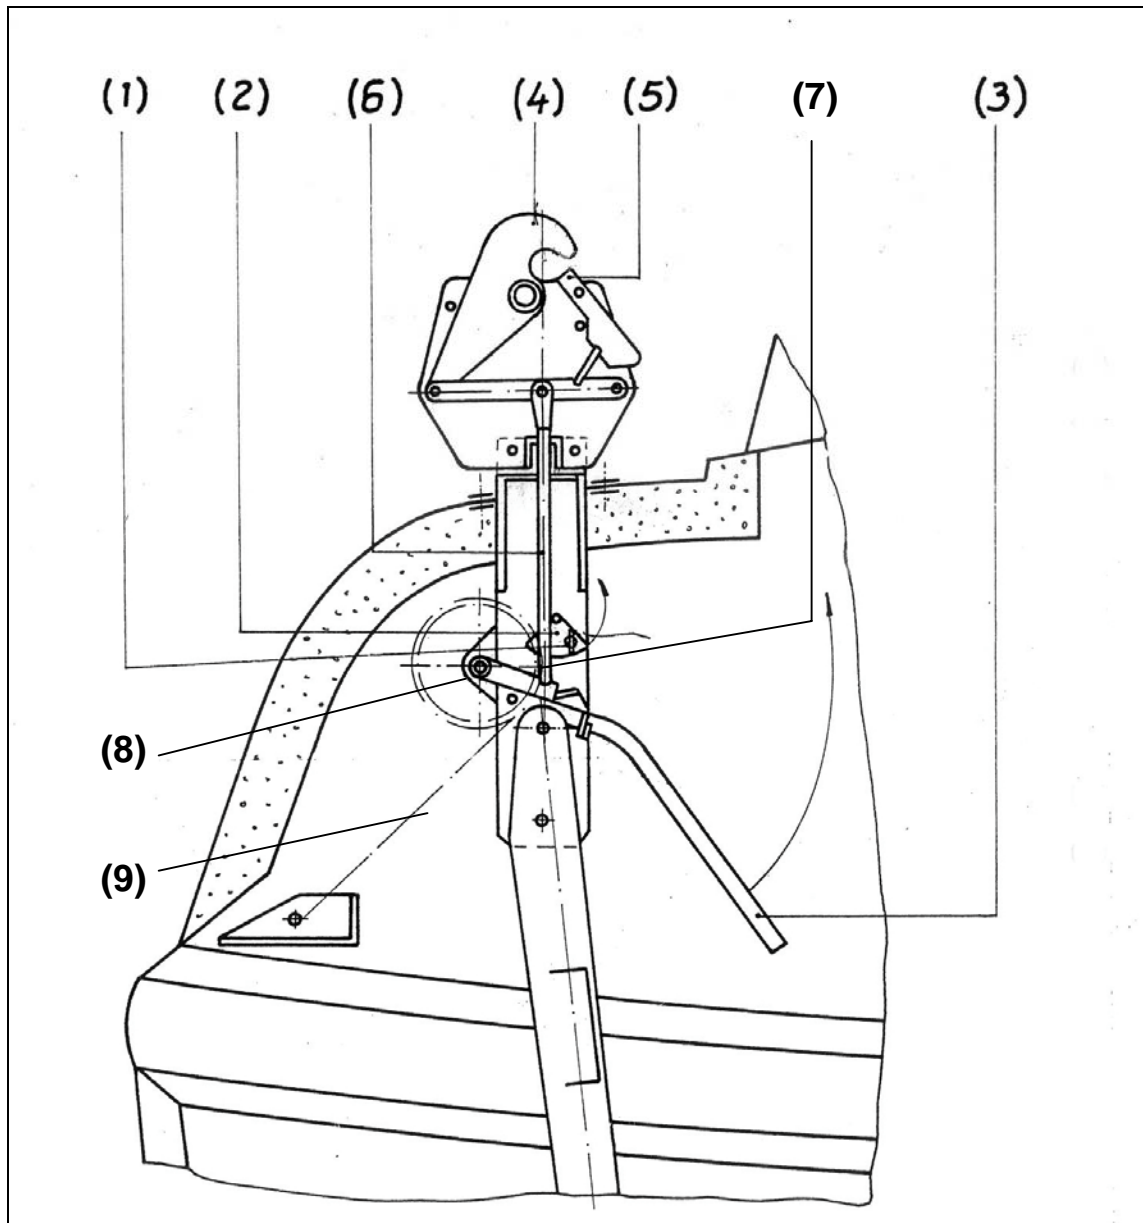
Two mechanical locks must be activated first to be able to move the release lever. Firstly a safety pin must be removed from both foundation plates and a segmented disk (lock washer) after a 180° rotation around the longitudinal axis. Only then is it possible to lift the lock washer (which is hanging down due to the force of gravity) on an outward projecting arm.

Figure 13: Release unit on the aft releasing hook; 1 – safety pin, 2 – safety washer, 3 – release lever, 4 – hook, 5 – mobile tongue, 6 – release rod, 7 – intermediate element, 8 – drum, 9 – cable

There is no link between release lever and intermediate element. Consequently the release system (including the releasing hook) is reset to its starting position not by a downwards movement of the release lever but purely by relieving the springs in the fore and aft releasing hooks.

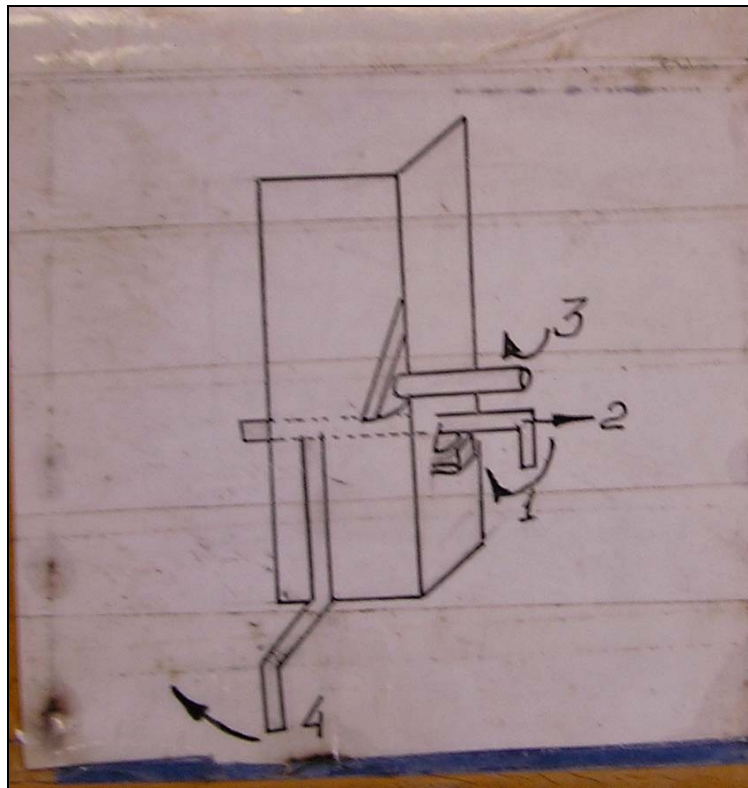
Apart from the hazard notice on the release unit, the starboard lifeboat had no description from the manufacturer about the components of the releasing hook or the process for releasing and securing. Seamen had taken the initiative and drawn a schematic drawing of the release process and attached it in the boat (Figure 17). Another description of the releasing and securing process (likewise drawn up by seamen) was secured in a plastic envelope in the aft area of the boat. Neither

illustrations corresponded to the recommended symbols used by SOLAS<sup>4</sup> Chapter III Regulation 9 No. 3.

Figure 17: Schematic illustration of the work steps required for the release process

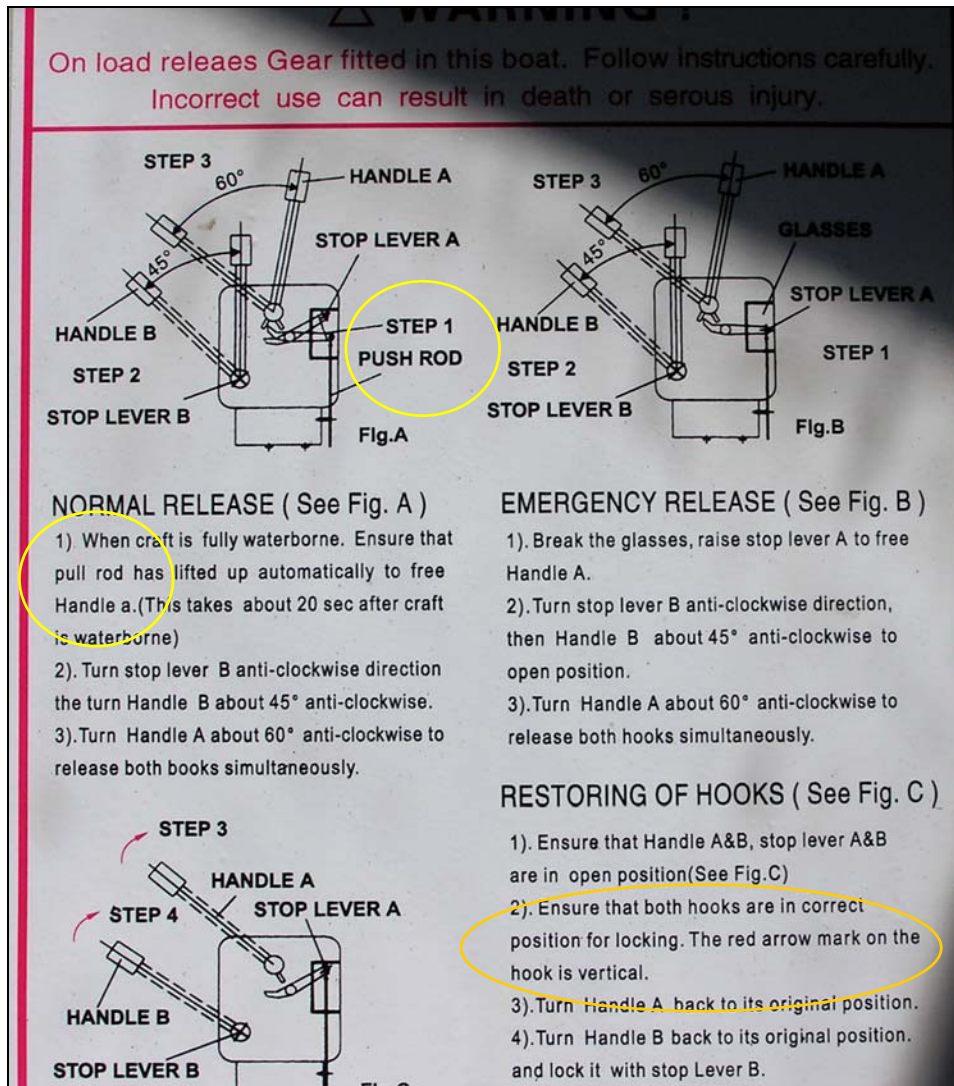
The new port lifeboat was also inspected during the investigator's stay onboard the MSC GRACE. Two things were apparent. On the one hand, there was the inconsistent description of the release process on a notice attached inside the boat

by the manufacturer. Text and pictorial labels for normal release use different terms. The release rod that was connected with the bowden cable coming from the hydrostatic interlock was called a "push rod" on the pictorial labels. In contrast, it was called a "pull rod" in the text (Figure 18). On the other hand, the section of text describing how to reset the hook under Point 2 was formulated as follows: "Ensure that both hooks are in correct position for locking. The red arrow mark on the hooks is vertical." In fact there was no visible mark on the releasing hook as the crew had painted over the releasing hook (Figure 19).

Figure 18: Description of the release process in the new port lifeboat

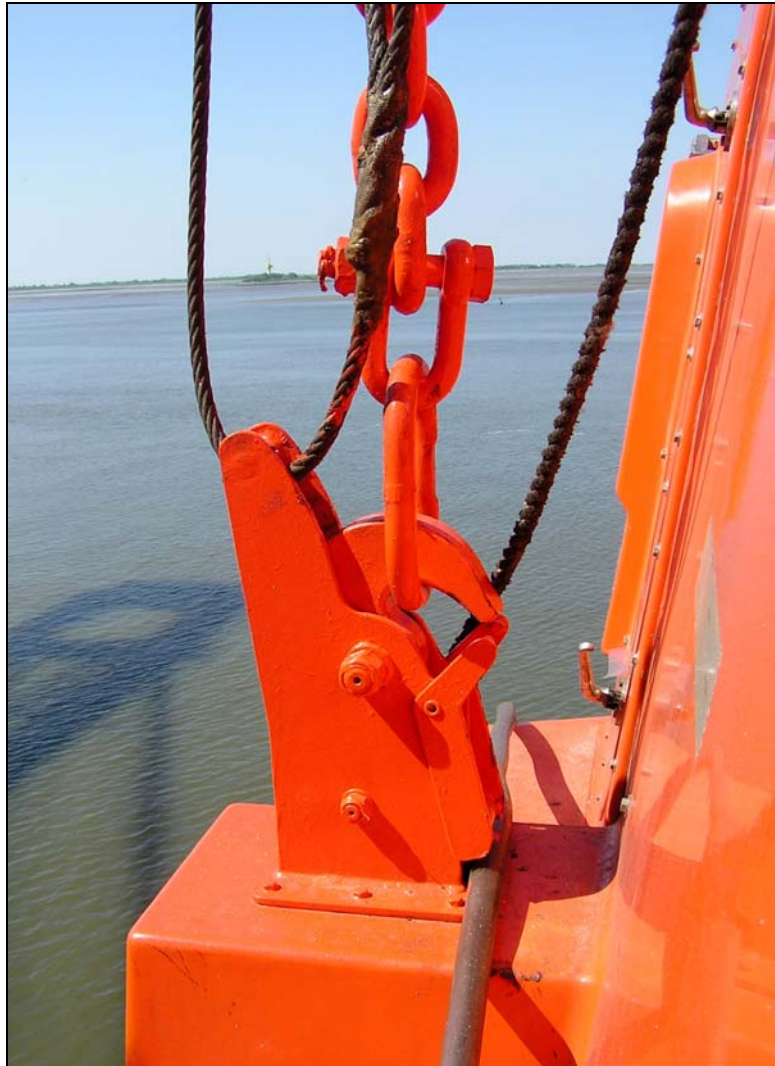
Figure 19: Aft releasing hook on the new port lifeboat, marking no longer visible

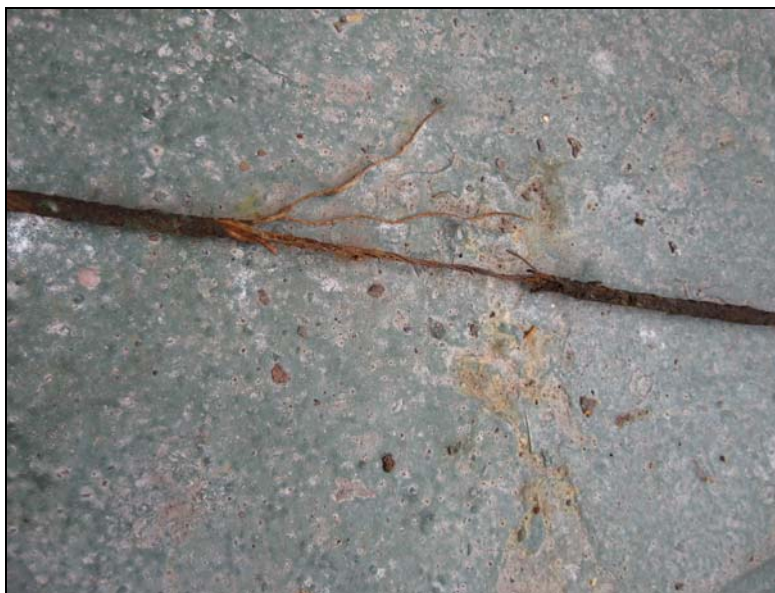
When the Bremerhaven waterway police inspected the site of the accident, they identified and criticised a nearly complete split in the remote control cable between the winch brake lever and the operator's station at the railing (Figure 20).

Figure 20: Damage remote control cabler
