# The deadliest cargo

Nickel ore has recently been described by Intercargo as the deadliest cargo in the world. This label is understandable, given the statistics, but what is behind it?

## John Poulsen

Principal Surveyor, Atlantic Marine Associates

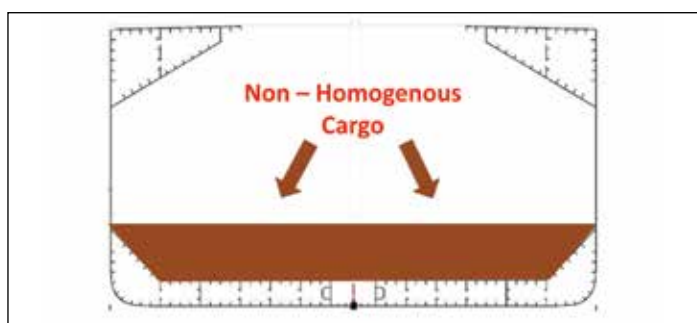
Fig 1: Moisture migration

One problem is that of moisture migration. Loading cargo from barges can take some time. Different particle sizes and different water content can produce a non-homogenous mixture (Fig 1). During the voyage, moisture can migrate causing a wet base to develop (Fig 2). Even then, capsizing still seems to need a catalyst. In the case of the *Harita Bauxite*, that catalyst was stopping at sea, but it could be a course alteration or heavy weather.
