## ACCIDENT INSPECTION REPORT

**LOCATION OF ACCIDENT: OCEAN AMBASSADOR RIG PLATFORM**

This report deals with the inspection made on board the oil rig OCEAN AMBASSADOR belonging to BRASDRILL - which was employed in off shore drilling for the company OGX,- in

order to investigate the fatal accident which occurred in connection to life-boat No.2 belonging to the above mentioned rig.

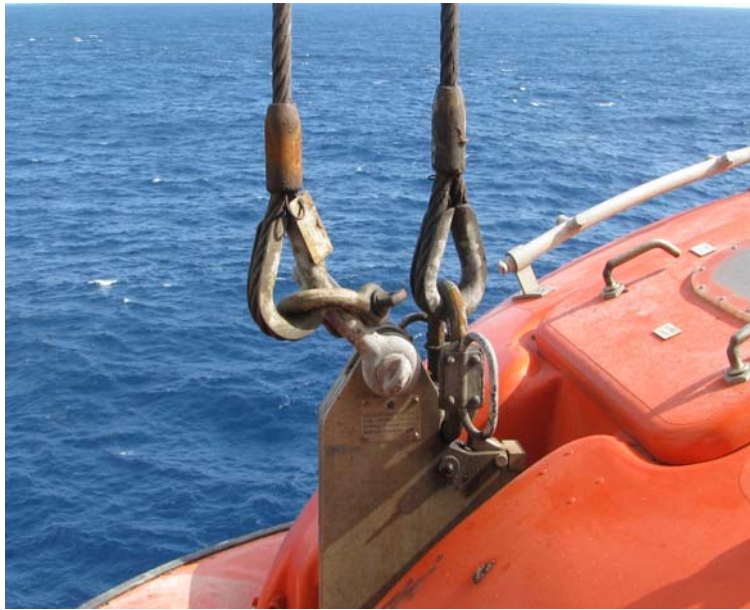
- a. The death of the crew members was a consequence of injuries suffered through the fall of the lifeboat;
- b. The fall of the lifeboat occurred by virtue of the lifting rings becoming detached from the fixed lifting hooks of the boat.

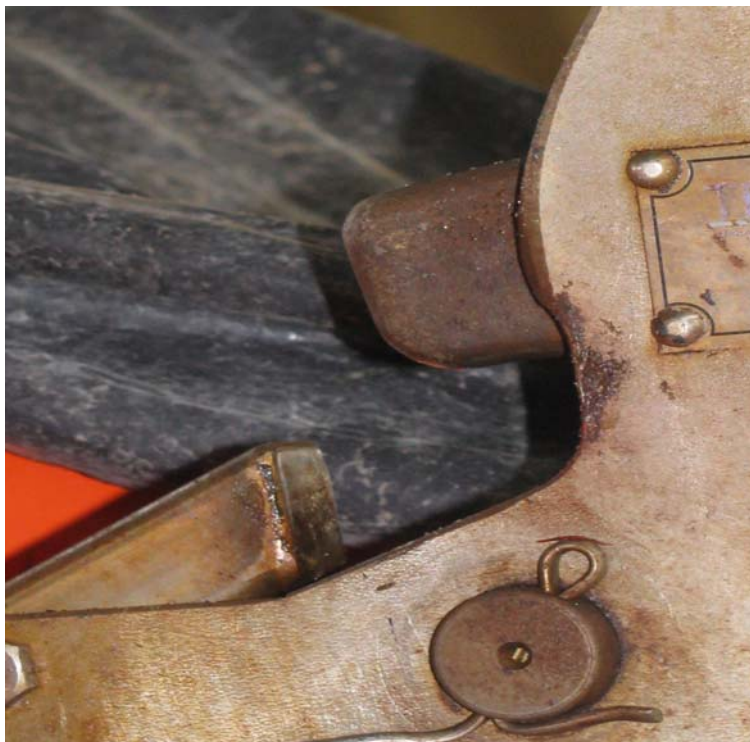
c The forward lifting ring became disengaged because it slipped between the lifting hook and the locking mechanism.

We conclude that the determining factor for the accident was a dimensional failure in the locking device for the forward lifting hook of the lifeboat.

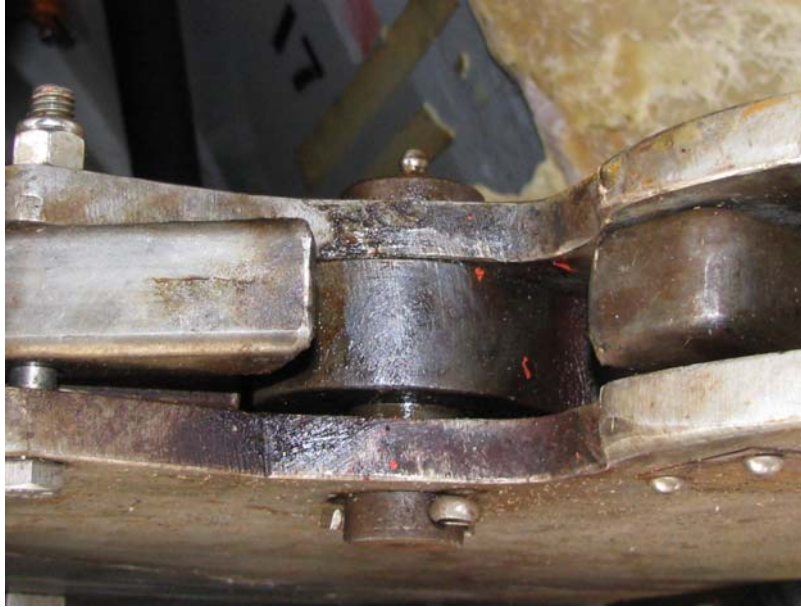
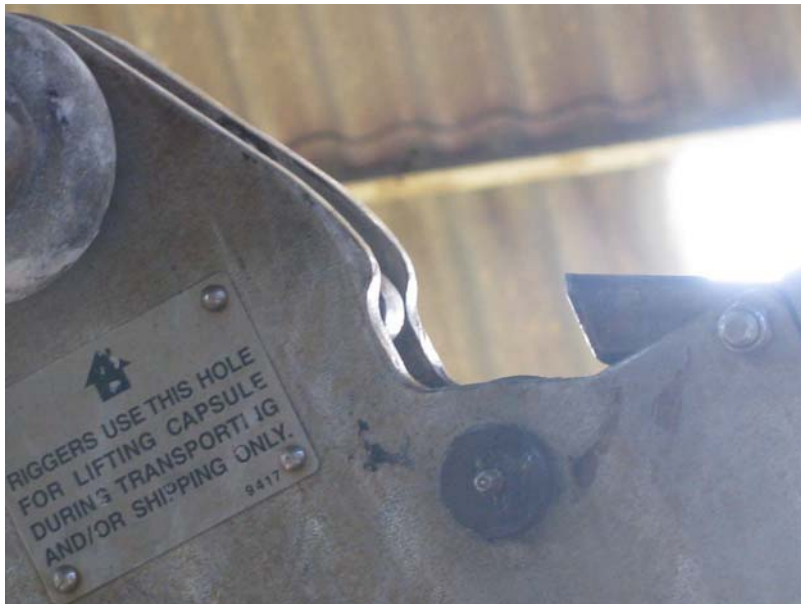
- d. This slip occurred due to a dimensional failure of the mechanism, or we would say that the distance between the (*point of*) lifting hook and its locking device was greater than the thickness of the lifting ring (one inch).
- e. The second ring (aft) disengaged in view of the fact that the aftermost fixed lifting hook was lowered, probably due to the applied weight when the lifeboat was swinging.

Finally we assess that the failure and consequent disengagement of the second hook (aft) demonstrates a certain fragility in the mechanism as a whole, in view of the fact that the lifeboat was not with its full complement and despite this exceptional situation, it would be reasonable to suppose that the after lifting hook should be able to sustain the weight of the lifeboat without opening up.

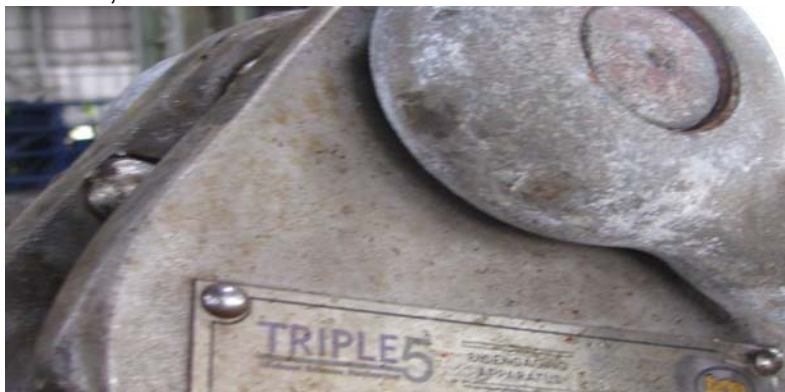
- f. We attribute these failures to a design error in the lifting equipment of the lifeboat, named TRIPLE 5.

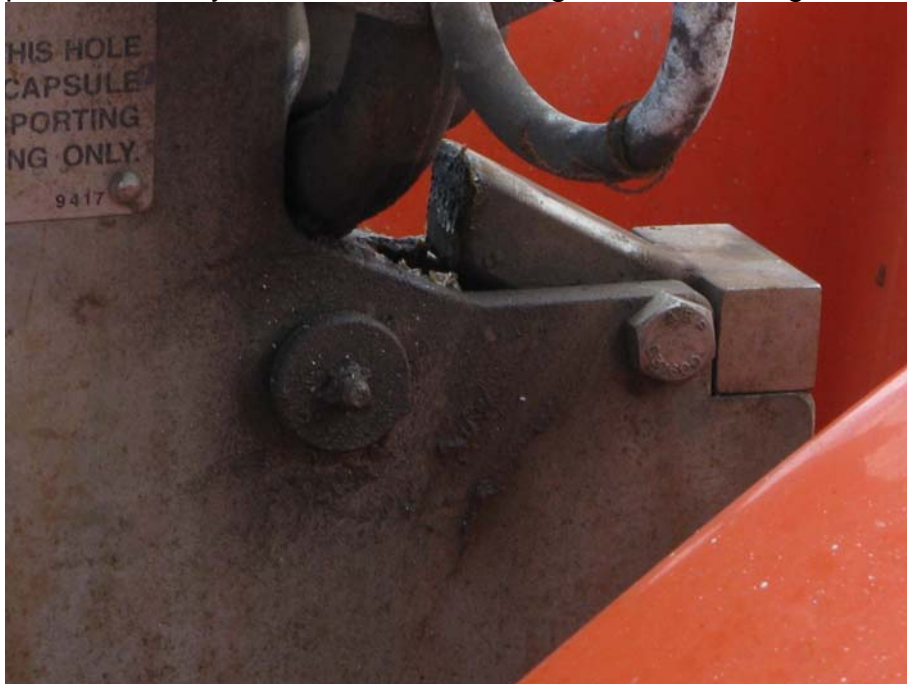
- g. We also observed that even though the hook locking device was of such dimensions to impede the lifting ring, there was still a possibility of failure.
- h. The locking device for the lifting hook remains in the correct position only due to the existing counter weight.

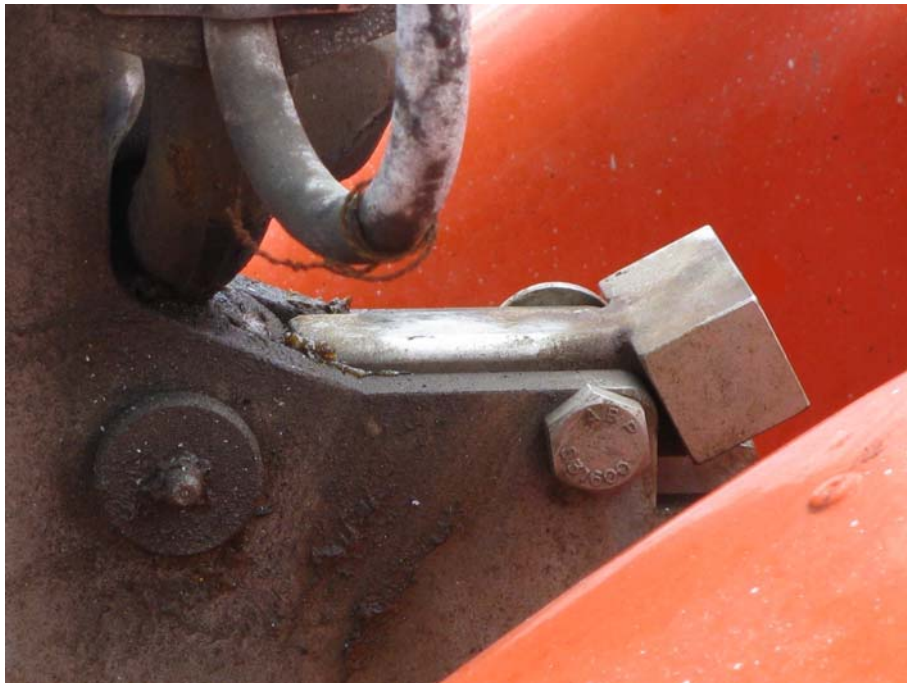
- i. We observed that in certain circumstances the locking mechanism can stay in the open position, permitting the lifting ring to slip out.

Also in our evaluation the equipment TRIPLE 5, even in its normal dimensions, has an inherent failure that could cause a further accident of a similar nature, due to the failure of the locking mechanism for securing the lifting hook in the correct position.
