**BRAZILIAN MARITIME AUTHORITY  
DIRECTORATE OF PORTS AND COASTS**

**FATAL ACCIDENT WITH LIFEBOAT ON BOARD PLATFORM  
“OCEAN AMBASSADOR”, CAMPOS BASIN – RJ**

**17 MAY 2010**

**MARINE SAFETY INVESTIGATION REPORT**

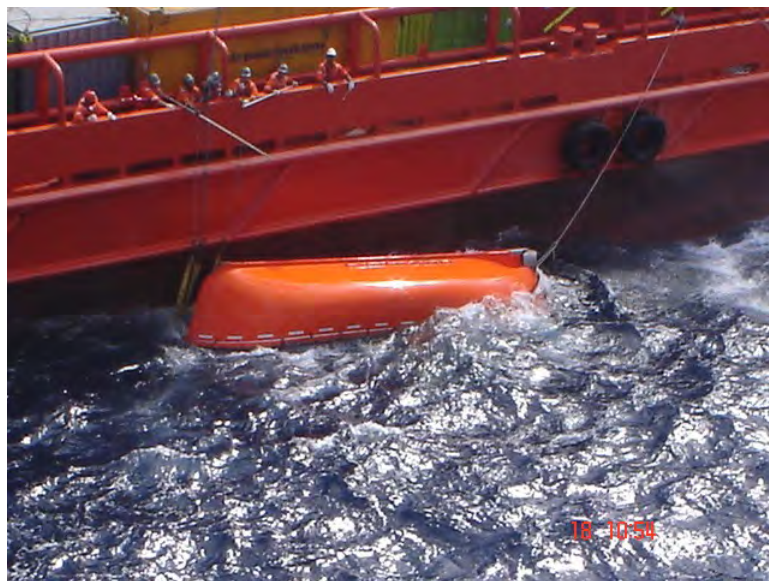
Lifeboat nº 2, that had fallen into the sea, was still in the water upside down and secured alongside a support tug (Photo 2) to avoid its sinking by virtue of the damages resulting from the fall of approximately 30 meters. Due to its positioning and the risk of new accidents it was not possible for the surveyors to go on board to verify the allotment of material on board the lifeboat. For the same reasons it was also not possible to carry out tests with the systems of propulsion and steering.

Photo 2 – The damaged Lifeboat moored to the support craft.

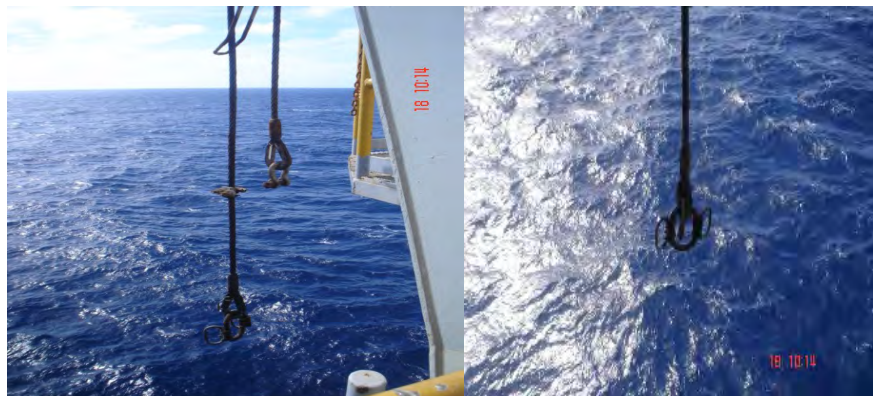
The cables of the davit and the rest of the components of the hoisting system were not broken, the eyelets as well did not present signs of rupture or wear (photo 3).

Photo 3 - cable and eyelets of sustentation of lifeboat nº 2 after the accident

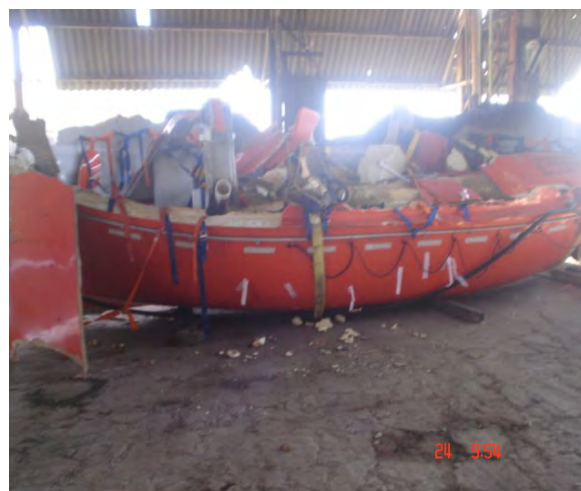
Photo 4 – damaged lifeboat in the installations of the company Brasdril.

b) Material damage of the lifeboat

- The deck of the bow with fissures and cracks around the reinforcement of the orifice of passage for the fixation bar of the Triple 5 device.

- Hull at the stern with a big tear, cracks, fissures and scratches.

- Interior with damages to the controls of maneuvering and of action of the motor of lifeboat nº 2.

- Damage of the cable activator of the Triple 5 device at the stern that was compressed by the fixation bar of the Triple 5 against the hull of the lifeboat.

The damages compromise the structural condition of the lifeboat (total loss).

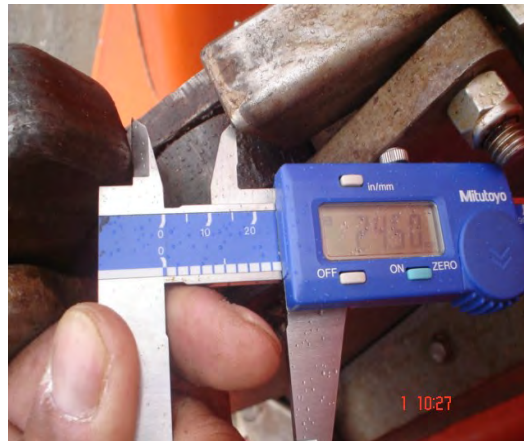
From analysis of the data gathered, it is verified that the position of the hook at the time of the task of hoisting the lifeboat, should have been totally closed, with the lever of the release mechanism in vertical position. During the survey carried out it was verified that the position of the forward hook of the damaged lifeboat presented an opening of 24.5 mm (Photo 5) between the hook and the retainer of the forward device. The initial evaluation of the experts is that this opening would permit the passage of the eyelet of the cable of the davit. However this opening was verified after the accident and it cannot be affirmed that it was pre-existent to the event.

Photo 5 - Gap between the hook and the retainer of the release mechanism forward

The opening of approximately 24.5mm in the hook of the forward Triple 5 Release Mechanism of the damaged lifeboat, presented before in photo 5, would allow the passage of the eyelet of the cable of the davit, through it. It was verified by photo 7 the position of the lever of the actuating device of the hooks of the damaged lifeboat inclined around 45°, in the position "half open" (RED), which could be due to the fact that the Teleflex cable of actuating of the hooks having been pulled and deformed during the accident (photo 8) causing displacement of the Triple 5 release mechanism.

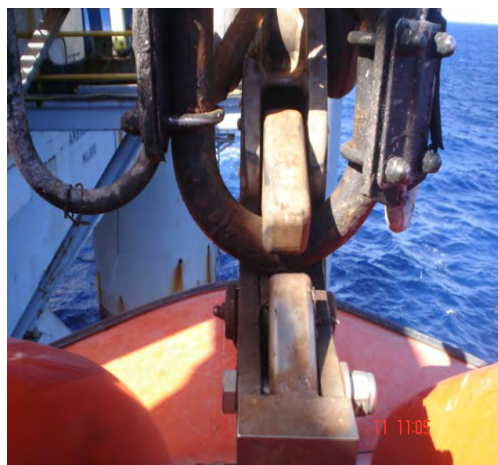
Photo 6 – Existing Gap between the hook and the retainer of the undamaged lifeboat (11 mm)

In accordance with a video of the manufacturer of the Triple 5 Release Mechanism, which may be seen on the site [http://www.survivalsystemsinternational.com/triple5/triple5\\_video.html](http://www.survivalsystemsinternational.com/triple5/triple5_video.html), during a simulation the position of the hook of the Triple 5 device when in the position of hoisting the lifeboat is totally closed, with the lever of the device in the vertical position (colour green), as was demonstrated by the representative of the manufacturer during the survey carried out. Remember that was observed a considerable gap of approximately 11mm on the hook of the lifeboat that was on board the platform (photo6).

Also it may be affirmed, by statements of crewmembers of the platform, that there was ignorance of part of the crew, of the release mechanism of the lifeboat (Triple 5 device) as well as of its maintenance, conditions and functioning, principally of the opening of approximately 11mm of the hook of the device (photo 6).

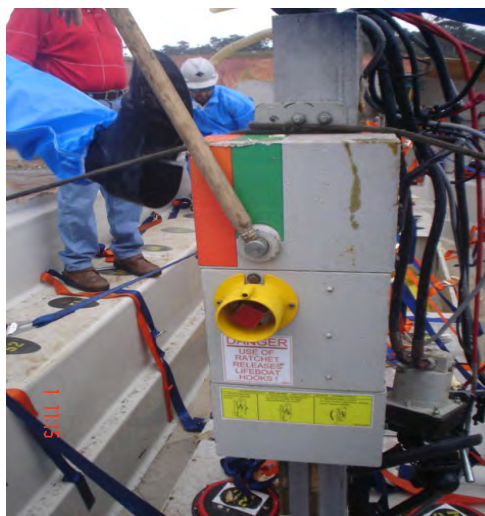
Photo 7 to follow, taken by the experts on the occasion of the investigation of the accident, presents the position of the lever of the actuating device of the hooks of the damaged lifeboat, that instead of being vertical in the colour green (hook closed) was in an inclined position of around 45°, in the colour red in the position “half open” (it is reminded that the lever totally in the red position represents that the hook was open or hook disarmed, or that is the position in which the lifeboat can be disconnected from the cable of the davit).

Photo 7- Release mechanism control box of the damaged lifeboat

As a result of the lifeboat having dropped in a free fall of a height of approximately 30 metres, there is no way to affirm with certainty if at any moment during the drill the lever was partially actuated, remaining in the incline position of around 45° (photo 7) and consequently causing partial opening of the hook.

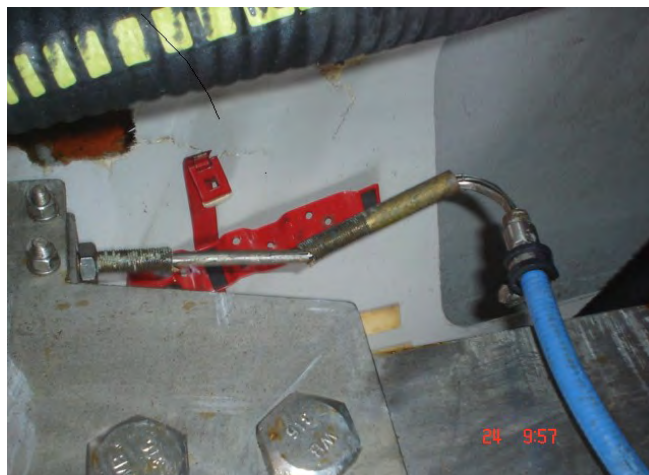
Photo 8 – Teleflex cable deformed by action of the fall of lifeboat 2

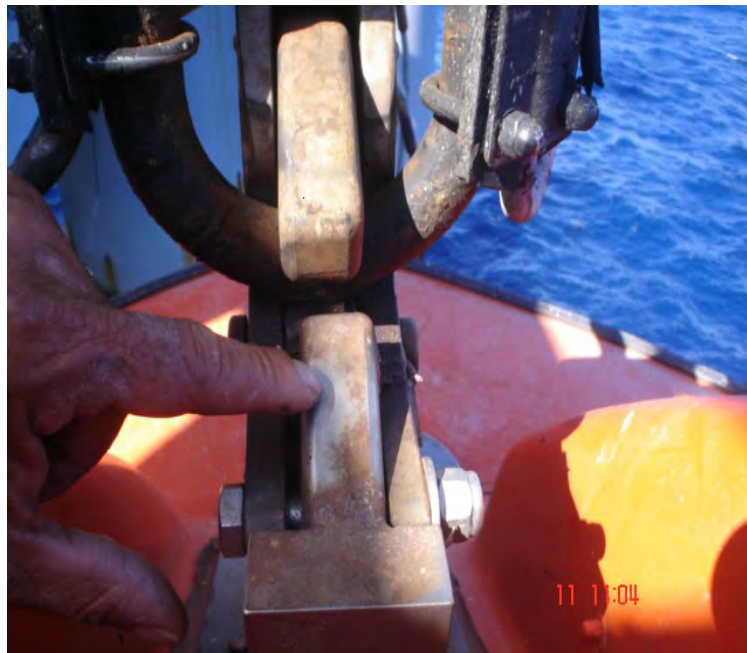
The investigators verified, in the other similar lifeboat existing on board the platform, that the diameter of the eyelet of the cable of the davit, that is held by the hook (Photo 9) presents practically the same measurement of the opening of the forward hook of the damaged lifeboat after accident. They also verified that the hook has a movable part that is part of the project (Photo 9), where is indicated the retention device.

Photo 9-Retention Device, eyelet and hook

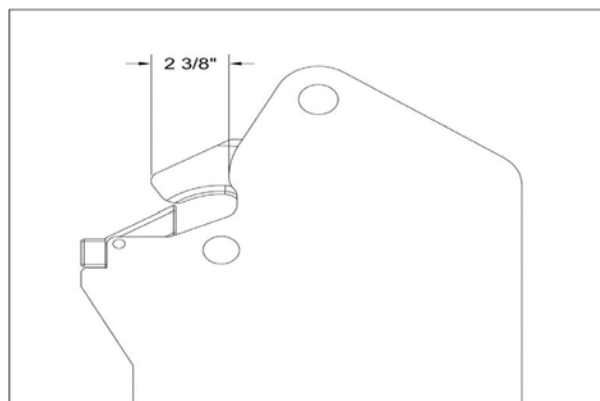
b.1) The 6.5 tonne Triple 5 Release Mechanism Operating & Maintenance Manual established that the distance that the hook should project itself is  $2 \frac{3}{8}$  ins, distance this that does not occur in the hooks of the lifeboats that are on board the platform (Figure 2).

Figure 2 – Adjustment of the hook foreseen by the Triple 5 Release Mechanism Operating & Maintenance Manual
