MARINE SAFETY INVESTIGATION REPORT

**Safety investigation into a crew member fatality
inside the cargo hold on board the
Maltese registered general cargo**

KATI

**in the port of Wismar
on 16 July 2018**

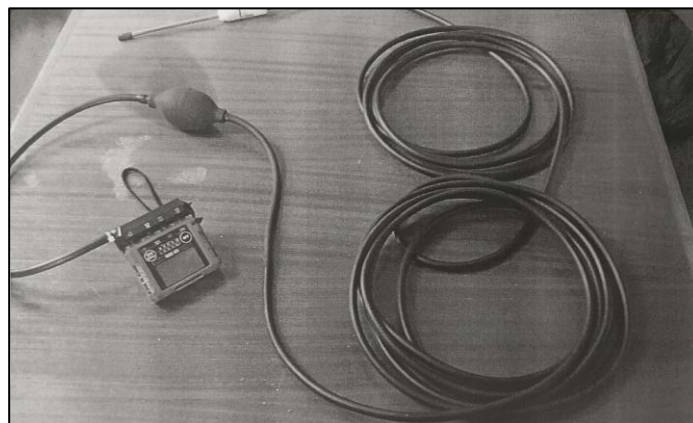
the risk assessment, the multi-gas detector carried on board had to be used (Figure 10).

Figure 10: The multi-gas detector available on board
