**The Bahamas  
Maritime Authority**

**NOVA BRETAGNE**

**Report of the investigation into the  
Accidental release of lifeboat during a drill**

**Antonina, Brazil**

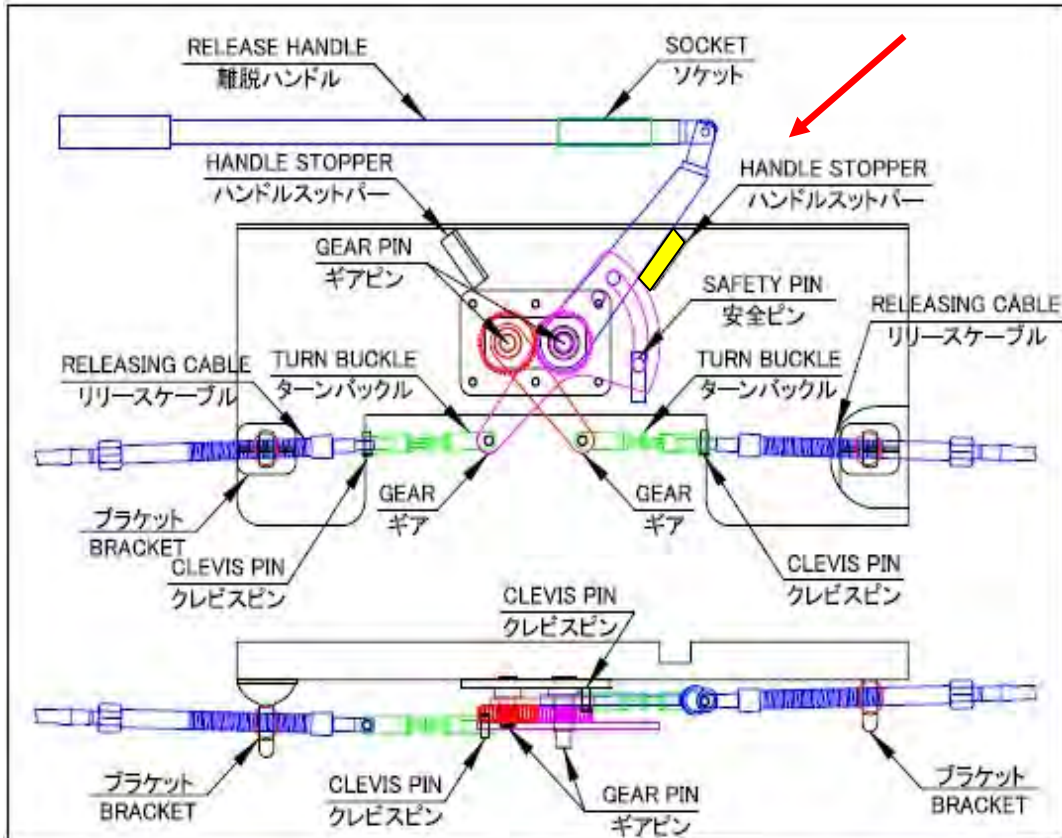
**Figure 1: Release handle mechanism. Diagram from SHIGI Manual**

- 4.6 Further damage to the release lever mechanism was also evident. The crank nearest the operator, labelled “gear” in the manufacturer’s diagram (Figure 1 below), was damaged, showing signs of being hammered in the past. This would suggest that the system could have been locked up at some time due possibly to misalignment of the damaged gear teeth and excessive force was used to free the mechanism. Impacts from the same force may have been responsible for damage to the gear teeth originally.

- 4.8 A stop, labelled “handle stopper” in figure 1 (below arrowed in red and highlighted in yellow), designed to prevent the handle being set too far forward during a re-setting operation, was found to be bent almost flat as a result of excessive force being applied to the handle in the re-setting position (the one illustrated). This would result in removal of a defined stop position for the lever. If, as would appear to be a possibility, this was the case and/or the turnbuckles connecting the cables to the two operating cranks were wrongly adjusted, the final position of the under-deck cam - known in manufacturer’s drawings as the Cam Plate - would be proportionately affected.

- 4.9** The stop referred to above is not fully visible in Photo 5 but it's joint with the back plate is. It is positioned behind the lever, between it and the back plate in a folded flat state. This means that the lever pictured is not in the correct position – it is too far forward – suggesting that the whole linkage is out of adjustment. This in turn allows for a final position of the Cam Plate intended to lock the hook could be out of the horizontal. (see also 4.5 above and 4.11 below).

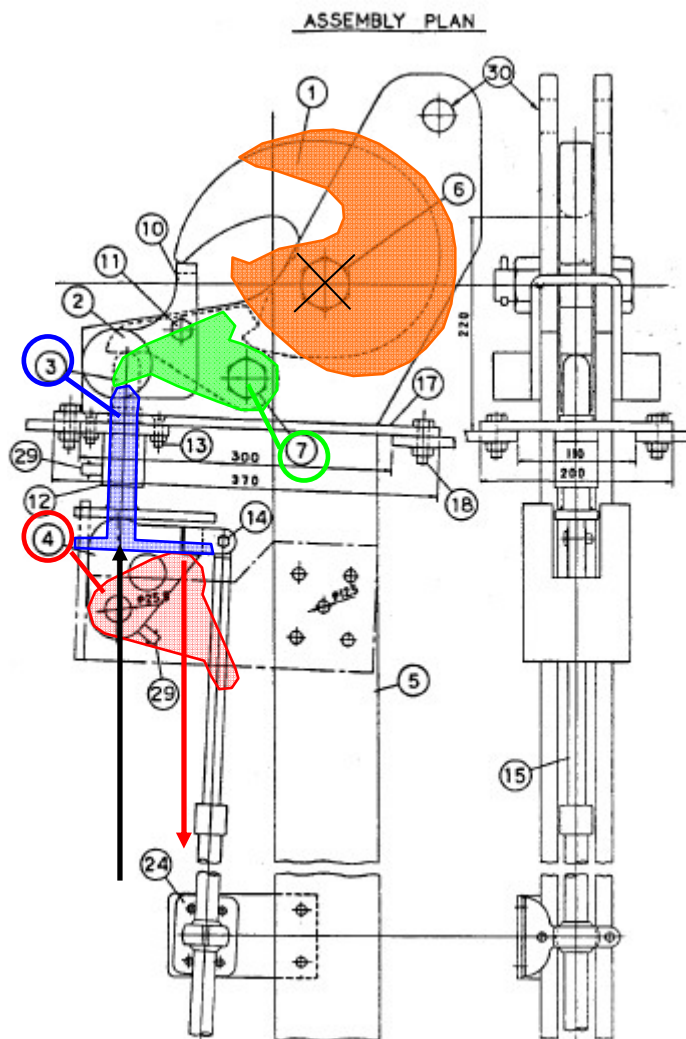
**Drawing: Developed from Excerpt from manufacturer's drawing B73-015**

In this position the tangential contact of the Cam Plate with the Hook Bearer will not be aligned vertically above the fulcrum point and the combination of the down thrust due to the pressure from the hook (red arrow) and the upward reaction through the Cam Plate fulcrum (black arrow) will result in an opening couple. See also Figure 2.

- 4.19** In order for the under-deck Cam Plate to rotate downwards, thus releasing the Lock Piece via the Hook Bearer the linkages of the operating cables must have been displaced, either by deliberate action or under load through the Lock Piece ⑦, Hook Bearer ③ and Cam Plate ④ (See Figure 2).

- 4.21** It is noted that there are some minor differences between the hook fitted to the boat (Photo 8) and the one depicted in the manufacturer's drawing (Figure 2). The side plates do not have the extended horn with hanging-off points formed by the shackling hole - Figure 2 - (30). They are however provided with lugs on either side (starboard lug visible in photo). These lugs have significance in the use of FPDs discussed below.

**Figure 2:**  
**Hook Assembly showing mode of operation. Note in closed position Cam Plate ④ is tangentially in contact with Hook Bearer ③ in position vertically above fulcrum of Cam Plate thus locking mechanism. In any other position an opening couple is possible under load, indicated by Red arrow, representing downward force acting in conjunction with the black arrow representing the lifting force exerted by the suspension link acting through from the hook ①**

- 4.23** If the cam plates were not in the locked position the weight of the boat – 4500 kg plus gear and occupants – would apply an opening couple through the Lock Piece – Fig.2 ⑦, Hook Bearer – Fig.2 ③ and Cam Plate – Fig.2 ④, illustrated by the red arrow in conjunction with the black arrow in Figure 2. The resulting force could displace the cable if the second articulation occurred at the Release Lever position.

**4.49** The safe status of the hooks was an illusion because they had not been correctly re-set. The Cam Plate, if it had been properly positioned, would have presented a bearing surface tangential to the Hook Bearer Boost Plate that was perpendicularly above the pivot pin of the cam (see Figure 2). With the Cam Plate in this position there could not be any rotating force on the cam and the Lock Piece would have to remain enmeshed with the Hook.

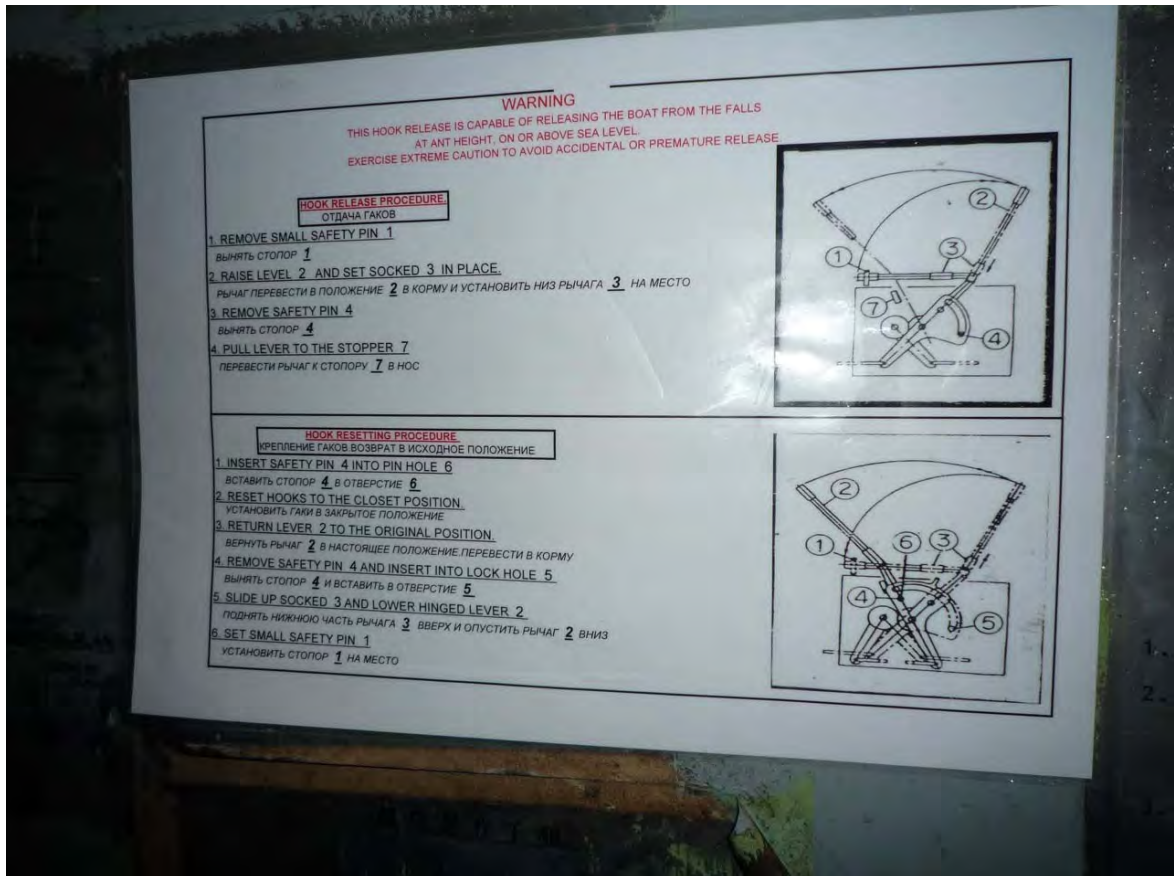
- 4.40** The lifeboats aboard NOVA BRETAGNE were manufactured by Shigi. The release gear was also manufactured by the same company. The arrangements in the boat included a set of instructions referring to the resetting arrangements of the hooks (Photo 9). Whilst the instructions are comprehensive, the mechanism is complex and it is debatable whether the whole arrangement and instructions could be regarded as intuitive.

Photo 9: Instructions for Operation of the release mechanism and hook resetting procedure.

The “Instructions for Operation” sign in Photo 9, located on the starboard side of the engine housing, beneath the feet of the helmsman has a warning header in red indicating that:

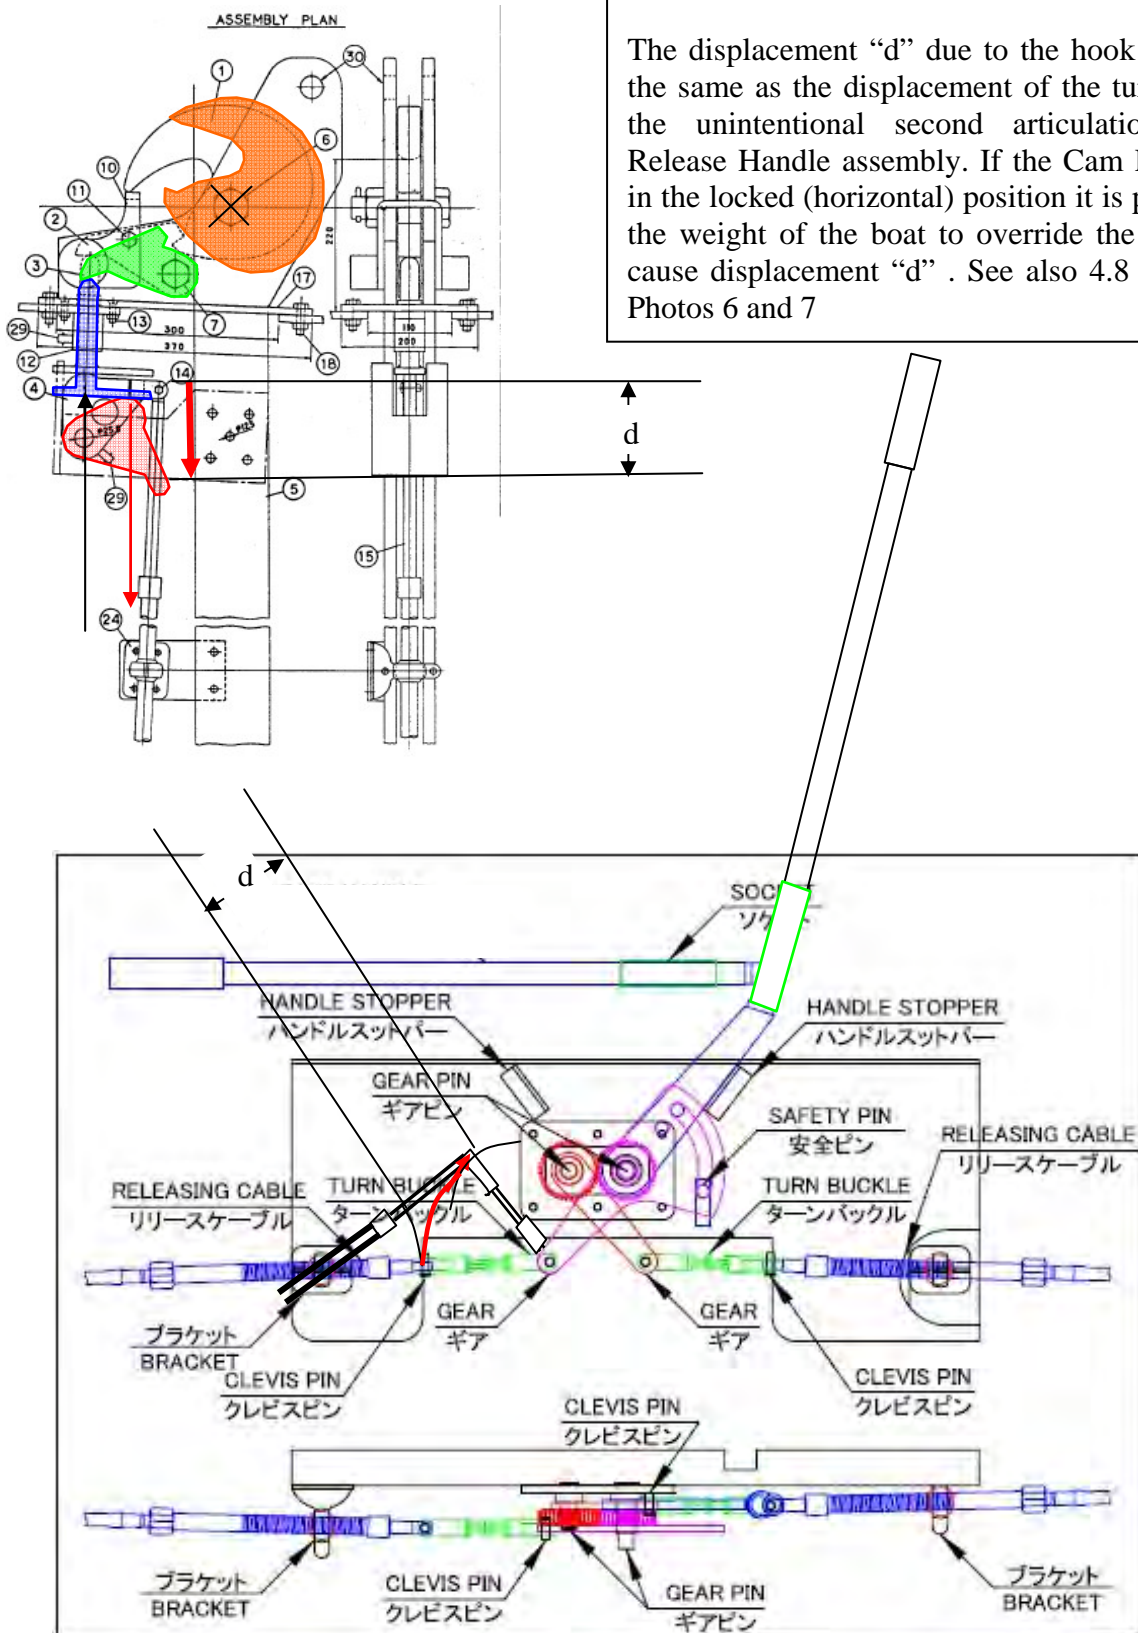
In the diagrams below scale is approximately the same for both drawings.

The displacement “d” due to the hook opening is the same as the displacement of the turnbuckle at the unintentional second articulation of the Release Handle assembly. If the Cam Plate is not in the locked (horizontal) position it is possible for the weight of the boat to override the levers and cause displacement “d”. See also 4.8 – 4.21 and Photos 6 and 7

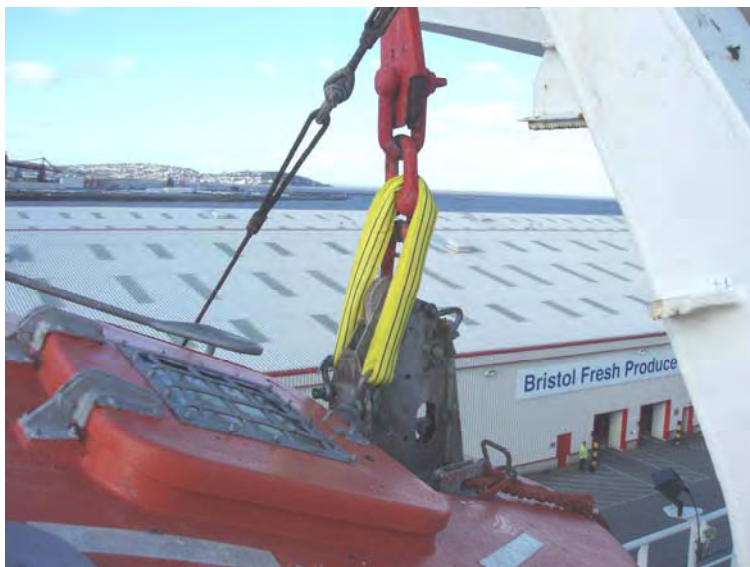
**Above and Right:** After hook arrangement on the SHIGI boat showing side lugs that are suitable points of attachment for FPD Slings.as in the arrangement below.

Note the close proximity to the access hatch, making this arrangement even more suitable as an immediate modification.

Note: Slings are more suitable as FPDs than are Stropps as they do not have eye splices. This eliminates additional points of weakness. It also enables a shorter connection where this may be necessary.

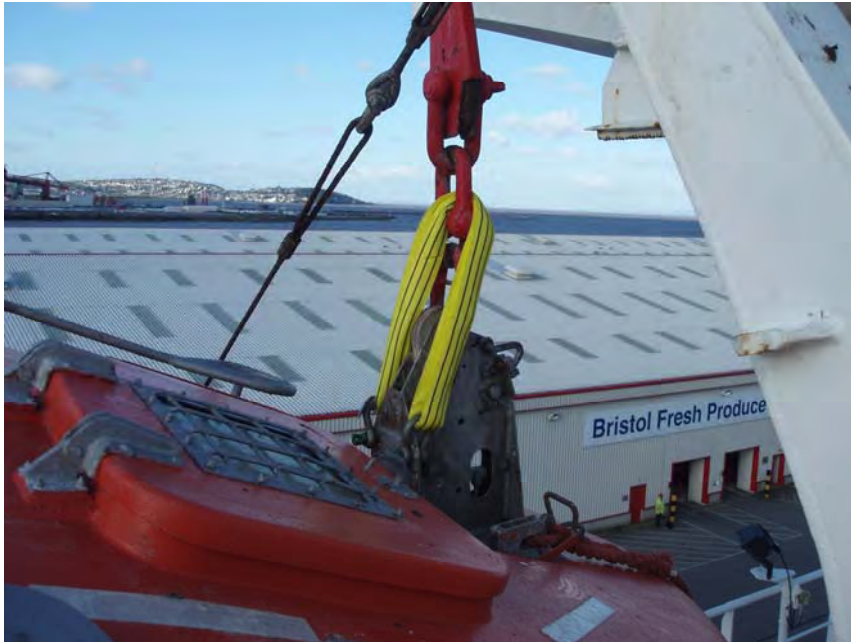
Continuous sling in place over-riding on-load release

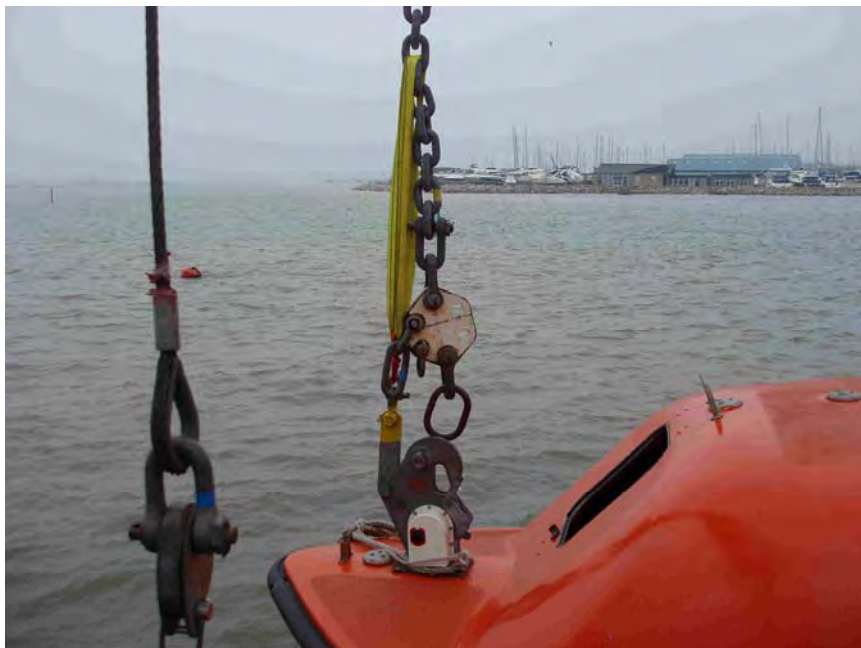
FPD taking load during exercise, simulating premature release of on-load hook. Note boat is not waterborne but suspended just above the water – a safety precaution for avoiding injury to personnel or damage to structures during the exercise.
