ATSB TRANSPORT SAFETY INVESTIGATION REPORT
Marine Occurrence Investigation No. 208
Final

Independent investigation into the lifeboat accident and
fatalities aboard the Hong Kong registered bulk carrier

Lowlands Grace

at anchor off Port Hedland, Western Australia on
7 October 2004

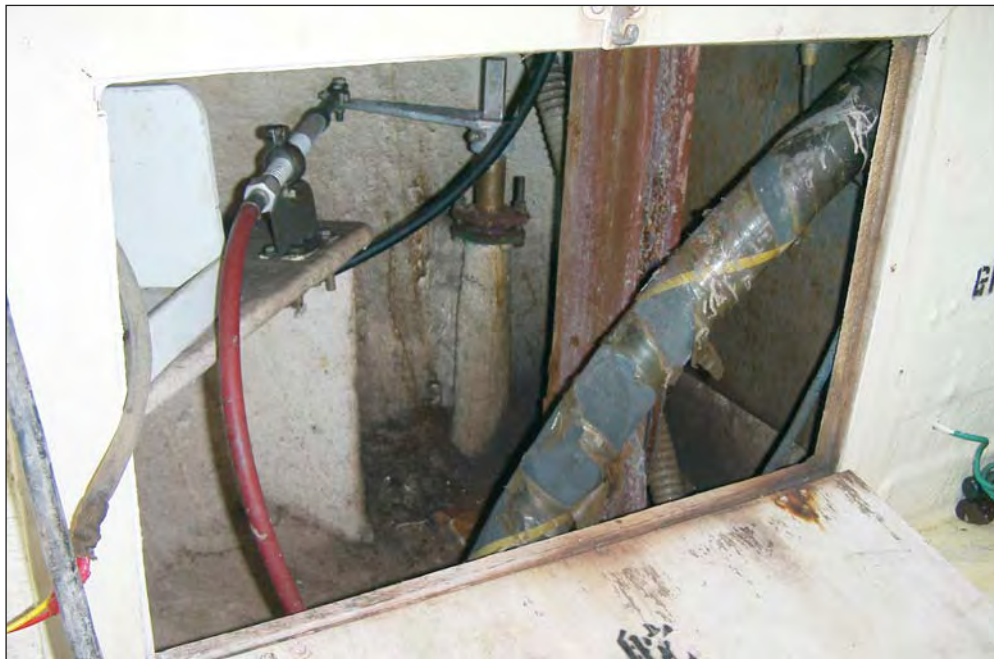
Figure 3: After bulkhead inside the boat with access door open

Plywood bulkheads are fitted to the forward and after ends of each lifeboat. The forward bulkhead encloses the keel stays and keel attachment for the forward lifting hook. The after bulkhead encloses the tiller mechanism, a section of the engine exhaust pipe and the after lifting hook's keel stays and attachment (Figure 3). Both bulkheads are fitted with doors which allow for the inspection of the enclosed spaces.

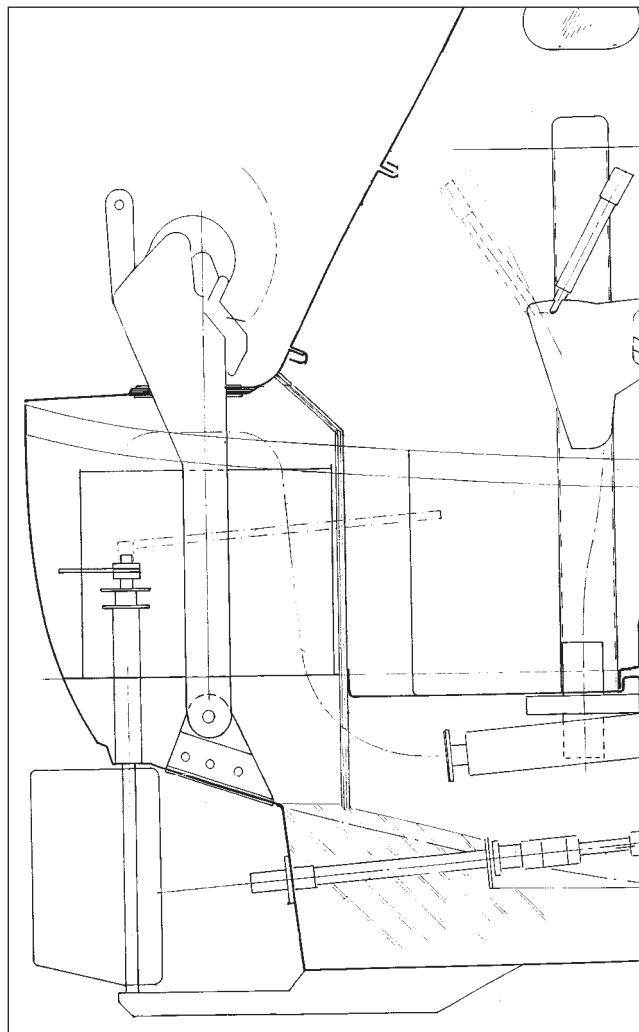
Figure 9: Schematic showing after hook keel attachment

Keel attachment: The cheek plates of each hook mechanism extend to form keel stays, which are through bolted to keel blocks fixed to the keel. The keel stays are fabricated from 15 mm galvanised mild steel plate and are attached on either side of the 20 mm galvanised mild steel keel block by a 30 mm stainless steel bolt (Figure 9).

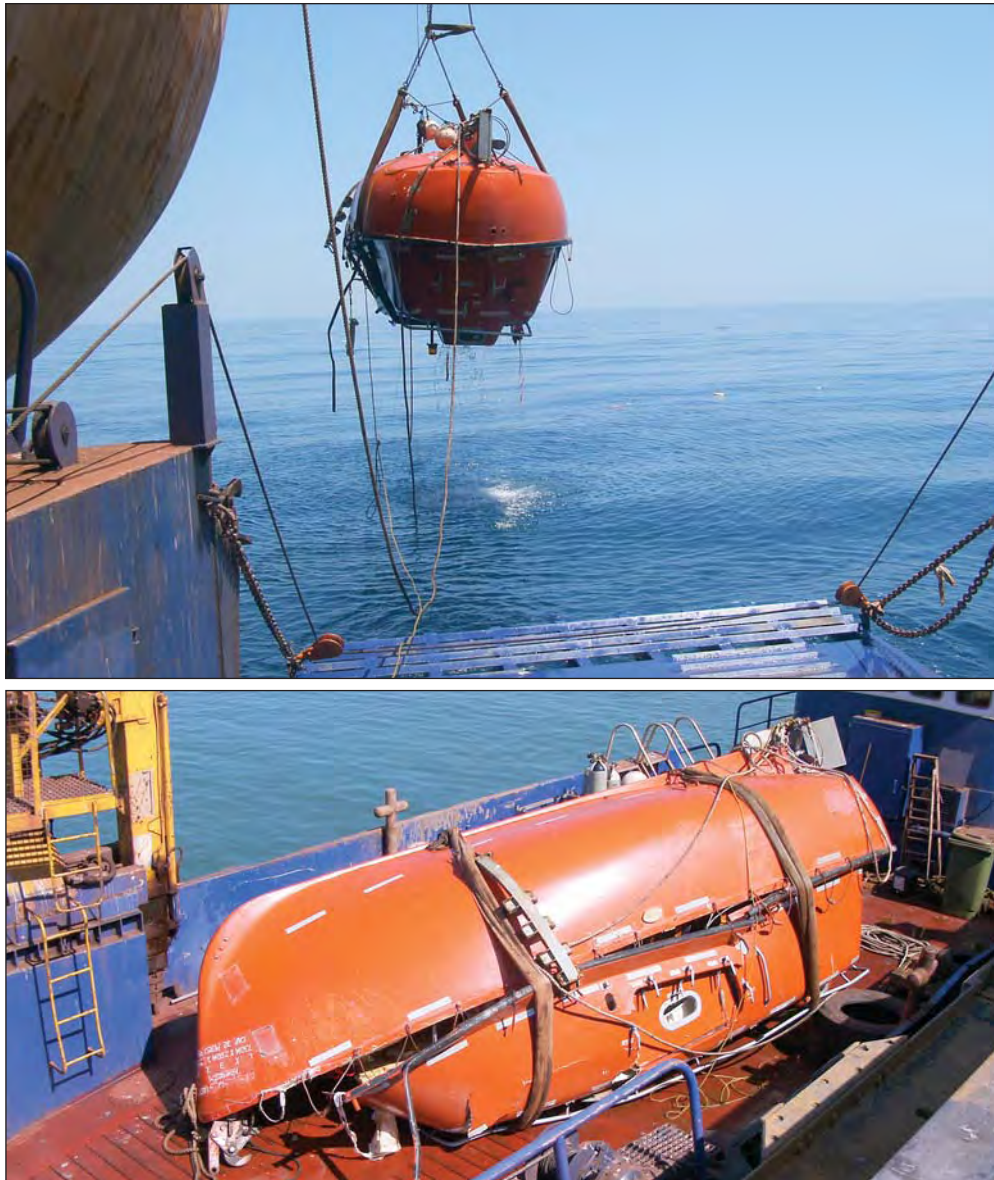
Figure 11: Port lifeboat being recovered

On 9 October 2004, investigators from the Australian Transport Safety Bureau (ATSB) arrived on board *Lowlands Grace*, at anchor off Port Hedland, to conduct an investigation into the circumstances of the lifeboat accident. At the time, the port lifeboat was still afloat, upside down, alongside the port side of the ship tethered by painters. Attempts were made during the day of 9 October to recover the lifeboat by righting it and pumping it dry so that it could be towed ashore. These attempts proved to be unsuccessful. The following day another attempt to recover the lifeboat was made by lifting the lifeboat clear of the water using slings passed around the boat, which were then attached to the lifeboat davit falls. This attempt was successful and the lifeboat was loaded on board a small landing barge for transport to a shore facility in Port Hedland (Figure 11).

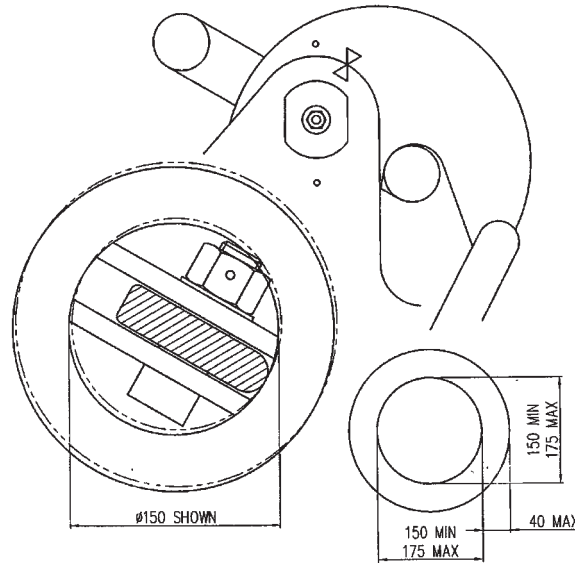
Figure 22: Lifeboat manufacturer's recommended suspension ring

The suspension ring specified by the on-load release manufacturer for 5 tonne Titan on-load release systems is a circular ring with a minimum internal diameter of 150 mm and a maximum internal diameter of 175 mm. This ring is sized to ensure that in circumstances similar to those which occurred on *Lowlands Grace* the suspension ring will clear the main pivot pin and thus not form a lever to increase opening forces on the hook (Figure 22). Had *Lowlands Grace*'s lifeboat davits been fitted with the suspension rings stipulated by the on-load release manufacturer, there would have been significantly less opening force applied to the forward hook and it may not have failed and opened under load.

5 – Tonne 'Titan' gear recommended ring size shown in detail.
Minimum ring size, showing clearance over hook pivot pivot pin

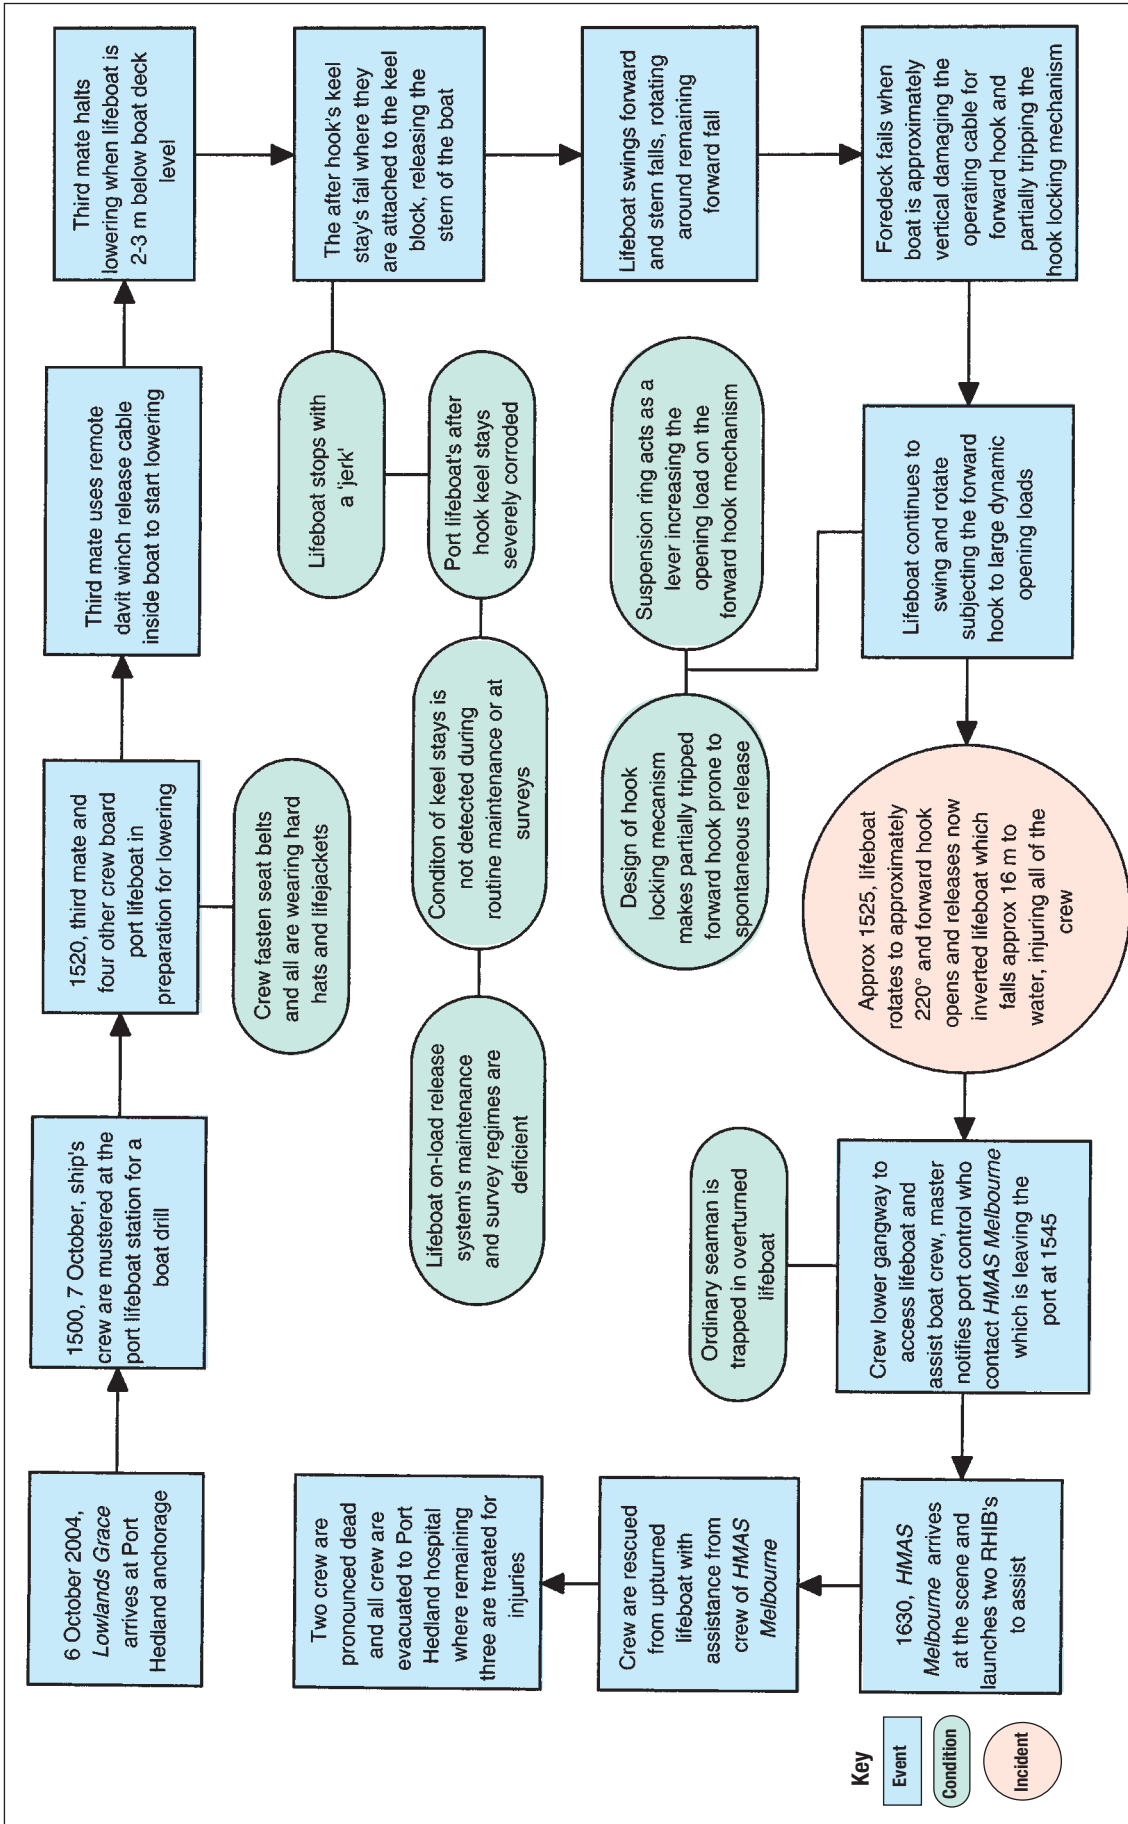
Figure 24: Lowlands Grace's Events and causal factor chart

While the *Lowlands Grace* incident is somewhat different due to the failure of the foredeck, the design issue vis-a-vis the cam release pin is still implicated. While the possibility that other designs of on-load release systems would also have failed in the circumstances cannot be ruled out, had *Lowlands Grace*'s port lifeboat been fitted with a system utilising a more positive method of locking the hooks, it is possible that the severe consequences of the accident could have been avoided.
