**Bundesstelle für Seeunfalluntersuchung**  
**Federal Bureau of Maritime Casualty Investigation**  
Federal Higher Authority subordinated to the Ministry of Transport,  
Building and Urban Development

**Summary**  
**Investigation Report 554/07**

**Person injured by the fall of a lifeboat on the**  
**MS MSC GRACE**  
**at Neue Weser North-Roads**  
**on 31 October 2007**

1 August 2008

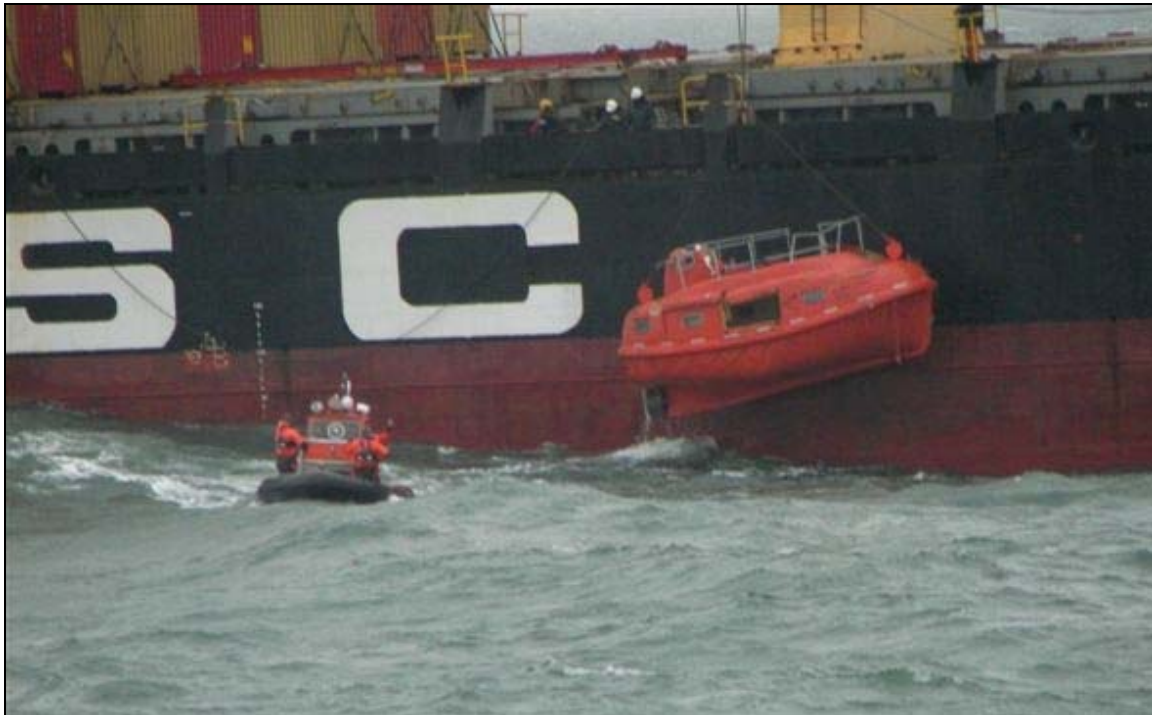
Figure 3: Taking the lifeboat onboard using the MSC GRACE cargo gear and a Federal Police control boat

At 13:50, the MSC GRACE picked up the lifeboat with its own cargo-handling gear and placed it on a clear hatch area (Figure 3).

The port lifeboat suffered serious damage from the fall and from lying alongside. It was taken to land at Bremerhaven and the MSC GRACE continued her voyage with an exemption certificate and additional life rafts.

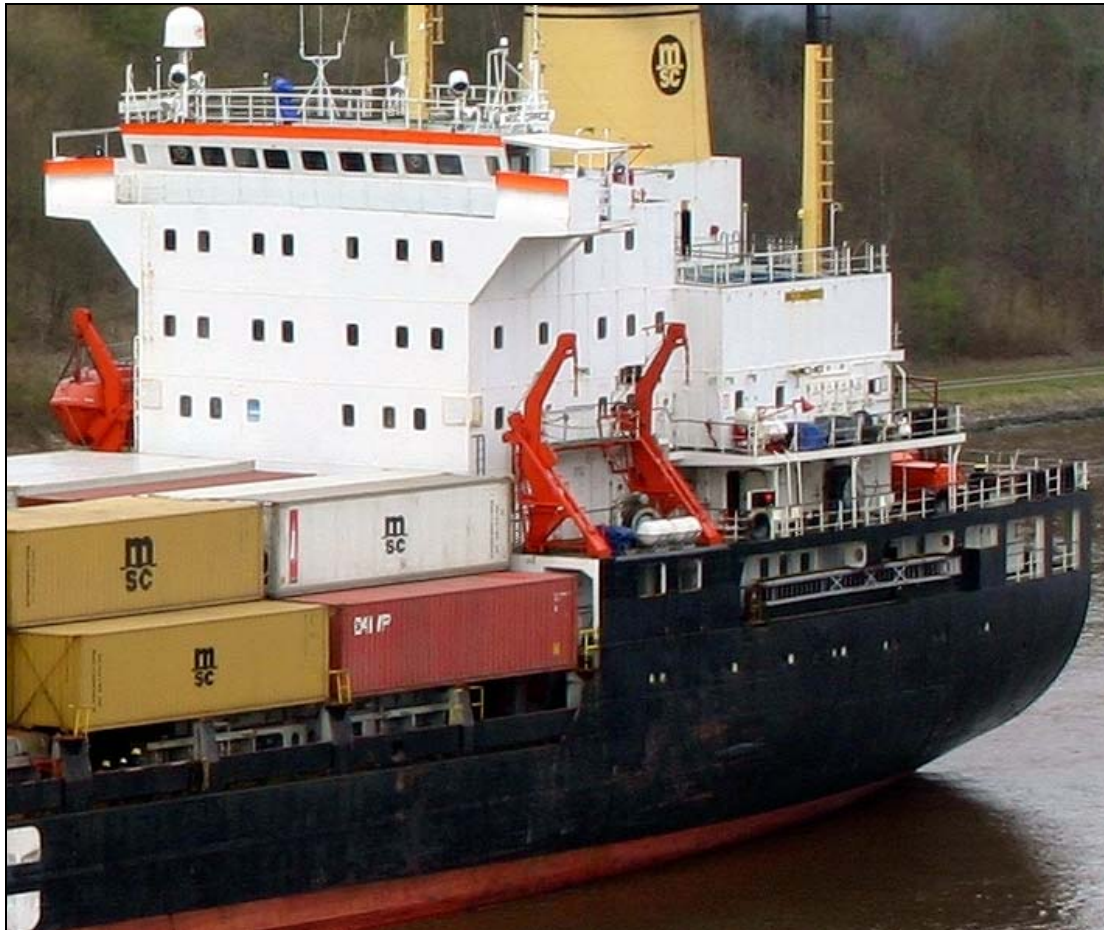
Figure 4: MSC GRACE superstructure

The lowering device is located on the boat deck, two decks above the main deck. The davit area is bounded to the aft end and towards the midship side by the vessel's superstructure (Figure 4). The lifeboat can be manned in stowing position. Access is from the next deck up via a platform which is integrated into the davit system. Access to the boat is through a large opening on the side of the top section.

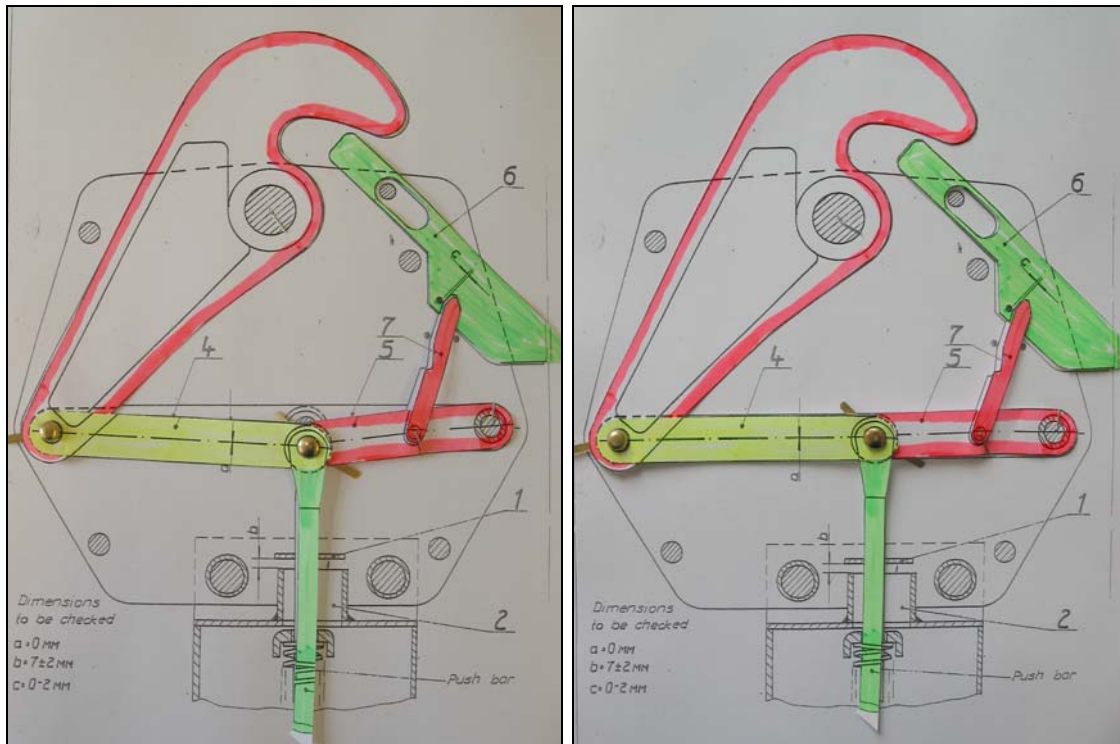
Figure 10: Releasing hook, left in closed position; right in blocked position<sup>2 3</sup>

In Figure 9, the releasing hook is pictured in a self-locking position. This position is characterised by two features. Firstly the cover (which is securely fixed to the release rod) is lying without a gap ( $b$ ) on the guiding mechanism of the release rod. Secondly, the arms of the connecting elements do not form a horizontal line but are at an obtuse angle to each other. The load applied to the releasing hook by the suspended boat consequently generates a downward motion of the release rod.

<sup>2</sup> Figures 10 to 12 do not reproduce the correct position of the cover in the corresponding positions of the releasing hook.

<sup>3</sup> The technical drawing labels for these positions state "closed" and "blocked position".

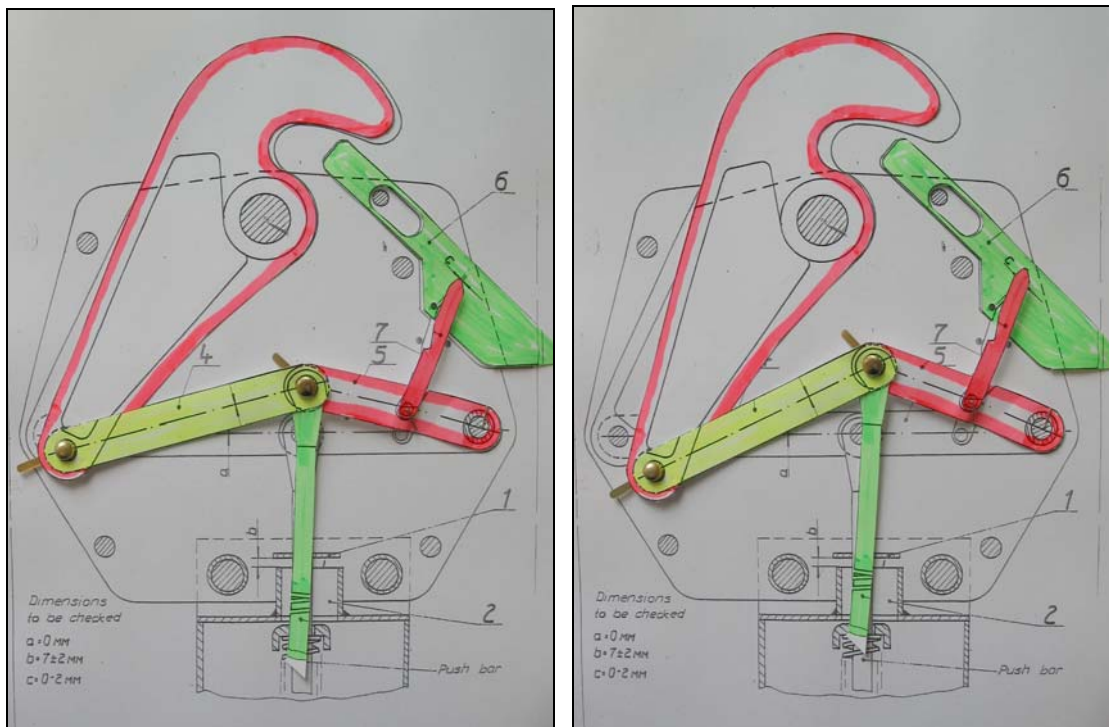
Figure 11: Opening process of the releasing hook

The release rod is guided from below inside the releasing hook. The release rod displaces the hook tail of the releasing hook via two connecting elements. Only the hook in its rotary axis and one connecting element have a fixed bearing between the foundation plates (Figure 9 = +). This facilitates the course of movement as illustrated in Figures 10 to 12.

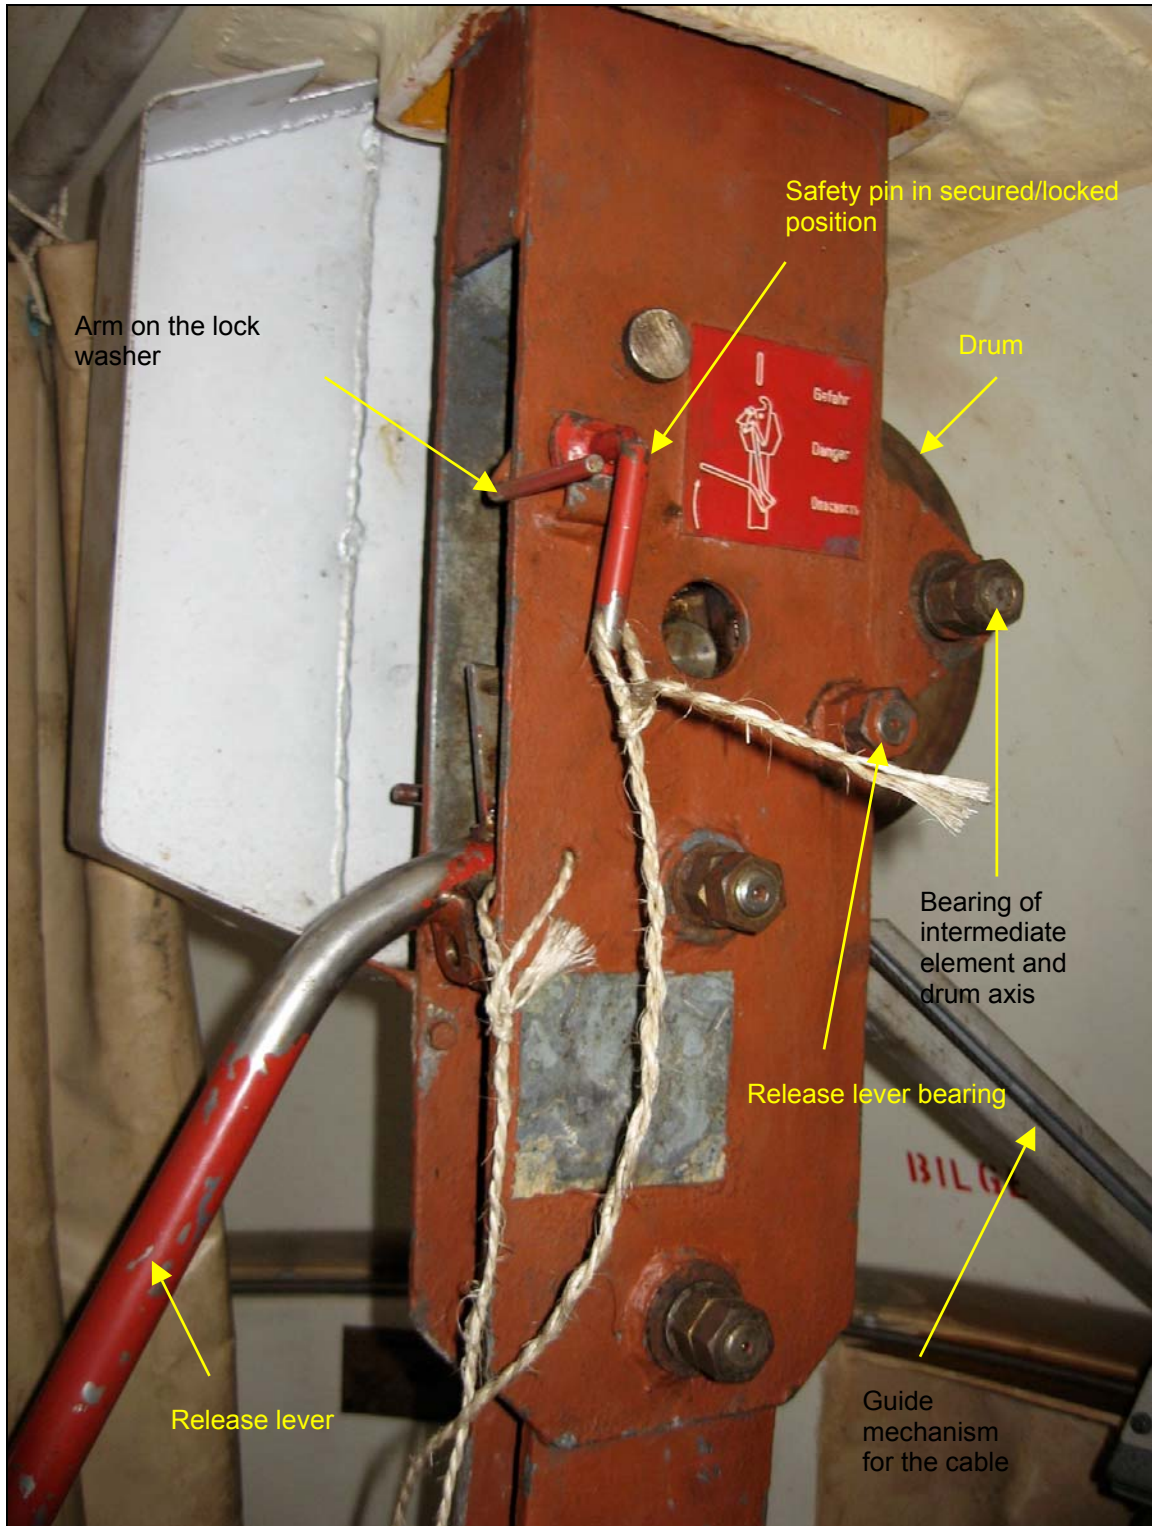
Figure 14: Release unit (view from port)

An intermediate element that only rests on the release lever is moved up as a result of the upward motion of the single-bearing release lever. The movement of the release lever is against a spring. The spring is pushed onto the release rod (see Figure 9).

If the system is set according to the design, the release system can only be secured by the segmented disk when the releasing hook is back in closed position. Only then will the connected release rod move down enough for the segmented disk to fall back into starting position.

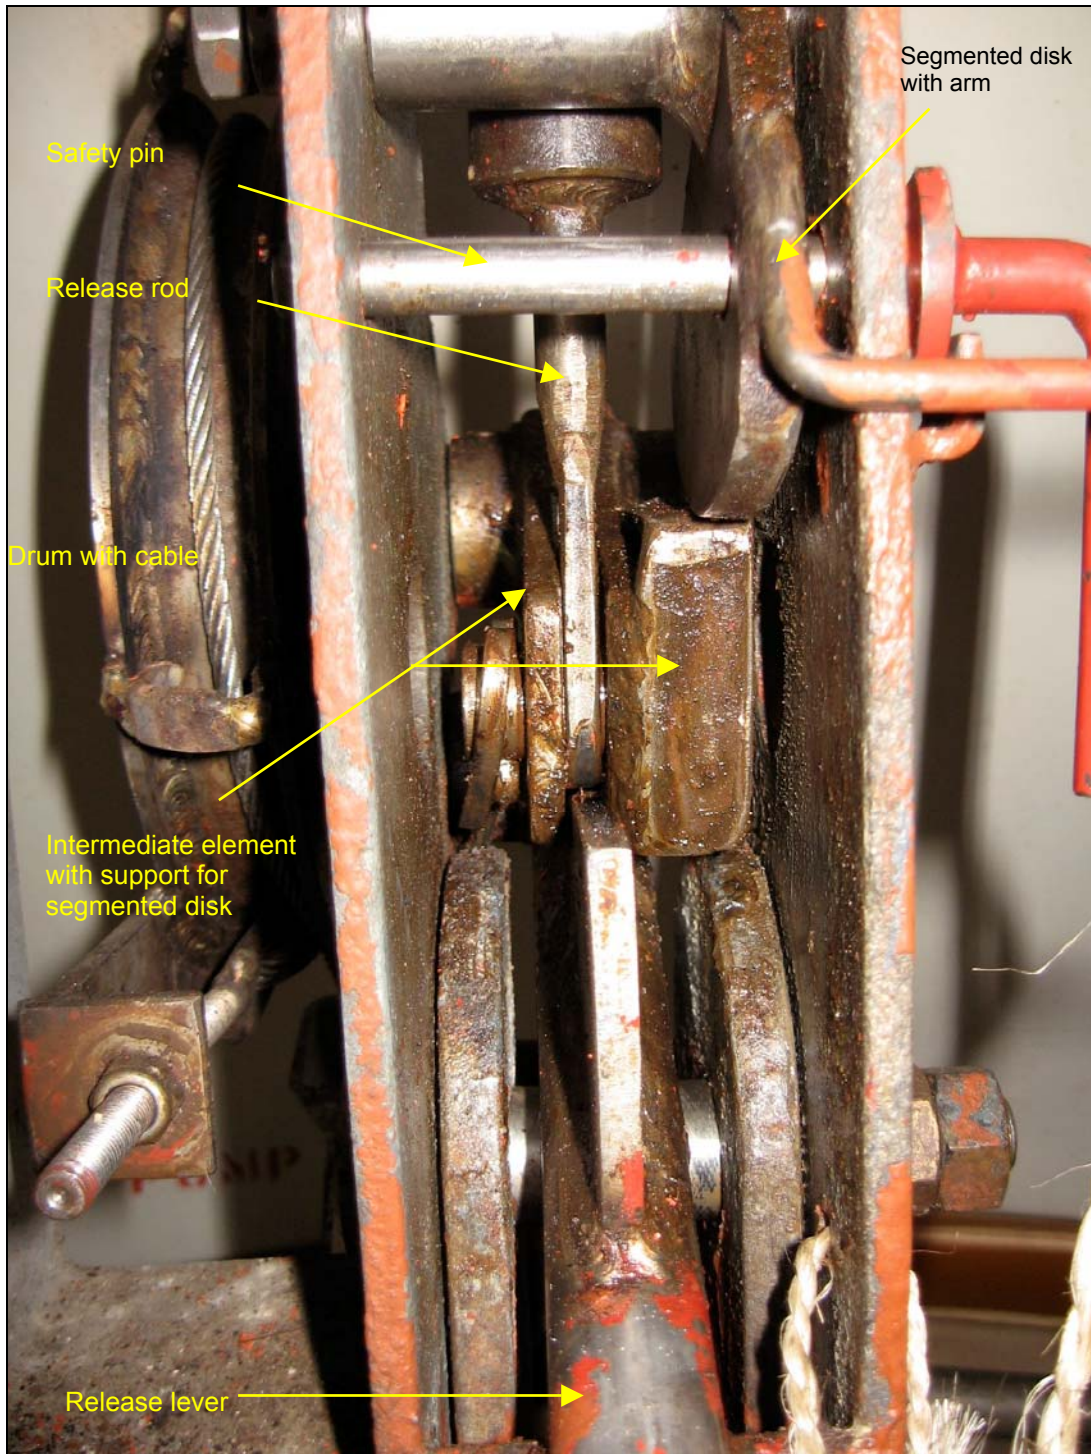
Figure 15: Release unit (view from aft)

The intermediate element (like the release lever) is a one-sided lever. The release rod and another component are secured to its free end; the segmented disk lies against this component in a secured position (Figure 15). A drum is located outside the foundation plates on the side of the lever's rotary axis. The drum turns with a movement of the intermediate element. A cable is placed onto the drum and tightened. With the aid of the cable, the movement of the release lever on the aft releasing hook is transferred to the fore releasing hook, where there is a similar drum. As a result of the rotational direction being opposite to that of the aft drum, the intermediate element here is also moved up which presses the release rod up to open the hook (Figure 16). At the same time, a spring is tensioned on the front releasing hook.
