Improving navigational safety

The role of e-navigation

Captain Harry Gale
MNI, Technical Manager
and **David Patraiko**
FNI, Director of Projects

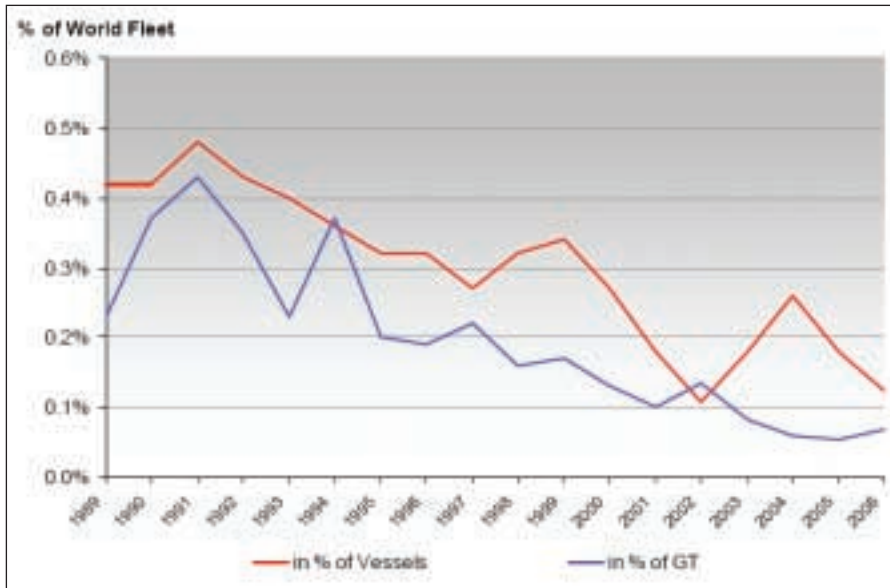
▲ Figure 1: Total losses 1989 – 2006 as percentage of world fleet - vessels >500gt

A recent report by the International Union of Marine Insurance (www.iumi.com) shows a continuing downward trend of percentage of total losses of ships, decreasing from about 0.5 per cent in 1990 to about 0.1 per cent in 2006 as shown in Figure 1 opposite.

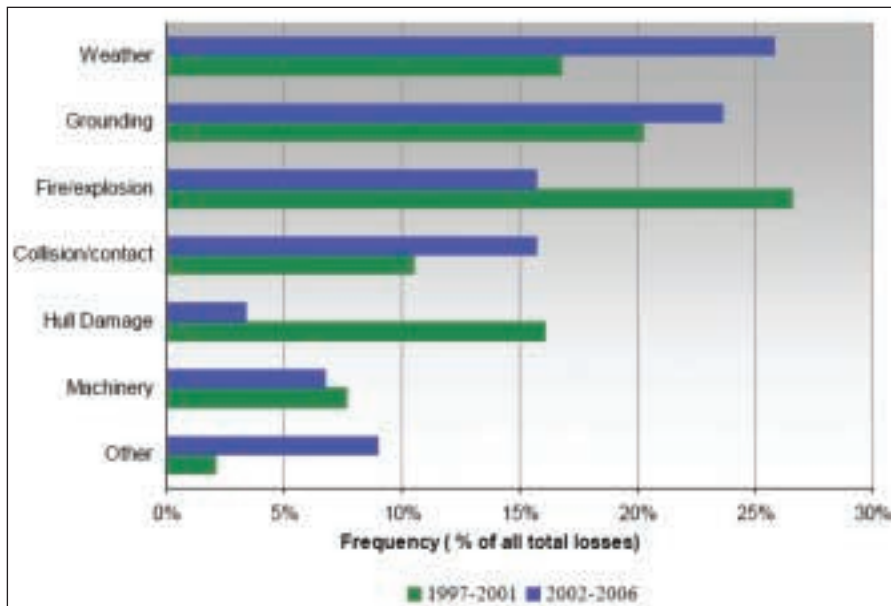
▲ Figure 2: total losses 1997-2006 by cause (all vessel types – vessels >500gt)

viewed, it is seen that total losses by grounding and collision have increased by four-five per cent and serious losses by grounding and collision increased by two-three per cent in the years 2002-2006, compared with 1997-2001, as shown in Figures 2 and 3 (opposite).

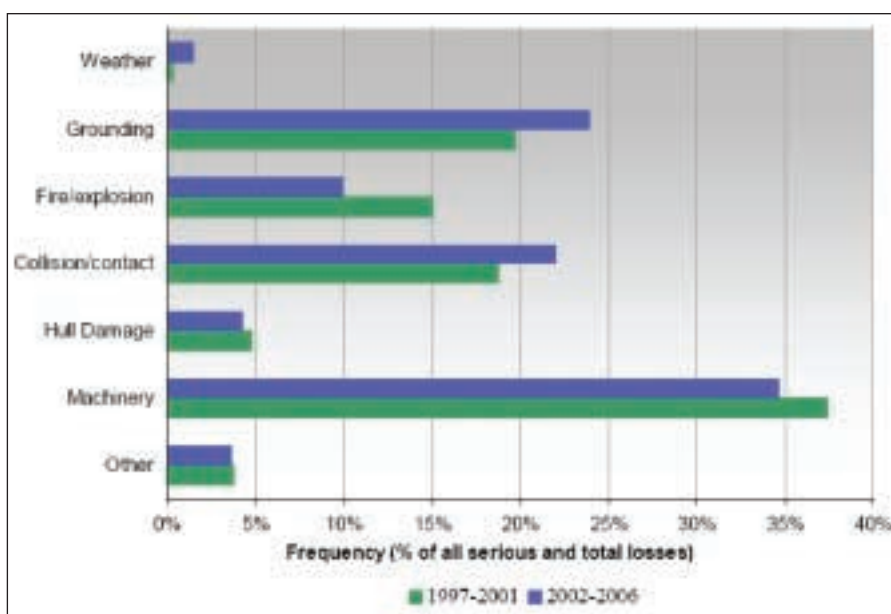
▲ Figure 3: Serious losses 1997-2006 by cause (all vessel types – vessels >500gt)

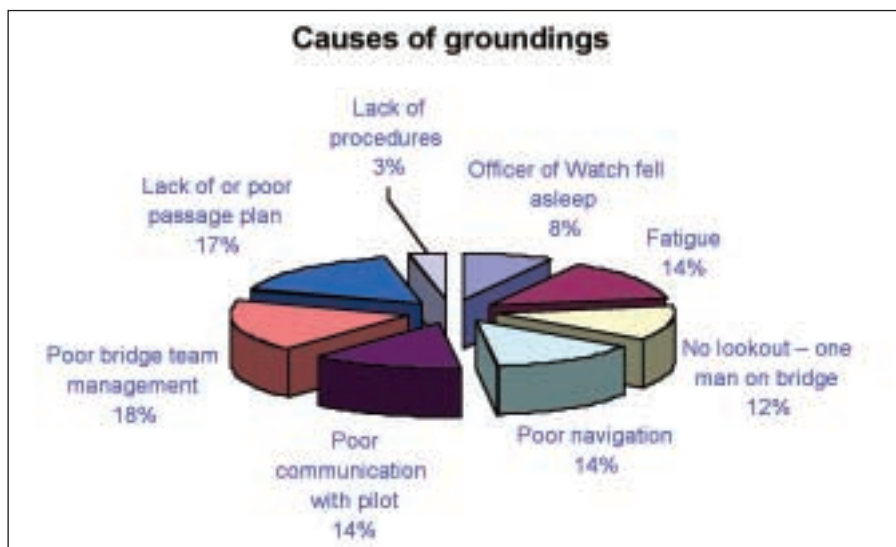
▲ Figure 5 Attributed causes of groundings

■ Figure 5 shows the percentage of the attributed causes of groundings. (Note: some incidents were attributable to more than one cause.)

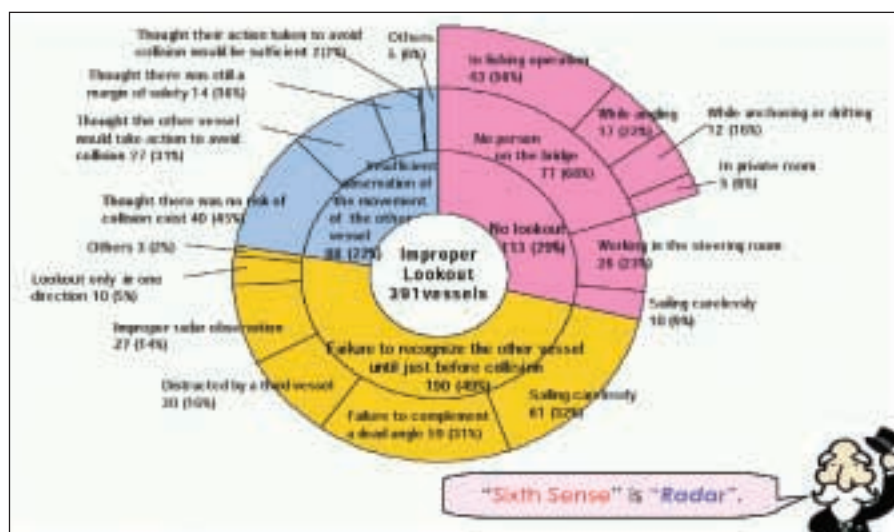
▲ Figure 6: Factors of improper lookout in case of collisions 2004

insufficient observations of the other vessel, as shown in Figure 6 below.

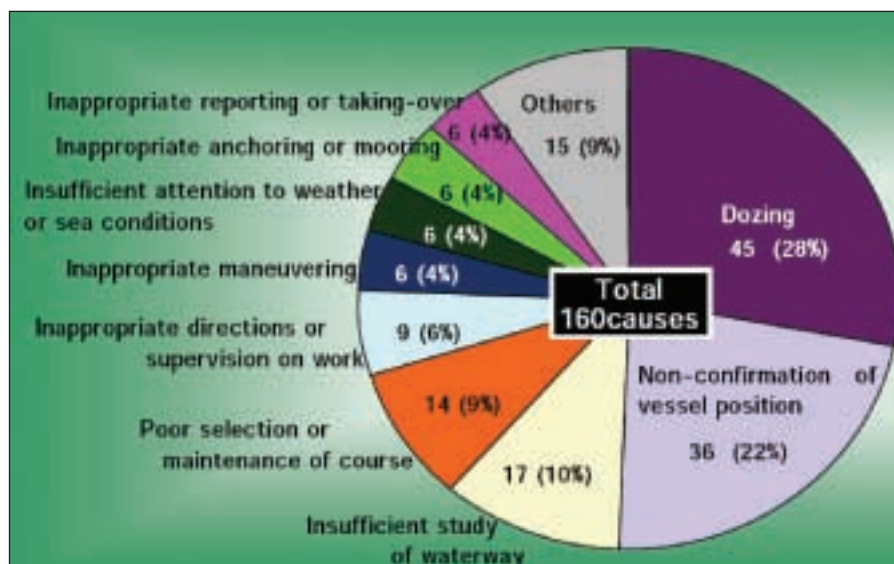
▲ Figure 7: Factors causing groundings 2004

In their investigations into groundings, the MAIA found that half the accidents were attributable to two factors – the OOW falling asleep and the vessel's position not being checked. This is shown in Figure 7.
